NBS BUILDING SCIENCE SERIES 102

# The Thermal Performance of a Two-Bedroom Mobile Home

U.S. DEPARTMENT OF COMMERCE • NATIONAL BUREAU OF STANDARDS

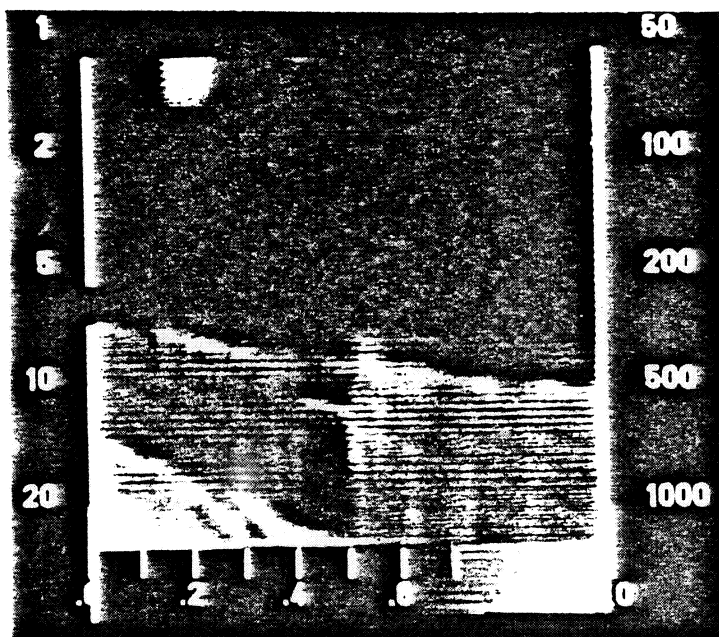
FIGURE 23. Angular thermograph of exterior sidewall of mobile home. Dark area (colder) is the aluminum wall surface. Lighter area (warmer) below is the skirting at base of mobile home, and white area in lower left is ground surface. Dark area found in skirting is an air vent (refer to figure 14).

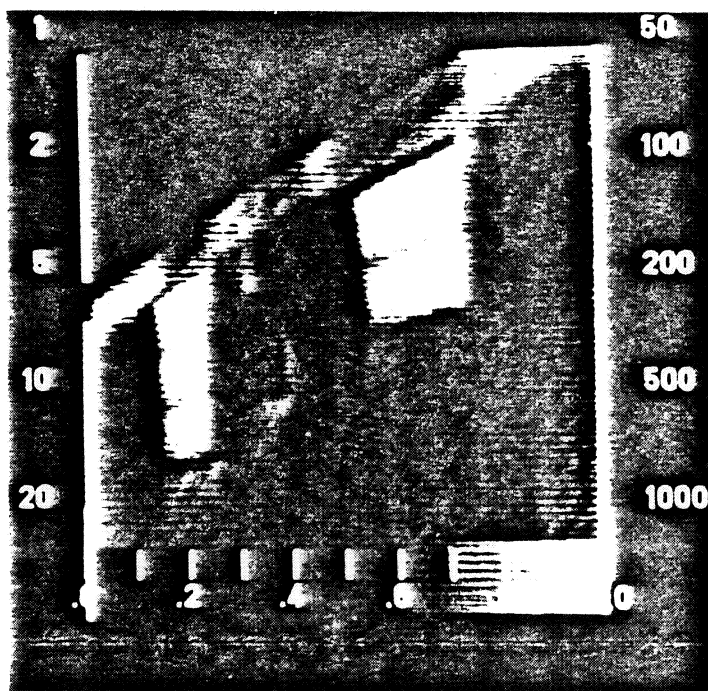
FIGURE 24. Warmer horizontal aluminum trim at wall/roof juncture.

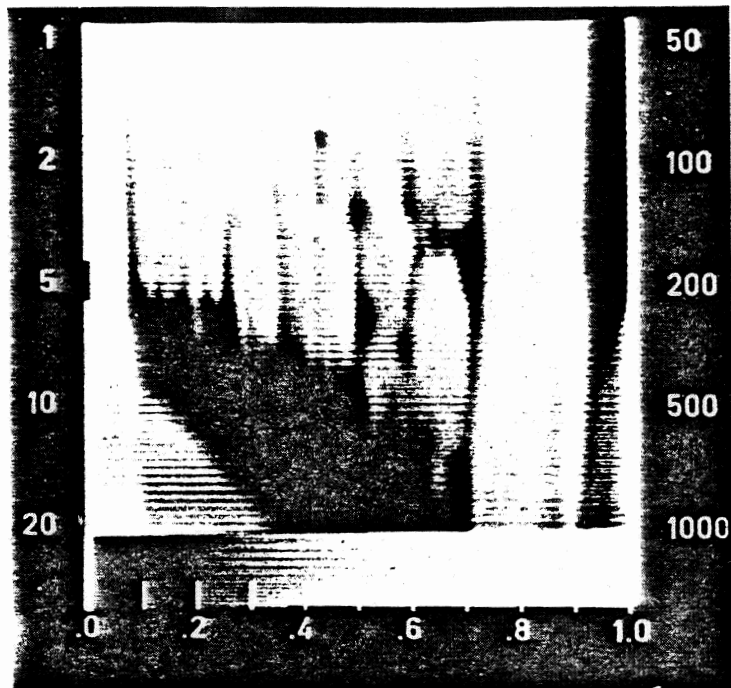
FIGURE 25. Wall along hallway looking from kitchen area. Walls are colder at the base of the wall. Cold streaks occur randomly along wall.

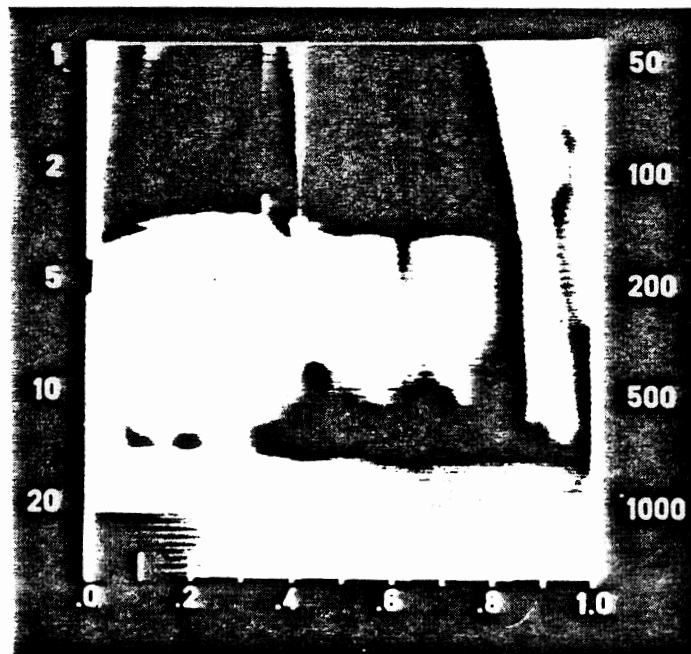
FIGURE 26. Wall at base of double living room window. Warm air registers at lower left is warming the wall surface under left window.

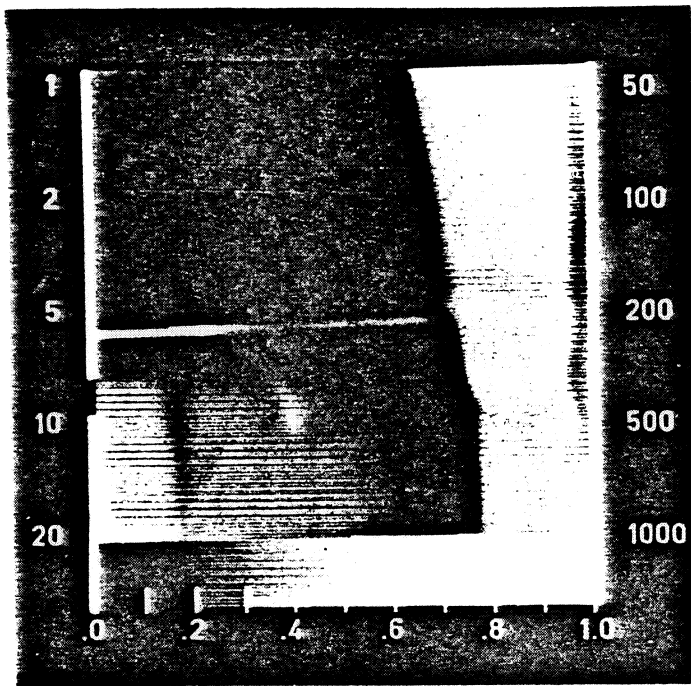
FIGURE 27. Window with warm curtain (light area) on right side. Dark (cold) area on wall under window is due to perceptible cold air leaking into mobile home.

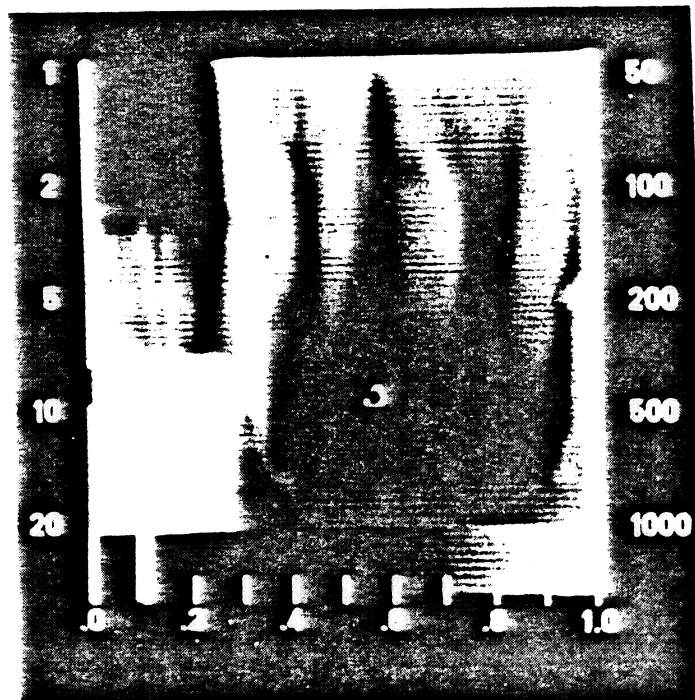
FIGURE 28. Living room wall/wall/floor corner. Perceptible air leak in corner created very cold spot, out of camera range. Light area in lower left is couch.

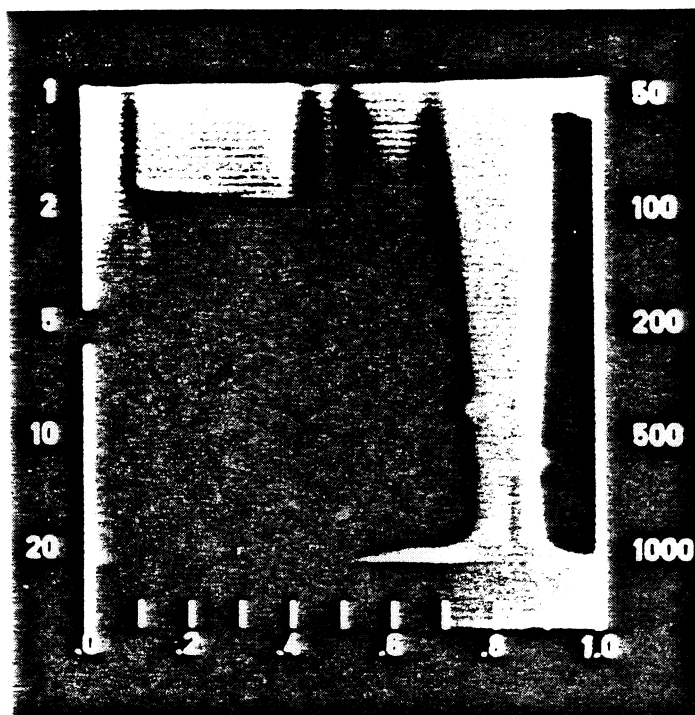
From these observations, it was hypothesized that cold air must be in contact with the interior wood paneling. This early hypothesis was later supported when it was observed that the cold patterns on the wall correspond directly with locations where the insulation was not in contact with the wood paneling, leaving an air channel between the insulation and the paneling.

FIGURE 29. Wall area to left of living-room side-wall window. Picture on wall at upper left, draperies along window on right side of picture. Dark areas are cold. Note wall studs showing through in upper center. Location as shown on figure 30.

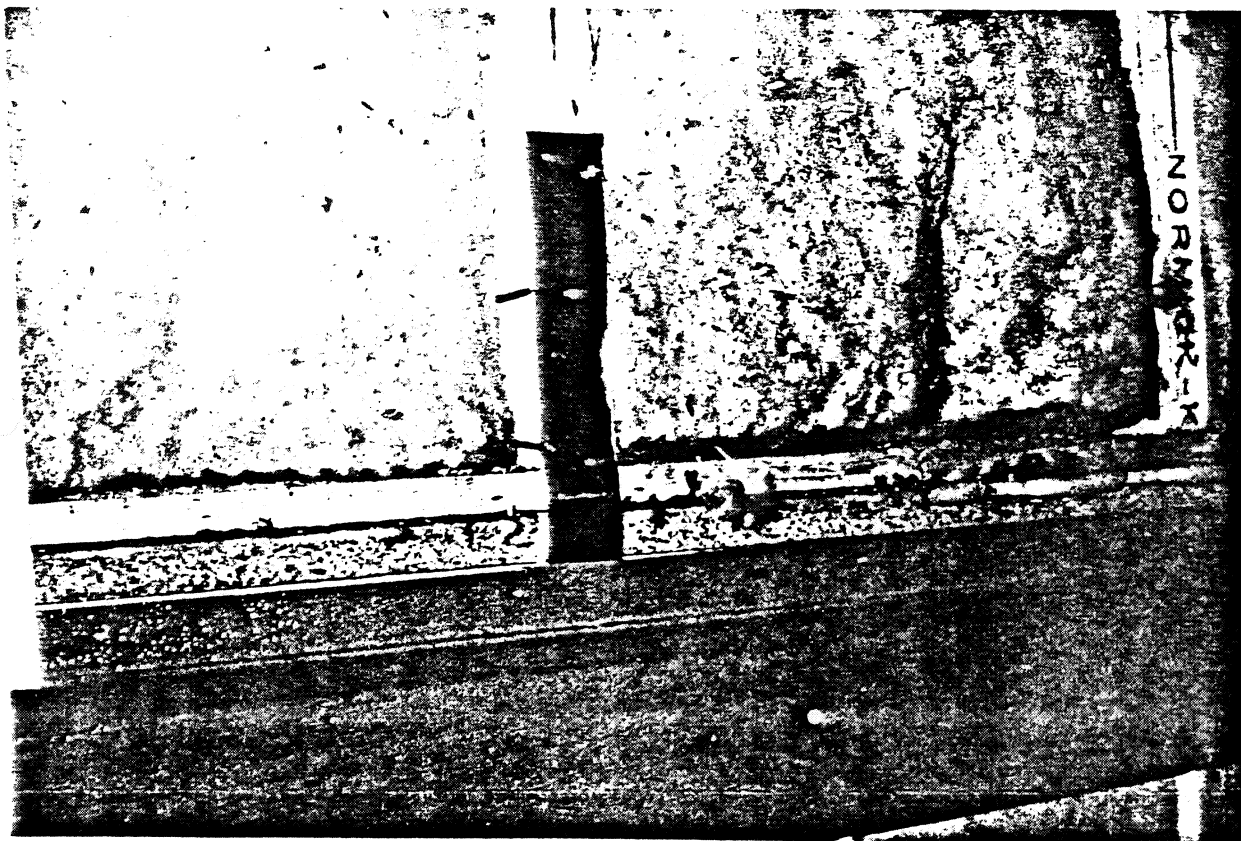
Since gaps were observed at the top and bottom of the insulation (fig. 31), it was considered possible that cold air could enter the cavity, pass under the insulation, rise between the insulation and interior paneling and then pass to the outside over the insulation at the top. The exterior aluminum paneling allows more or less free passage of outdoor air into and out of the wall cavity outside of the insulation.

FIGURE 31. Gap between still plate and bottom of insulation which could allow outside air in contact with back of inside paneling.

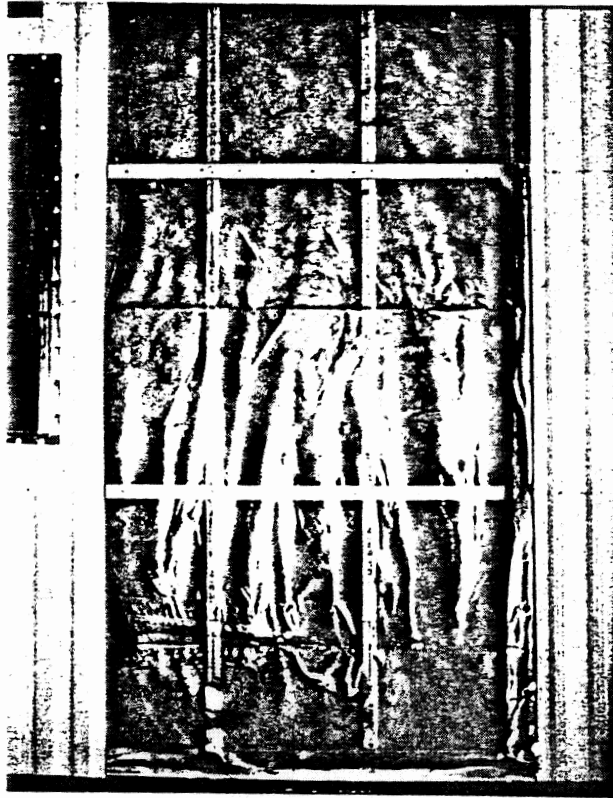
FIGURE 32. Six mil. polyethylene film used to seal insulation cavity from penetration of outside air.

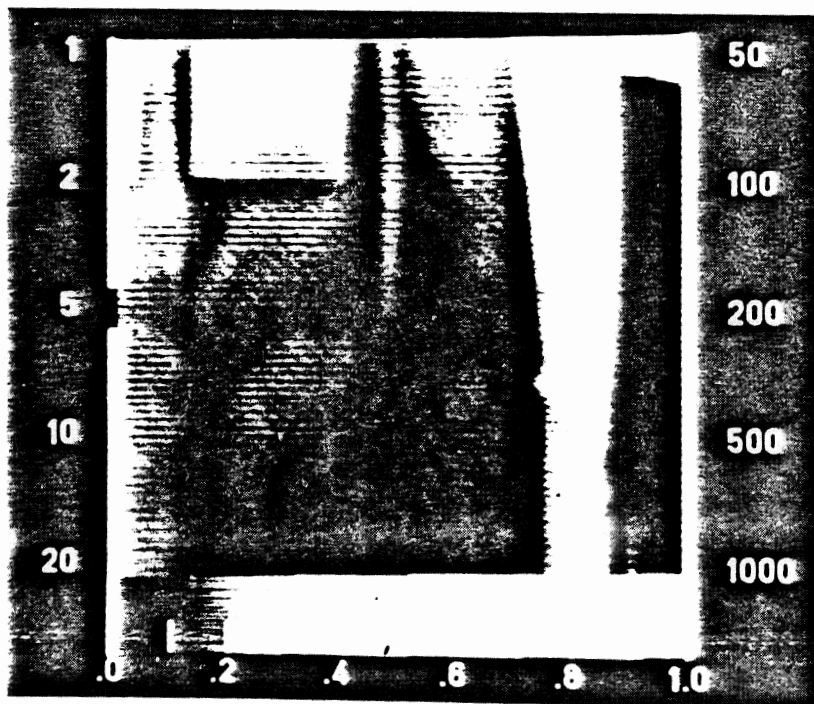
FIGURE 33. Thermograph of wall test area after sealing outside of insulation cavity with polyethylene film.

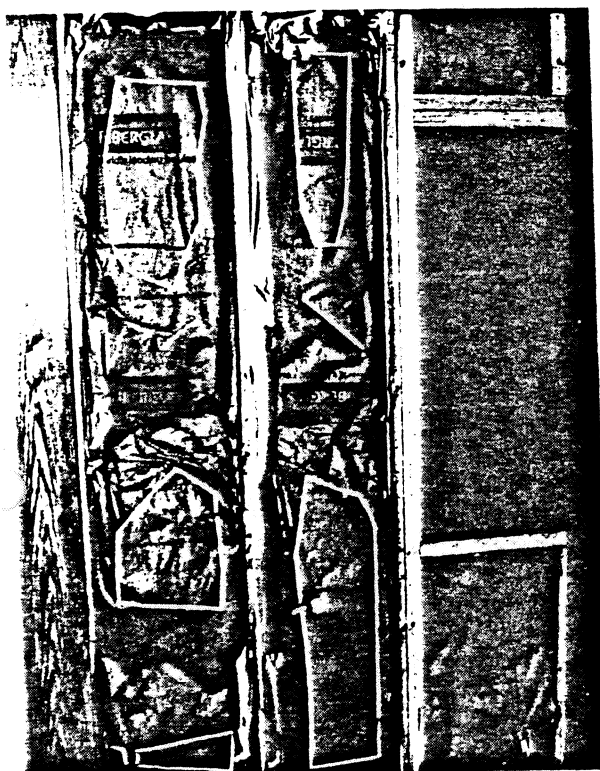
FIGURE 34. Inside of mobile home wall with paneling removed. Insulation vapor barrier has been sealed to stud with duct tape. White tape outline on surface of insulation outlines area in contact with back of paneling.

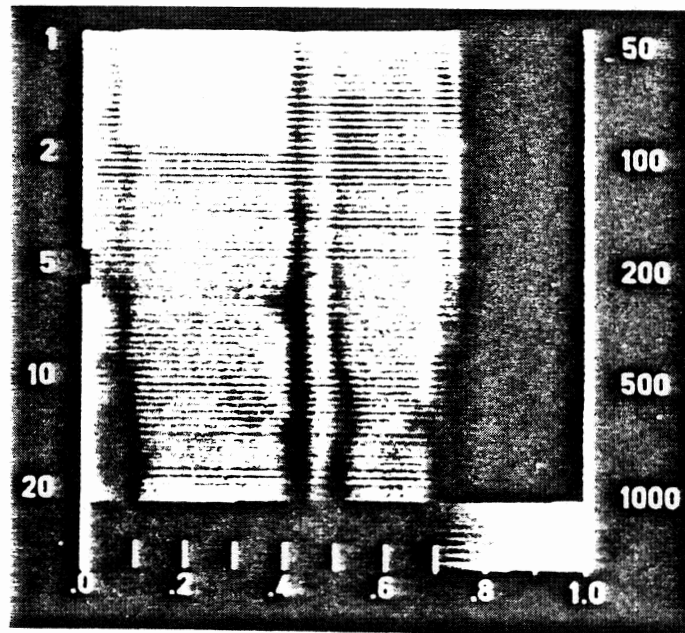
FIGURE 37. Interior thermograph after installing R-11 batt with friction fit. Note studs and cold streak caused by wrinkle in friction fit batt in narrow cavity.

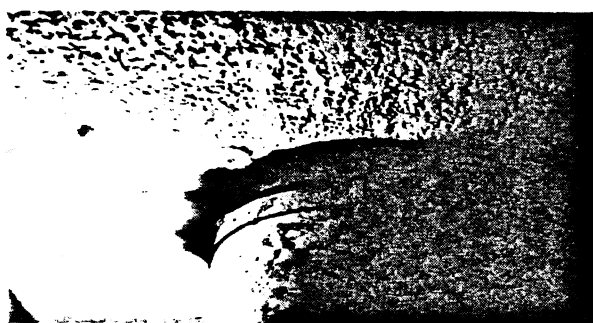
The reason for the large effect of furnace blower operation on infiltration rate was observed to be an annular gap around the furnace flue where it penetrated through the ceiling (see fig. 40), allowing the furnace room to communicate almost unobstructed with the vented attic space. When the fan was operated, the furnace room was under a slight negative pressure which induced outside air from the attic space.

FIGURE 40. Ceiling of furnace room showing air gap to attic space at the furnace air intake flue annulus.

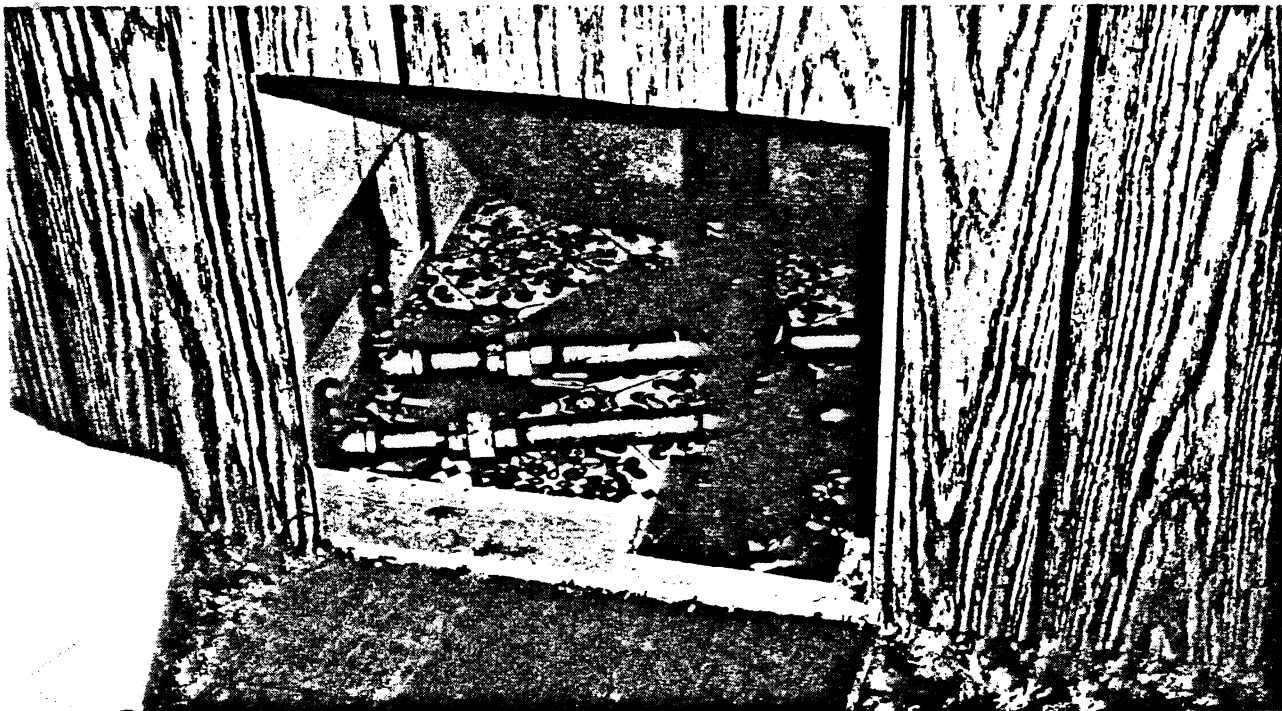
FIGURE 47. Plumbing hole through floor under bathtub sealed with duct tape. Access gained through hole cut in end bedroom wall.

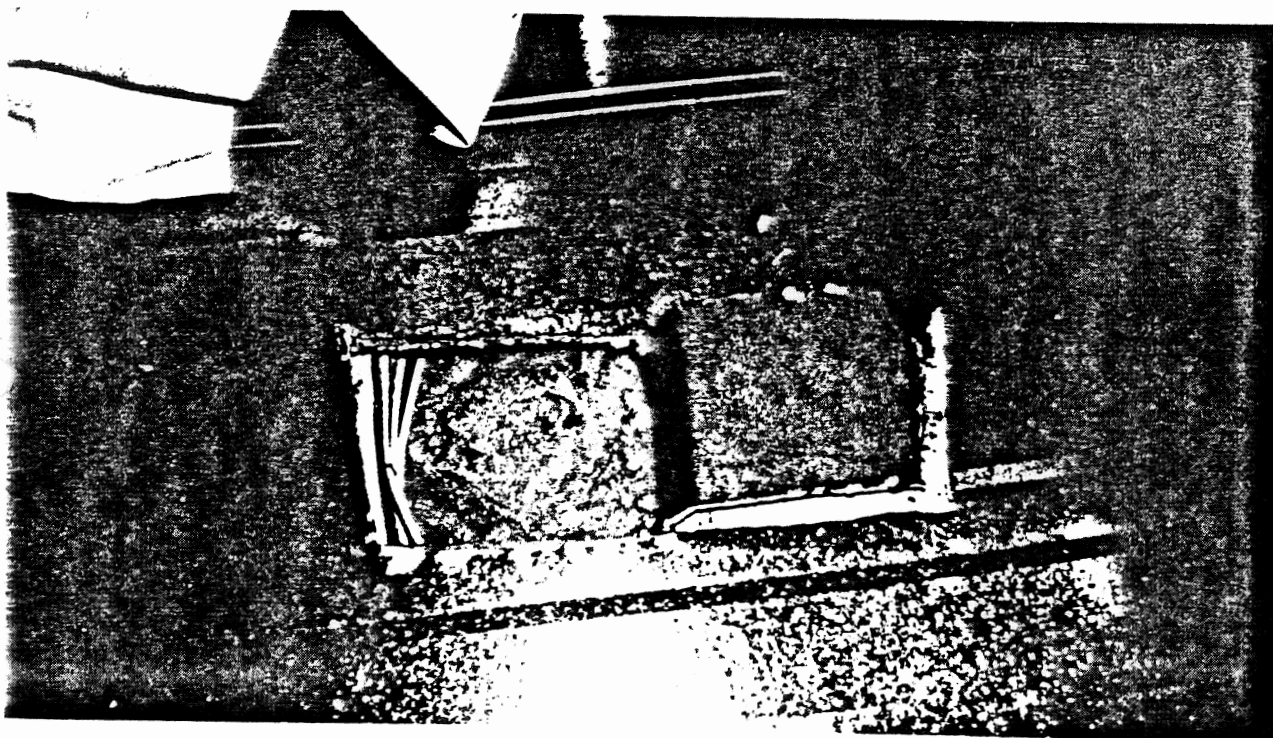
observed on the underside of the sheathing and water droplets covered the surface of the batt insulation. See figure 50.

FIGURE 50. Roof test cut number 3 showing water and ice on bottom surface of sheathing and water droplets on top surface of roof insulation.

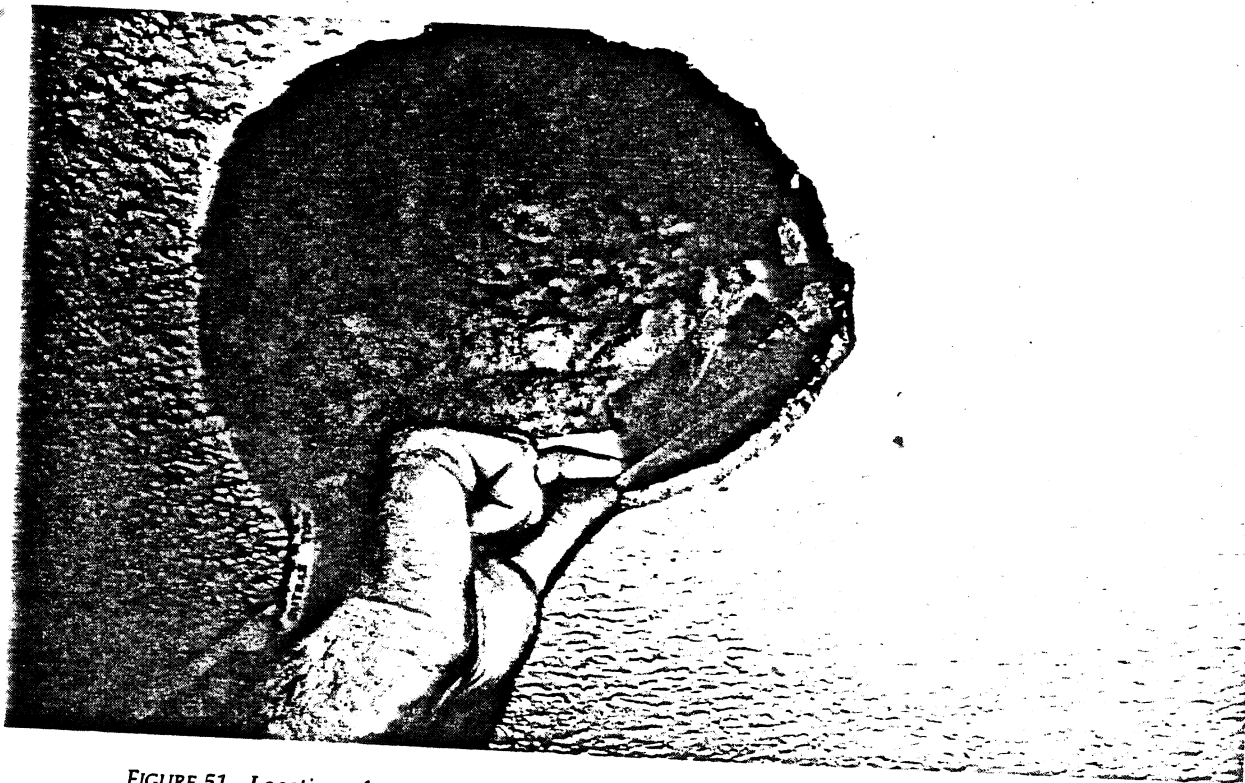
FIGURE 51. Location of water found on top of plastic film vapor barrier of bathroom exhaust.

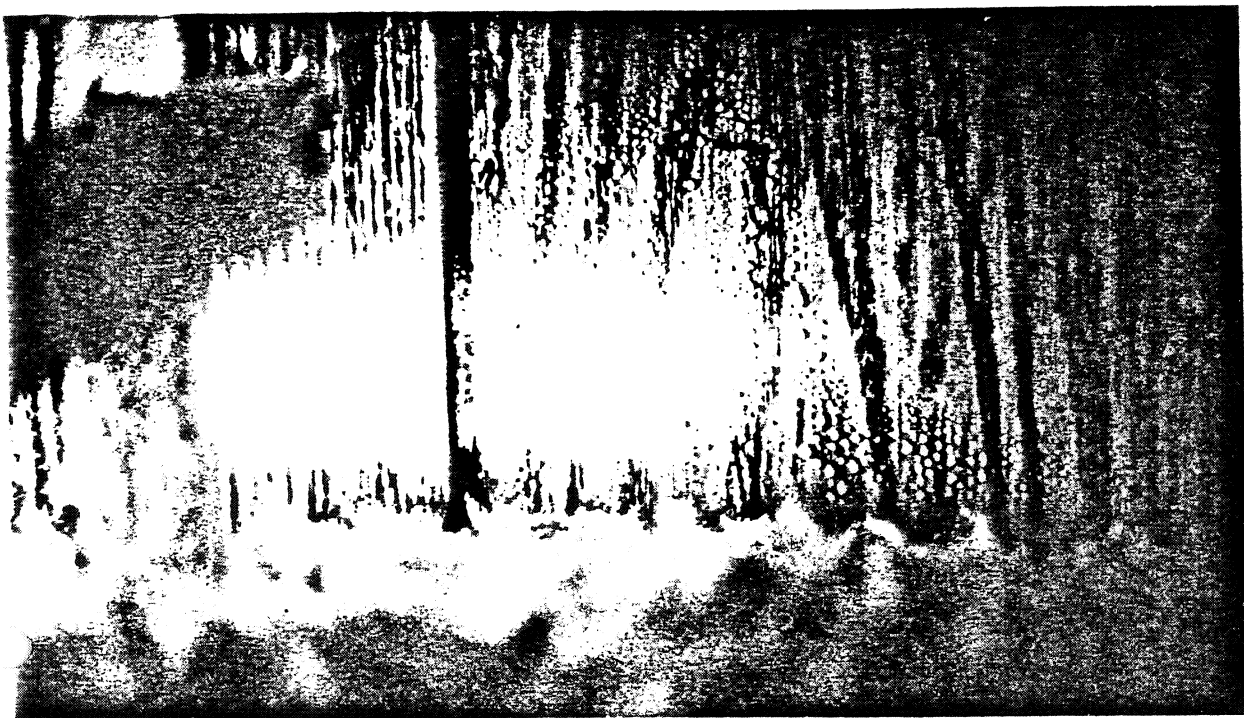
FIGURE 53. *Surface moisture condensation at base of wall.*

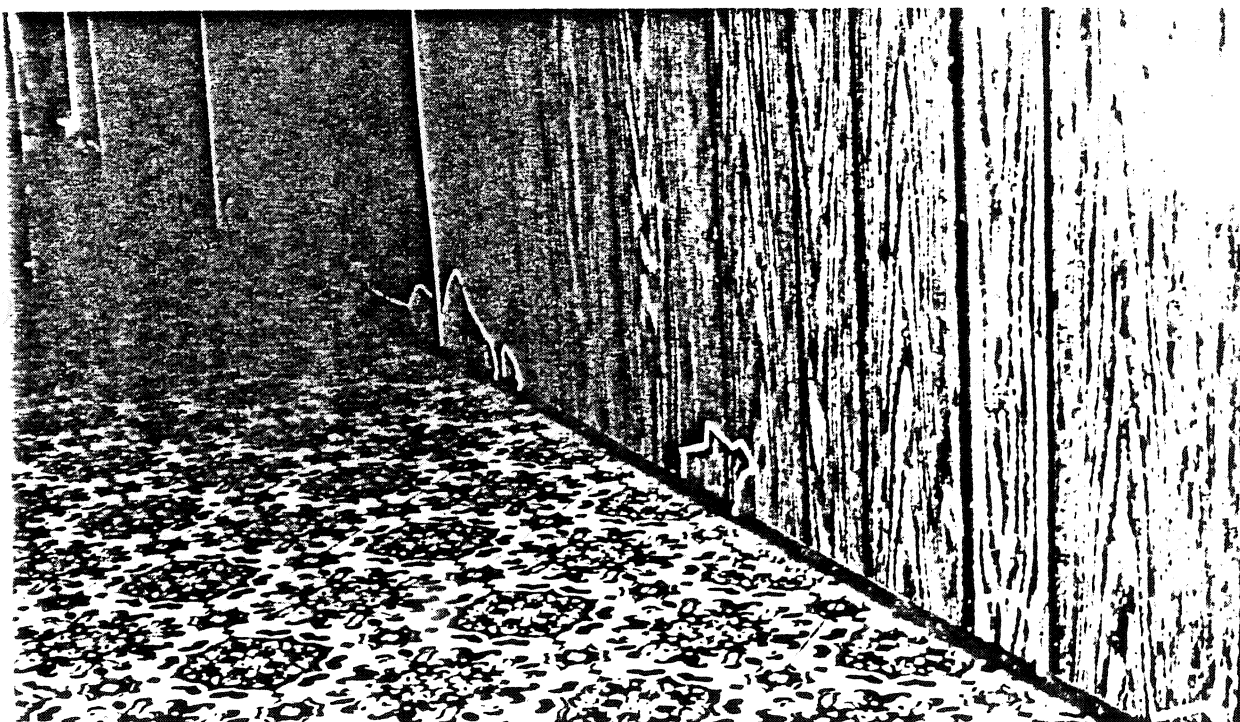
FIGURE 54. *Pattern of surface condensation at base of wall.*

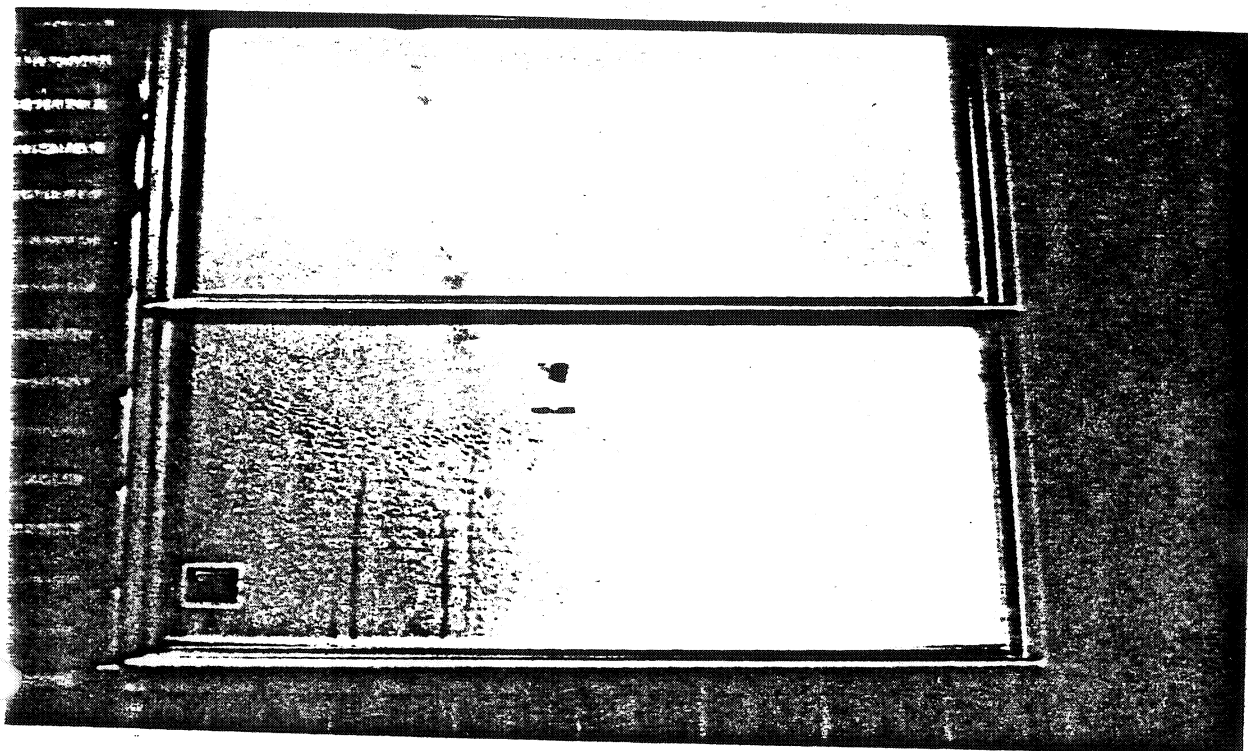
FIGURE 55. Typical window condensation.
