BUILDING PRACTICE NOTE

IMPROVEMENT OF AIRTIGHTNESS IN FOUR SCHOOLS

C.Y. Shaw

Division of Building Research, National Research Council of Canada

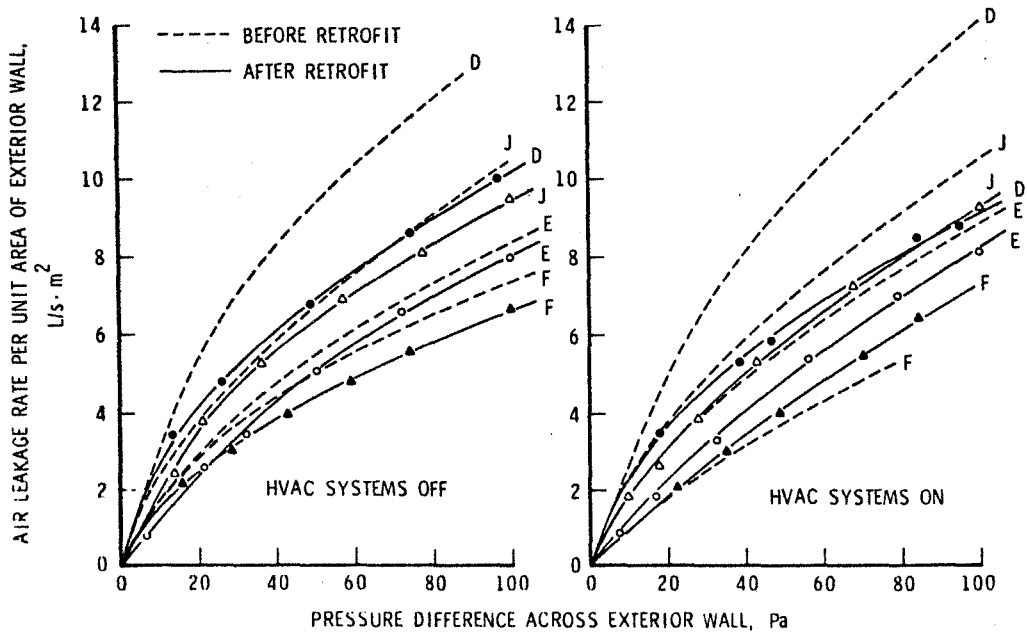
FIGURE 2
OVERALL AIR LEAKAGE RATES BEFORE AND AFTER RETROFIT

Air leakage characteristics of the four schools, before and after retrofitting, are presented in Fig. 2.

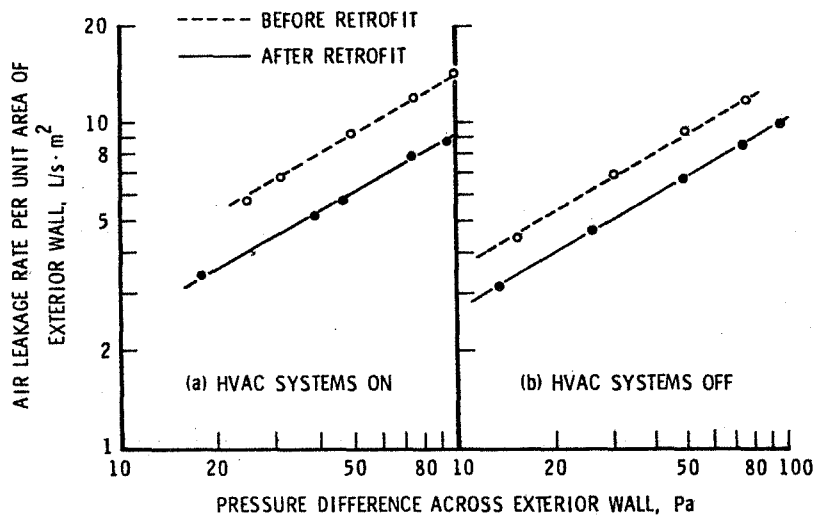
FIGURE 3
OVERALL AIR LEAKAGE RATES BEFORE AND AFTER
RETROFIT FOR SCHOOL D

This single-storey school had the highest overall air leakage rate of the eleven schools originally tested. Investigation of the wall construction revealed many unsealed openings at the intersection of roof joists and exterior wall. Retrofit measures consisted of the following:

The total cost for the two measures was approximately \$1300 for labour and materials. As indicated by Figs. 2 and 3, the leakage after retrofit was 73% of that recorded before, with the air handling system shut down. With the system operating leakage was reduced to 67% of that measured before. Unfortunately, the relative benefits of the two retrofit measures cannot be inferred from these results. Although the percentage reduction in leakage due to retrofit was large, this school still had a comparatively high leakage rate.

1. Polystyrene insulating boards (5 cm (2 in.) thick) were fastened to the inside surface of the exterior wall, between the suspended ceiling and the roof slab. An attempt was made to fit the boards around the joists.
2. Caulking was applied around the window frames but not around the insulating boards.

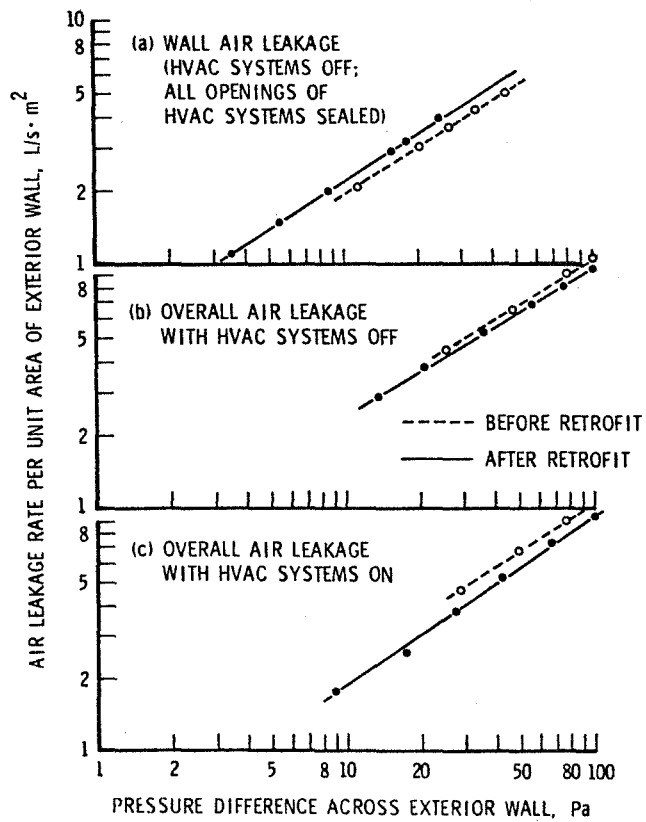
FIGURE 4
AIR LEAKAGE RATES BEFORE AND AFTER
RETROFIT FOR SCHOOL J

The previous study¹ showed that this school had very leaky exterior walls: nearly 81% of the total leakage occurred through the walls. Visual inspection revealed no obvious cracks or openings. A pressurization and smoke test, however, revealed air leaking out through numerous openings in the exterior block facade, and through the recessed light fixtures in the soffits over the doorways.

An attempt was made to caulk some of the joints in the exterior block facade, and to reduce leakage at the light fixtures by covering them up with metal plates. This effort at exterior sealing was not successful. Figure 4(a) compares the leakage characteristics of the wall alone between the 1976 and 1980 tests. The wall now registers slightly more leakage than before.

Inspection of the roof-top air handling units had revealed that one of the fresh air dampers was not closing properly, and this deficiency was corrected prior to the latest tests. The reduction in leakage shown in Fig. 4(b, c) can probably be attributed to the damper adjustment.

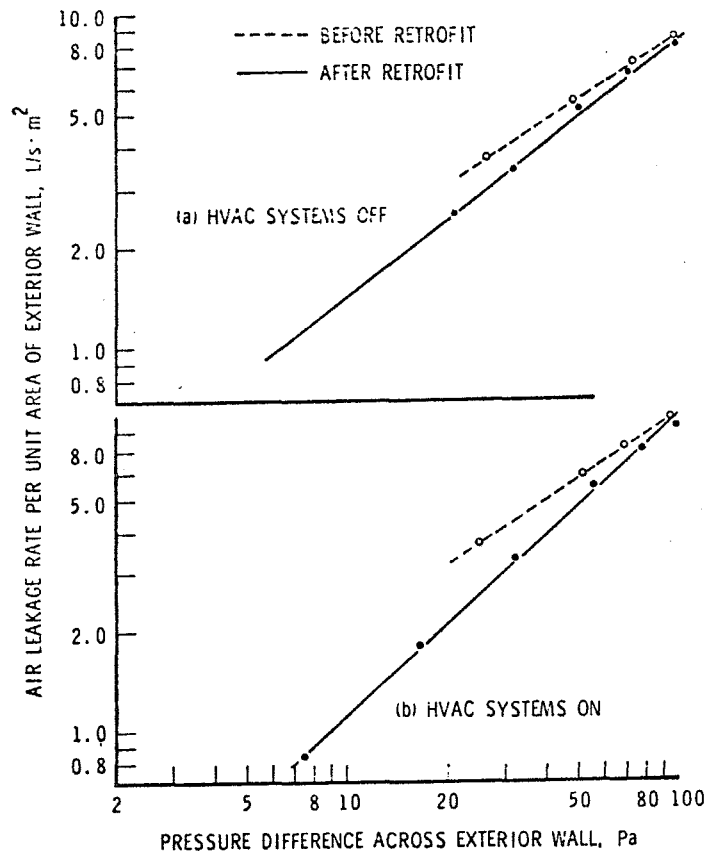
FIGURE 5
OVERALL AIR LEAKAGE RATES BEFORE AND AFTER RETROFIT FOR SCHOOL E

The school consists of a two-storey classroom wing and a single-storey block containing the gymnasium and offices as well as classrooms. The exterior facade of the two-storey wing consists of steel wall panels set in aluminum framing. Aluminum windows are set in the steel panels. All joints between framing, panels and windows had been sealed with caulking compound at construction, nearly 20 years prior to the original tests.

The one retrofit measure undertaken in this school was to replace the defective caulking for the joints in the exterior facade (approximate cost \$500). Fig. 5(a, b) indicates that leakage after the retrofit measure was approximately 70% of that before at the lower pressure difference. This also suggests that exterior sealing has a finite life, and should be replaced periodically as part of a maintenance schedule.

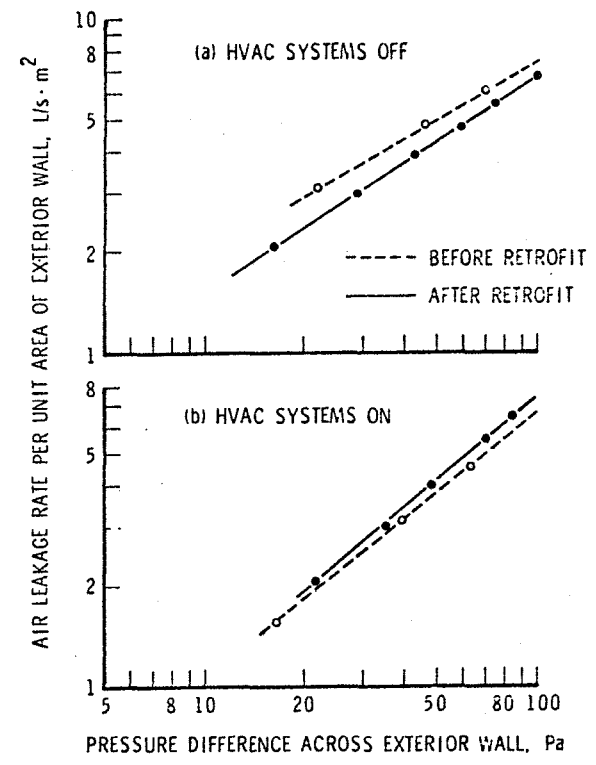
FIGURE 6
OVERALL AIR LEAKAGE RATES BEFORE AND AFTER RETROFIT FOR SCHOOL F

This single-storey U-shaped building has a window-to-wall ratio of 30%. After the original test in 1976, School Board staff conducted air leakage tests on the windows and found that those in the west wall were especially leaky. At a cost of approximately \$18 000, the thirty-two

windows in the west wall were replaced. This represented approximately a third of the total windows in the school. Figure 6(a) indicates a 20% reduction in leakage with the air handling system off: Fig. 6(b) shows no apparent reduction with the system on. The window replacement program was influenced mostly by a need to replace windows that had deteriorated with time.
