**19TH ANNUAL AIVC CONFERENCE
OSLO, NORWAY 28-30 SEPTEMBER 1998**

IMPROVEMENT OF INDOOR CLIMATE AND VENTILATION SYSTEM IN A RENOVATED MULTISTORIED RESIDENTIAL BUILDING

Jari Palonen

HVAC-laboratory
Helsinki University of Technology, Finland

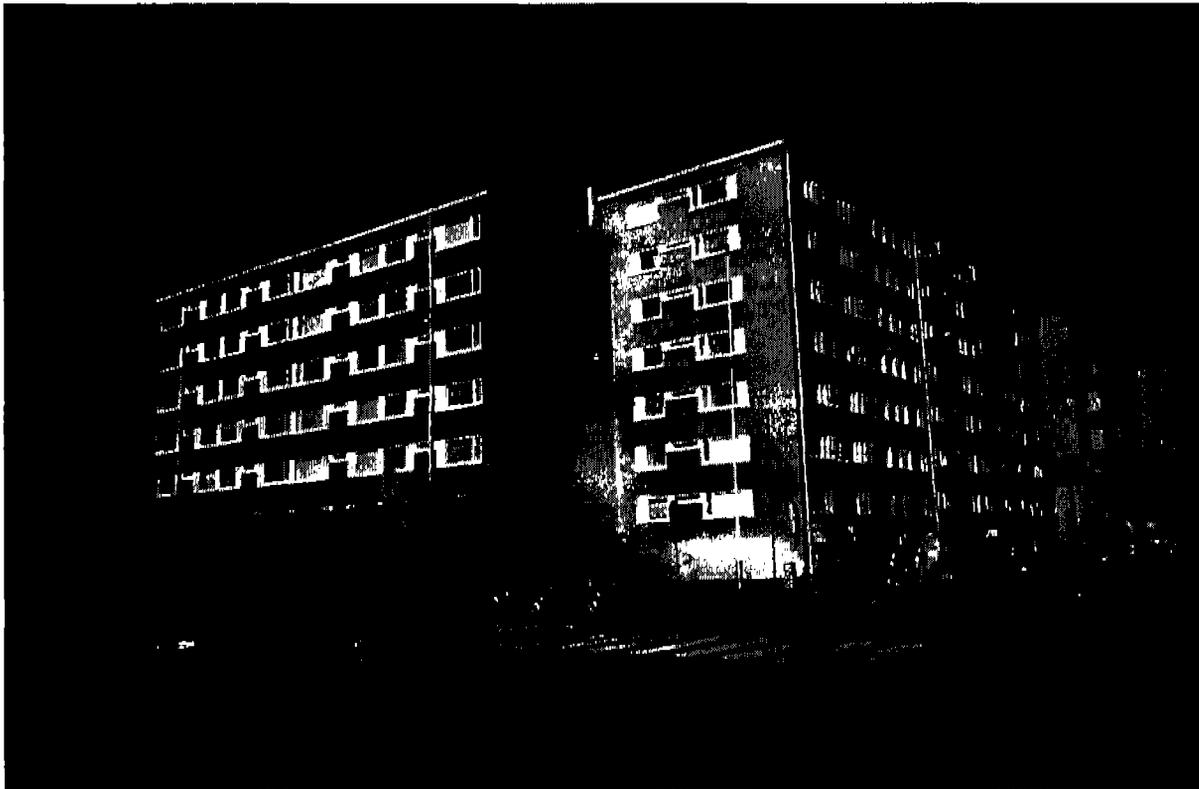
Figure 1. Building in summer 1998 after the new windows have been installed.
