CHARACTERISATION OF GARAGE-AIR RECIRCULATION IN A NEW BUILDING USING A TRACER

J. P. Rydock

Norwegian Building Research Institute, Oslo, Norway

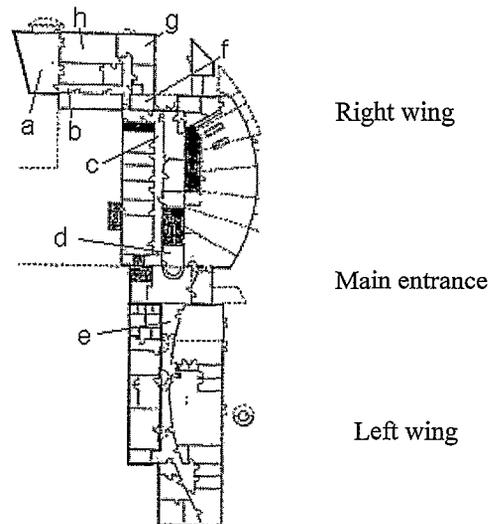
Figure 1 – Points where tracer concentrations were measured on first floor of building.

Sample location (from figure 1)	Description	Tracer concentration (pptv SF ₆)
a	garage, tracer storage area	6000
b	hallway adjacent to garage	2700
c	hallway, right wing	1400
d	reception area	710
e	hallway, left wing	0
f	stairwell	750
g	laboratory	0
h	workshop	820

Background tracer concentrations in the building exhibited a maximum in the garage where the cylinder was stored. Concentrations in the hallway leading to the garage (with the connecting door closed) were approximately 45% of the values inside the garage. Concentrations in the reception area were about 10-15% of the SF₆ concentration in the garage. In addition to the values displayed in Table 2, tracer was also repeatedly detected in offices on the third floor, right wing of the building at concentrations of 2-3% of those in the garage. This was presumably the result of recirculation up the back staircase. It is interesting to note that no tracer was detected on the second floor, right wing of the building, or anywhere in the left wing.
