FIELD CHARACTERIZATION OF THE ENVELOPE LEAKAGE OF HOUSES FOR DETERMINING REHABILITATION PRIORITIES

Karine Guillot, Pascal Achard, Patrice Berger, Andrés Litvak, François Rémi Carrié

*Centre d'Etudes Techniques de l'Équipement de Lyon
46 rue Saint Théobald
F – 38081 L'Isle d'Abeau Cedex, France*

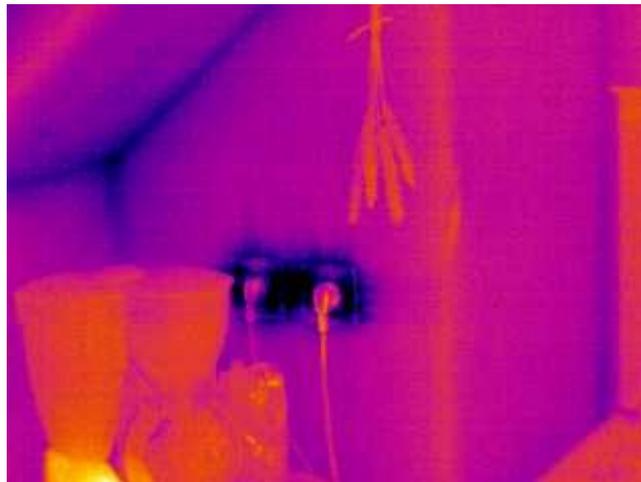
Infra-red thermography. Together with the envelope leakage measurement, we looked at window frames; electrical plugs (Figure 1), switches, and boards; exterior doors and access doors to attics; skirting boards; joints between walls, floors, and ceilings.

Figure 1. Photograph with IR-camera of electrical plugs. The building was depressurized with a blower-door.

3.2 Electrical conduits endings (plugs, switch, light fixtures, convectors)	1	- Mastic joint or insulation foam around the light fixture openings. - Insulation foam behind the plug boxes in cold walls. - Removable caps at the end of the conduits.
