Long-time durability of passive house building airtightness

Søren Peper¹, Oliver Kah¹ and Wolfgang Feist^{1,2}

*1 Passive House Institute
Dr. Wolfgang Feist
Rheinstr. 44/46
64283 Darmstadt, Germany*

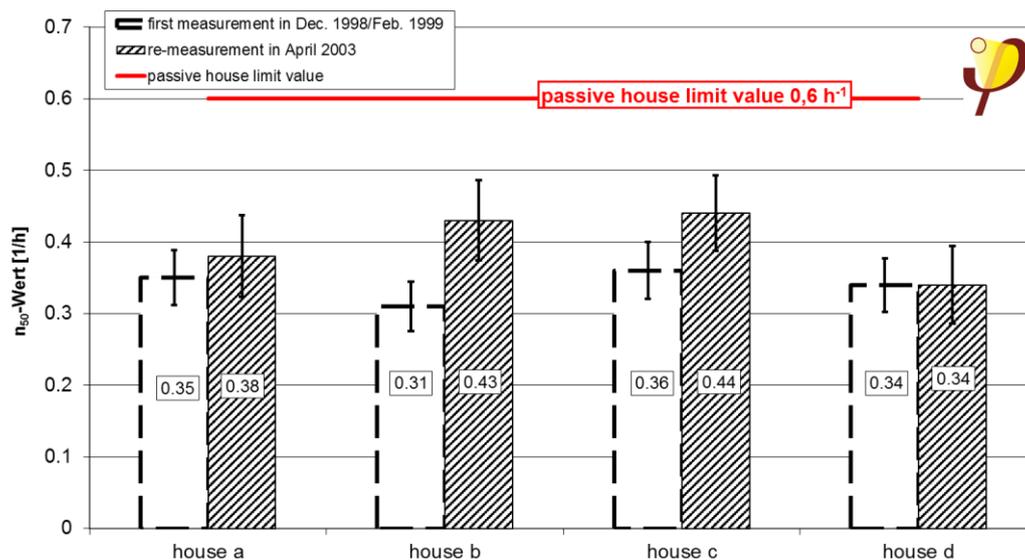
In the housing development in Hanover-Kronsberg, four of the 32 terraced houses were re-measured after four years and two months and the measurements documented. In all four houses, residual leakages were found in the following areas: front-door sealings, some window sealings, some glass-strip connections, integration of window and front-door frames

Figure 2: Example of the results of the four airtightness re-measurements in Hanover-Kronsberg in comparison to the results of the first measurements. The bars show the measuring uncertainty of each measurement.

The results of the four re-measurements show that all buildings tested have maintained a very high quality of airtightness. The mean of all four re-measurements is at $n_{50}=0.4 \text{ h}^{-1}$. For three of the four buildings, the measuring value has slightly increased, for the fourth, it has remained the same. However, the changes range within the area of the measuring accuracy of the tests. This makes it impossible to make a clear statement on an increase of the n_{50} -values. House B is the exception, because it shows a slight increase of the measuring value even after having considered the measuring accuracy. Overall, the four objects show very high airtightness in the first measurements as well as in the re-measurement.

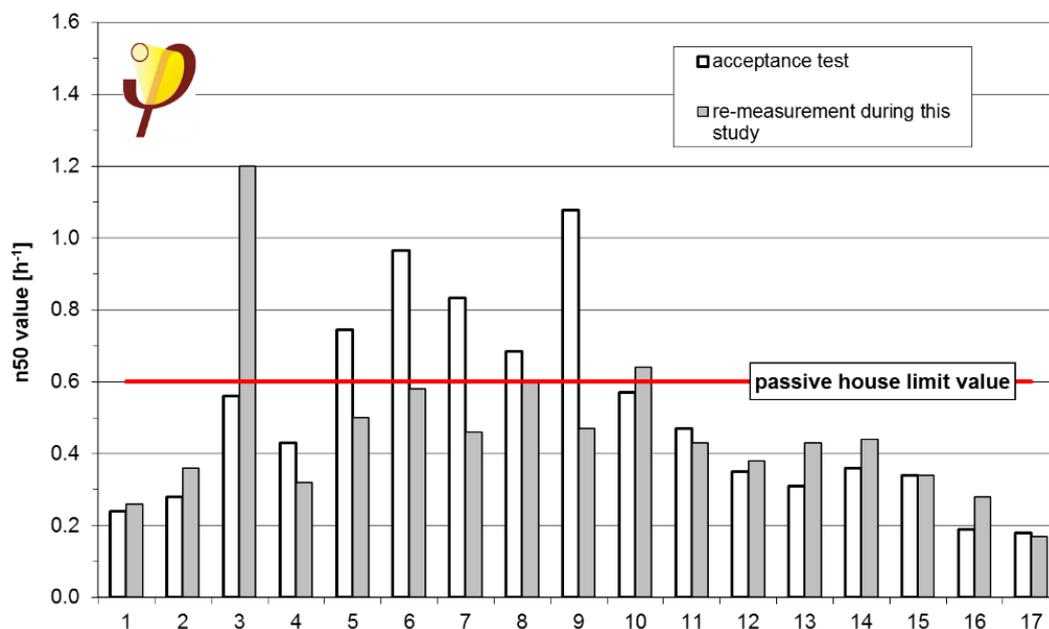
For 16 of the 17 buildings, the results of the re-measurement were good to very good – and that for the strict passive house requirements with a limit of $n_{50}=0.6$ 1/h. These 16 passive houses averaged at a n_{50} -value of 0.42 1/h. In the exception, the main leakages supersede the quality of the other connections. The n_{50} -value was 1.2 1/h. It was not possible to draw conclusions on long-term stability. The architect of the building indicated the lack of a sufficient airtightness design. For the structurally identical subsequent buildings, such a design was available leading to a positive result (see number 4 in Figure 3). For the 16 positive results, the changes between the first and the re-measurement were almost always within the measuring accuracy. Five buildings even showed a significant improvement of the measuring values due to rework following the first pressure test.

Figure 3: Overview of the measuring results of the airtightness tests of the 17 buildings analysed (acceptance test and re-measurement during this study).

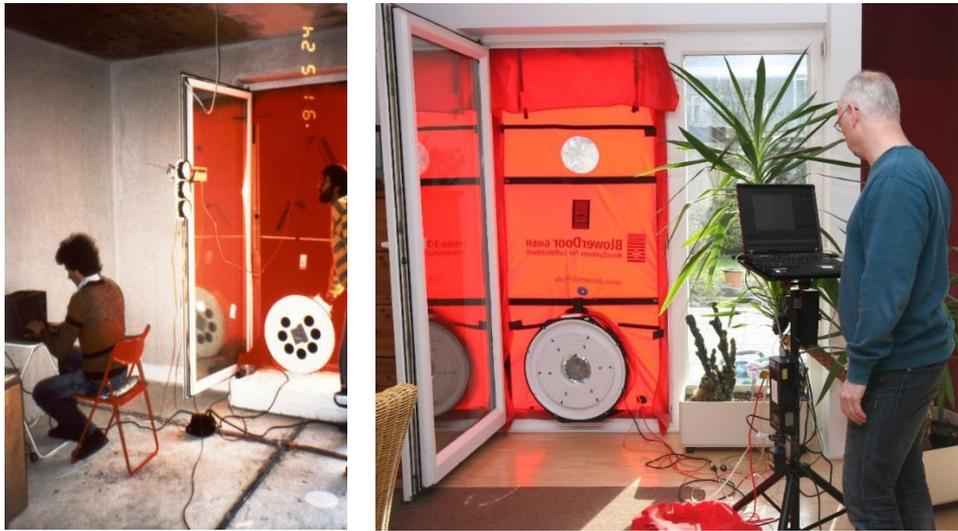
Figure 4: Left: The first pressure test was conducted on 24/26 of May 1991 by Ingenieurbüro ebök once the airtight envelope had been finished. Right: The current Blower Door Test (here in House B) was conducted on 11/12 of February 2016 by the PHI 25 years after construction.

The only significant shortfalls in the two houses were detected at the sealants for windows and doors that can be opened. After 25 years, the sealants have become somewhat inelastic. Adjustments to the windows did not fix the issue sufficiently, so all of the windows and the front door were additionally sealed.

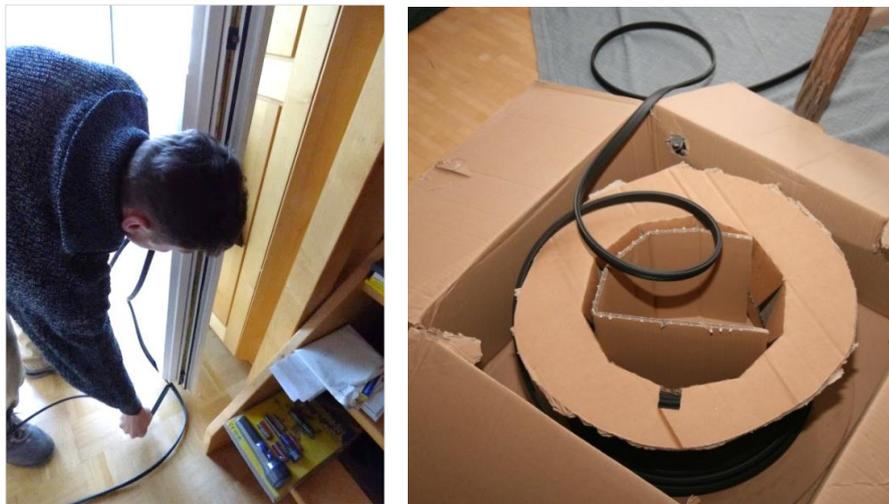
Figure 5: A qualified contractor replacing the window seals in House A on 12/02/2016 and the sealing material used (yard ware).

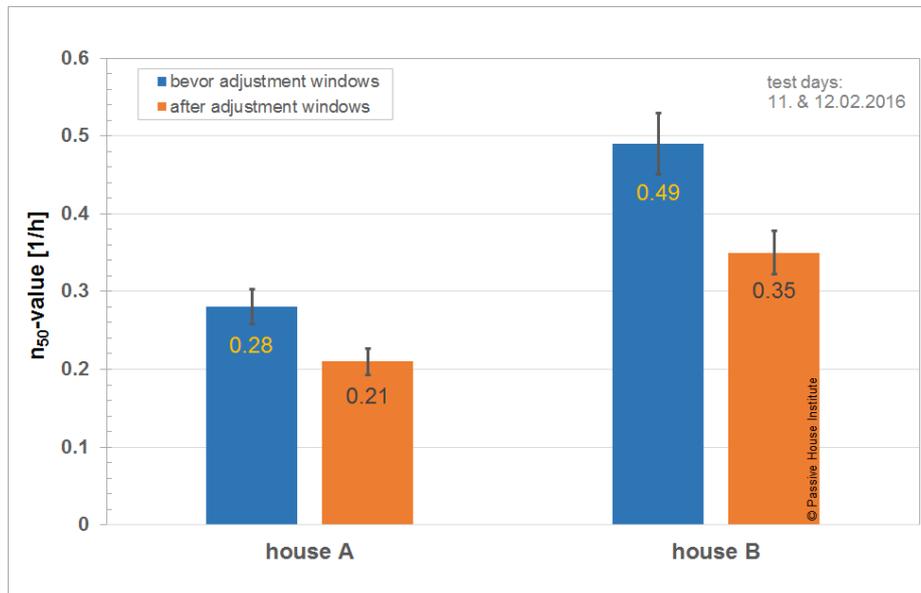
As a result, the original value has once again been reached in both houses: At $n_{50} = 0.21$ and 0.35 h^{-1} (see Figure 6), respectively, the extremely good results of the preliminary measurements were reproduced. Detailed inspections of the building component connections revealed how durable they were although the materials available today were not yet on the market in 1991. For instance, the acrylic seals between the window frames and plaster end rails are nearly perfectly airtight everywhere, as is the connection between the airtightness foil in the

Figure 6: Airtightness tests of the passive house in Kranichstein (Houses A and B) in February 2016, 25 years after construction, before and after replacing the window and door seals.

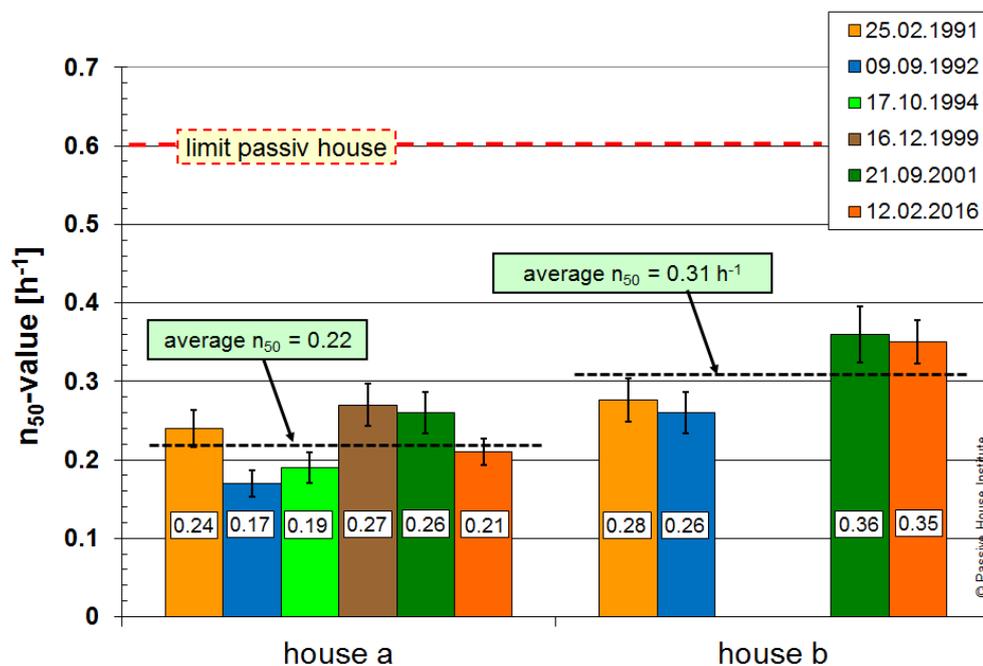
The terrace houses in Darmstadt-Kranichstein originally had n_{50} -values ranging from 0.2 to 0.4 h^{-1} , which not even experts had previously thought possible. As shown in Figure 3 (buildings number 1 and 2) during the in previous chapter described tests in 1991, the n_{50} -values had not significantly gone down since then (see also Figure 7). The latest measurements in 2016 after 25 years once again revealed extremely good levels of airtightness.

Figure 7: Overview of all pressure tests of two of the four units of the passive house in Kranichstein conducted over the years. The two measurements before replacing the seals are not included.
