CHECKING “FABRIC FIRST” REALLY WORKS: IN-CONSTRUCTION TESTS USING THERMOGRAPHY

Tim Taylor^{*1}, John Counsell¹, Andrew Geens², Steve Gill¹ and Gerraint Oakley³

ABSTRACT

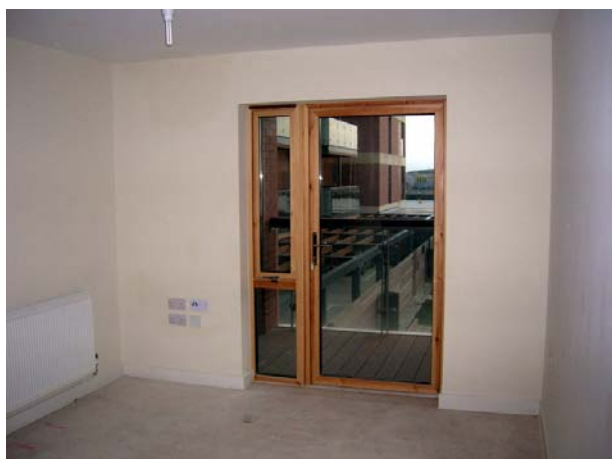
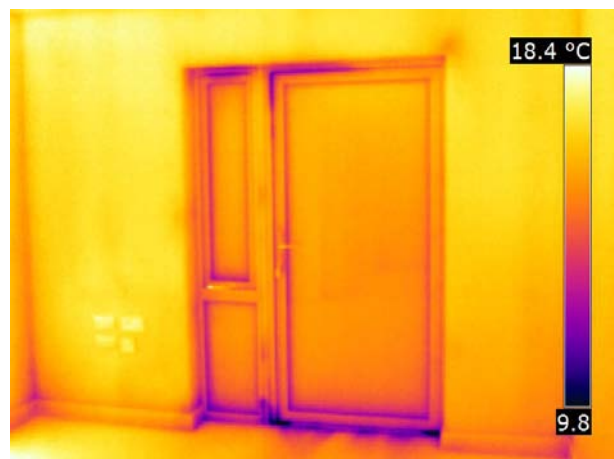
Figure 2. Thermal images of flat in Case Study B.

The environmental design strategy at Case Study A (a block of 69 flats in timber frame construction) was developed with an assumption that the building would be constructed to high standards of airtightness (achieving an air permeability of $3.0 \text{ m}^3/\text{h.m}^2$ at 50Pa). To determine if this level of performance was likely to be achieved in practice, one of the flats in the development was brought to a more advanced stage of completion so that a pressurisation test could be carried out at an early stage of the construction process. The result of this test showed a measured air permeability of $1.09 \text{ m}^3/\text{h.m}^2$ at 50Pa had been achieved – a significant improvement on the design target. However, masking tape was used extensively to seal around openings and sockets prior to the pressurisation test. The use of temporary seals in this way is not permitted according to the testing protocol that is specified in the Building Regulations: “*All external doors and windows should be closed (but not additionally sealed). This includes door thresholds*” [15]. A thermographic survey of the flat 14 months later showed extensive air leakage around the balcony doors as shown in Figure 2 below.

(a) Photograph taken of balcony doors in living room of test flat at time of thermographic survey

(b) Thermal image of balcony doors corresponding to photograph (a)

The masking tape applied around the balcony doors before the pressurisation test effectively concealed these locations of air leakage². On this basis, the pressurisation test result is unrepresentative of actual performance and higher levels of infiltration may mean that the energy performance of the flat is less than predicted. The wind pressures that caused the air leakage observed in Figure 2 can also result in other types of heat loss. In the same flat, a thermographic survey indicated a localised surface temperature decrease in the ceiling of one of the bedrooms. The area of the ceiling where this was observed corresponds with the location of an extract duct for the mechanical ventilation unit. It follows that a possible

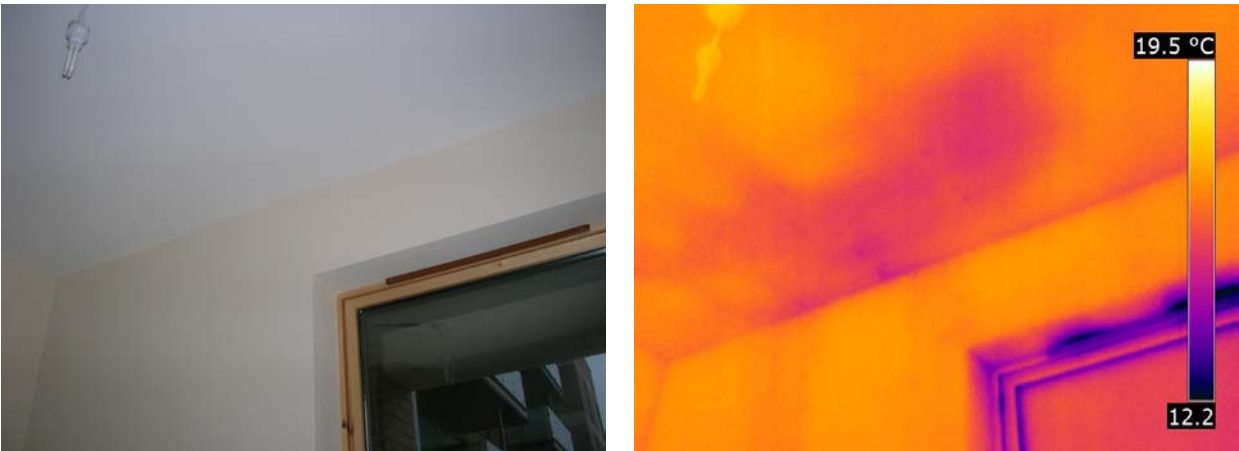
Figure 3. Wind cooling effect observed in ceiling below mechanical ventilation extract duct.

explanation of this thermal pattern could be wind penetration above ceiling level around a poorly-sealed or damaged duct air terminal. This type of defect would contribute to heat loss but does not constitute an infiltration mechanism. It would therefore not be detected by a pressurisation test (this is also the case for thermal bypass caused by “wind-washing” [16]).

(a) Photograph taken of the junction between the wall and ceiling above a window in one of the bedrooms of the test flat

(b) Thermal image shows localised surface temperature decrease in ceiling area corresponding with the position of the extract duct for the mechanical ventilation unit

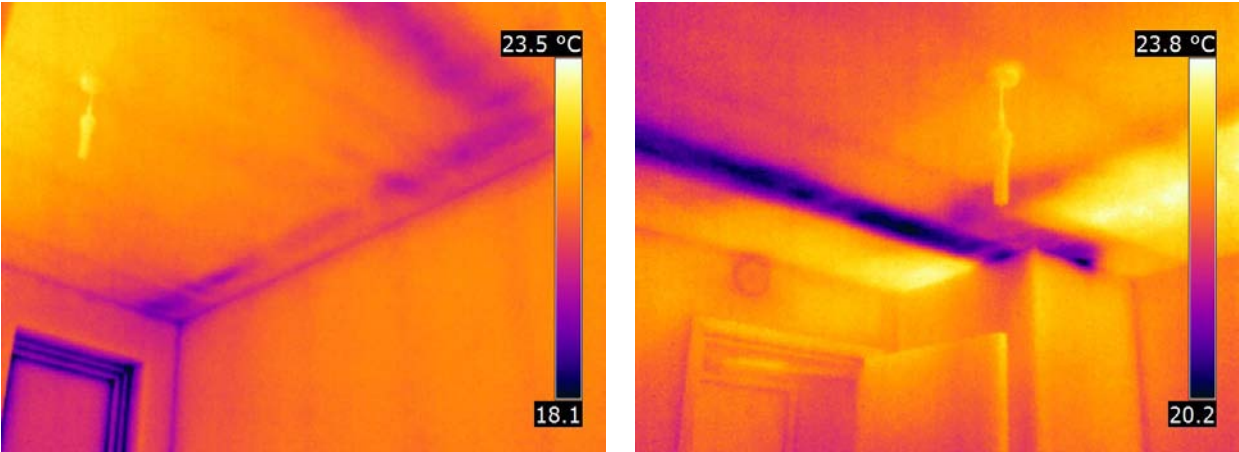
Figure 4. Insulation not continuous around MVHR ductwork.

At Case Study B (a block of 32 flats, part new build and part refurbishment) the ventilation strategy utilised mechanical ventilation heat recovery (MVHR). A thermographic survey in one of the top floor flats indicated that the inlet duct for the MVHR unit was not correctly insulated as shown in Figure 4 below. Poor installation of the MVHR ductwork will reduce the energy performance of the dwelling.

(a) The reduced surface temperatures along the ceiling follow a linear pattern corresponding with the position of the MVHR unit ductwork

(b) The MVHR unit is located in a storage cupboard adjacent to this corner of the room
