# Assessment of durability of airtightness by means of repeated testing of 4 passive houses

Jiří Novák<sup>\*1</sup>

*1 Czech Technical University  
Faculty of Civil Engineering  
Thákurova 7*

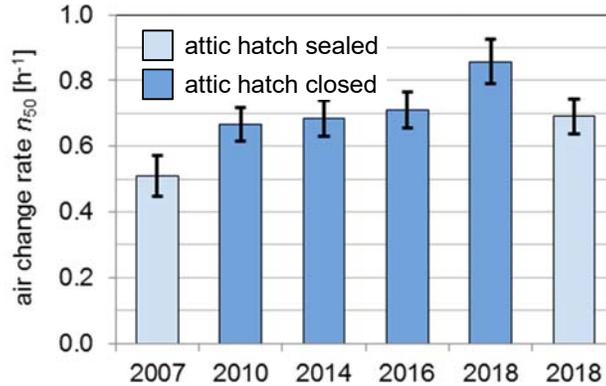
Figure 4 Repeated testing results for building A

The airtightness of the building A has deteriorated over the 11 years - the  $n_{50}$  value rose from  $0.51 h^{-1}$  in 2007 to  $0.71 h^{-1}$  in 2016. The  $n_{50}$  value increased mostly in the first 3 years, between 2007 and 2010 (from  $0.51$  to  $0.67 h^{-1}$ ). It is not clear whether the difference between the test results from 2007 and 2010 is due to the effect of ageing or rather to different building preparation (sealed attic hatch). Between 2010 and 2016 the  $n_{50}$  value increased slightly, but the differences between the test results are lower than the uncertainty. Between 2016 and 2018 the  $n_{50}$  value increased suddenly and significantly. A defect or accelerated degradation of the attic hatch gaskets are very likely causes of this change as shows the result of the second test carried out in 2018 with sealed attic hatch.

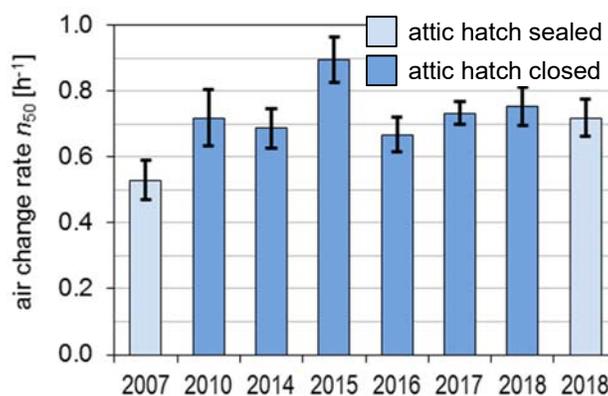
Figure 6 Repeated testing results for building B

The  $n_{50}$  value rose from 0.53 h<sup>-1</sup> in 2007 to 0.75 h<sup>-1</sup> in 2018. The most significant increase occurred between 2007 and 2010 (from 0.53 to 0.72 h<sup>-1</sup>). Unlike in the case of the building A, the difference between the test results from 2007 and 2010 seems not to be a consequence of a different building preparation (sealing of the attic hatch has a little influence – see the test results of 2018). Between 2010 and 2018 the airtightness of the building remained almost at the same level (the test of 2015 should be disregarded because of a different building preparation). Surprisingly, the  $n_{50}$  decreased between 2010 and 2016 but the differences between the test results are lower than the uncertainty. After the refurbishment in 2016, the  $n_{50}$  increased, but the increase is not really significant with regard to the measurement uncertainty. The  $n_{50}$  measured in 2017 and 2018 is very similar to the value of 2010.

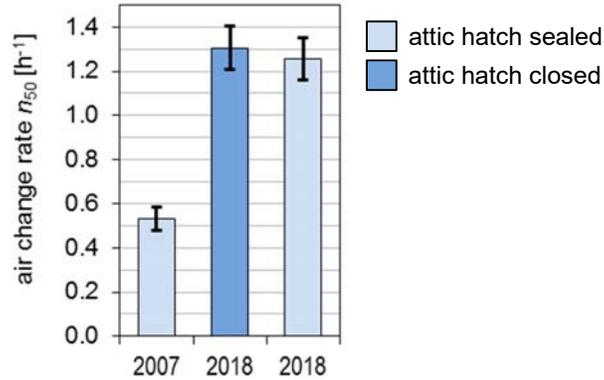
Figure 8 Repeated testing results for building C

The  $n_{50}$  value obtained in 2018 is substantially higher than in 2007. The most likely cause of this increase is neglected sealing of the air barrier layers during the repair of the sewage water system failure. An improperly sealed penetration the sewage water pipework (significant leakage path) was found in an accessible installation gap. Perhaps, similar leakage paths resulting from improper repair works remained undiscovered in inaccessible parts of the external wall as well.

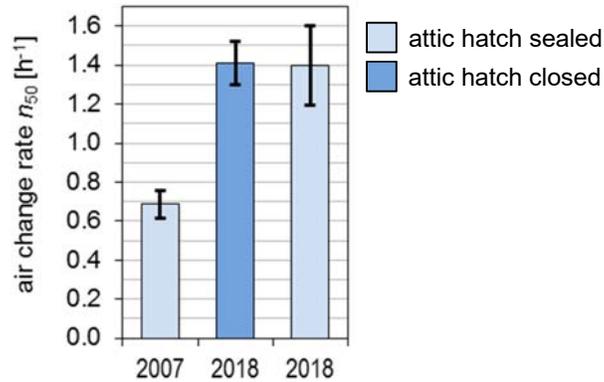
Figure 10 Repeated testing results for building D

The  $n_{50}$  value increased significantly between 2007 and 2018. Very likely, this increase results from the refurbishment carried out without any special concern about the airtightness.
