## INTERZONAL AIRFLOW FROM GARAGES TO OCCUPIED ZONES AS ONE REASON FOR BUILDING RELATED ILLNESS: THREE CASE STUDIES USING TRACER GAS MEASUREMENTS

P. Tappler<sup>1</sup>, B. Damberger<sup>2</sup>

<sup>1</sup> Centre for Architecture, Construction and the Environment, The Danube University of Krems, Austria

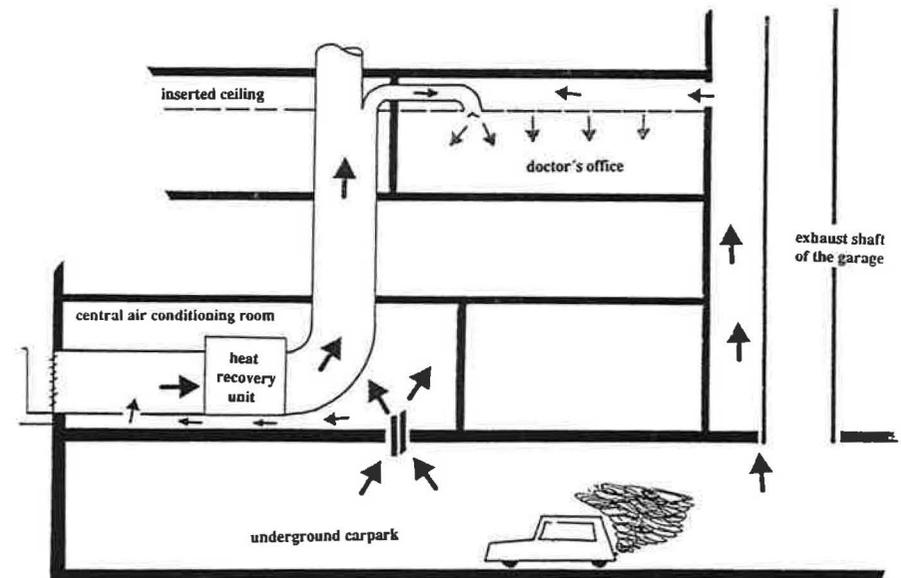
Fig. 1: Case No. 1

The one-year old commercial building had an HVAC system with three independent ventilation systems. The building housed offices, various shops, dwellings and a doctor's office on the third floor (fig. 1). Beneath the first floor was a two-storey underground carpark, which was mainly used during the opening hours of the shops (8 a.m. to 6 p.m.). Some months after the opening of the doctor's office the majority of the staff of the doctor's office complained about lethargy, headache, irritation of the eyes and upper airways, lack of concentration and the typical smell of garage air, on some days of the smell of gasoline, too. These symptoms belong to the so called Sick Building Syndrome (SBS). The odor annoyance was noticeable only in one zone of the building. The quality of indoor air was much worse than in the previous doctor's office, which had been situated in an older, naturally ventilated building. These facts gave rise to the assumption that the HVAC system may be responsible for the symptoms.

About 10 minutes after injecting  $\text{SF}_6$  into the garage air a noticeable increase in concentration of tracer gas in the supply air was detected. Tracer gas was measured in the air diffuser at the ceiling of the doctor's office as well as in the room air itself. The concentration of tracer gas in garage air about 25 minutes after injecting ranged from 20 - 30  $\text{mg}/\text{m}^3$ ; the time dependent concentration in the room air of the doctor's office is shown in figure 3. Concentration measurements in the space above the inserted ceiling showed high concentrations of  $\text{SF}_6$ . An inspection of the walls revealed an opening of about 100x100 cm in the encasing wall of the exhaust shaft of the garage. The pressure difference between the room and the garage induced interzonal airflow from the garage to the space between the ceiling of the fourth floor and the inserted ceiling. From this space contaminated air infiltrated the air of the doctor's office on the third floor (fig. 1).

The concentration of  $\text{SF}_6$  was much higher in the supply air duct directly behind the heat recovery unit than in the extract air duct. Therefore, a short circuit in the heat exchanger, as reported in the literature (7), could not be the reason of the elevated concentrations. As tracer gas could not be found at the air intake louvre, a short circuit of air from the exhaust fume of the garage into the air intake duct could be excluded, too. The results showed that the central air conditioning room had to be the reason for the elevated concentration of  $\text{SF}_6$  in the supply air. To locate the exact area where the fresh air was contaminated, the air intake duct was perforated at equal distances of about one meter. Afterwards  $\text{SF}_6$  was added directly to the room air near the intake air duct. As the fresh air was measured at the individual holes, a sharp increase in the concentration of  $\text{SF}_6$  could be measured at the third hole and all subsequent holes. When the bottom part of the air intake duct was inspected with the help of a mirror, a large opening (5 x 60 cm) was detected in the bottom part of the duct.

The central air conditioning room was situated directly above the garage from which several tubular feedthroughs in the ceiling of the garage led into that room. They were insulated only with PU-foam. Thus considerable amounts of contaminated air were sucked from the garage into the central air conditioning room. As the air supply fan caused underpressure, air from the central air conditioning room was sucked into the air intake duct and subsequently distributed in the building.

The opening in the encasing wall of the exhaust shaft was closed, gaps between the ceiling of the garage and the walls of the exhaust shaft were sealed off carefully with elastic sealants. However, contrary to all expectations, after those remedial measures had been carried out, tracer gas could still be detected in the supply air duct after injection into garage air.

After the opening in the air intake duct was closed and the holes between the garage and the central air conditioning room were sealed off, only negligible amounts of  $\text{SF}_6$  ( $< 0,3 \text{ mg}/\text{m}^3$ ) were detected in the supply air after charging the garage with tracer gas (fig 4).

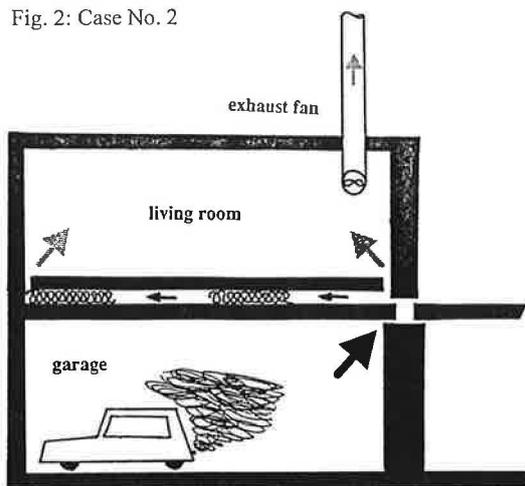
Fig. 2: Case No. 2

An apartment was situated directly above a garage, which was used only by the inhabitants of the building (fig. 2). The inhabitants of the apartment complained both about the typical smell of garage air in all rooms of the apartment and about headache, irritation of the eyes and sore throat. Two exhaust fans in the kitchen and the toilet as well as tightly sealed windows and doors led to a noticeable underpressure in all the rooms (the exhaust fans couldn't be deactivated by the occupants).

About 20 minutes after injecting  $\text{SF}_6$  into the garage a slight increase in the concentration of tracer gas could be detected in the air of the living room. The time dependent concentration in the living room is shown in figure 5.

The pressure difference between the garage and the apartment led to a penetration of contaminated air into the rooms. The problem was solved by sealing gaps in the ceiling of the garage with elastic sealants. Additionally, outdoor air inlet pipes were installed in the outer walls of the flat to eliminate the pressure-difference between the garage and the apartment.
