## Today's Weather: Rain in the Living Room!

by Bruce Davis

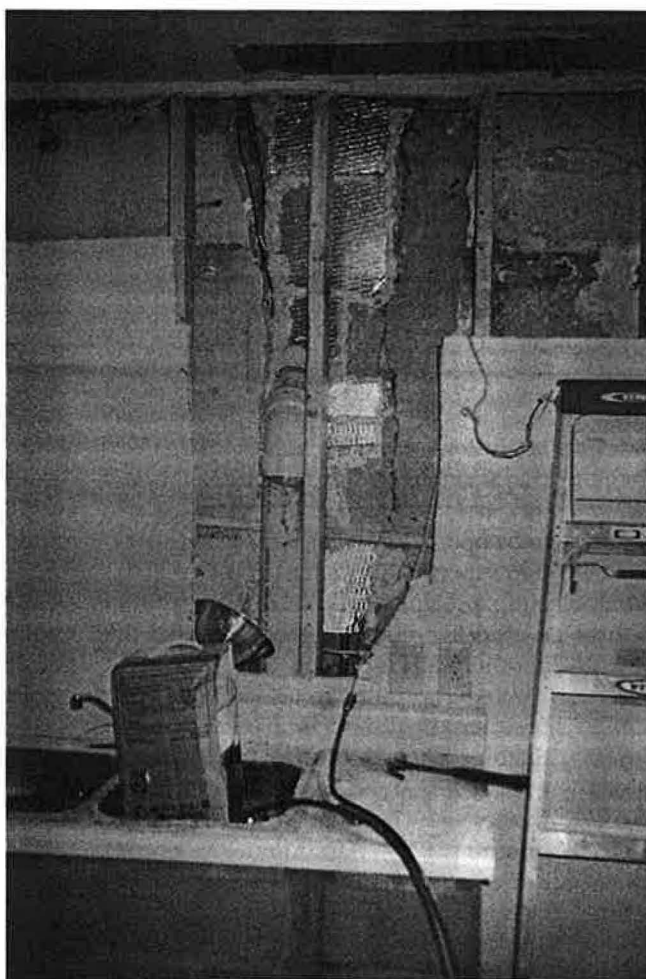
After the new cabinets were taken off the wall, we began to tear into the wall to seal the open air passages. This cutaway revealed leakage paths to the outside, into the next apartment, and into the attic and the floor cavity. The base cabinets had to be removed as well. To make matters worse, this was only one of six such areas that had to be torn open because of similar unsealed air passages. The construction supervisor in charge of the remodeling project began to dread getting our calls, because with each call another wall had to go.

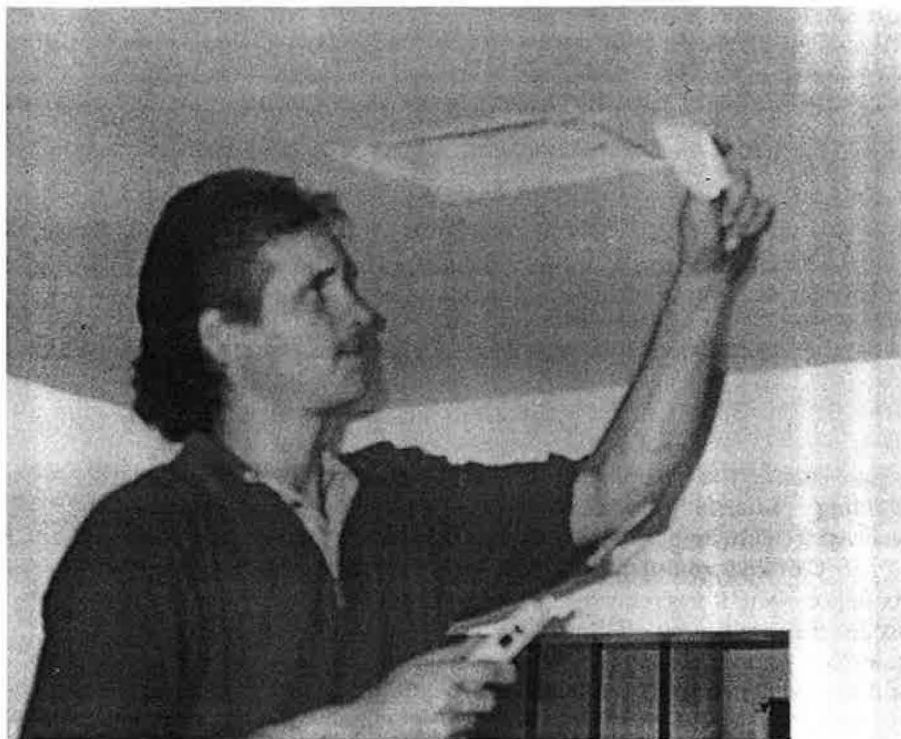
The rain coming from the living room supply register was apparently caused by outside humid air moving through the dropped ceiling and condensing on exposed metal in the register boot. But because the house was leaky in so many places, sealing a leak or two wasn't enough. We started air sealing in the attic and continued to run the blower door. Every time we sealed one leak, our smoke just changed direction, leading us to another big opening. It was shocking enough for the owner when we announced we would have to cut holes in his newly remodeled ceiling. But we kept finding more leaks. Smoke went

Jeff Tooley from the North Carolina Alternative Energy Corporation cuts sheet rock around the supply register boot, where water was dripping into the living room.
