Low-rise attached apartments pose different challenges for energy auditors than either single-family or large multifamily buildings. One project for a Pennsylvania housing authority shows some of the situations auditors may find.

The Lycoming County Housing Authority (LCHA) pays the gas bills for

■ CONSERVATION IN GARDEN APARTMENTS

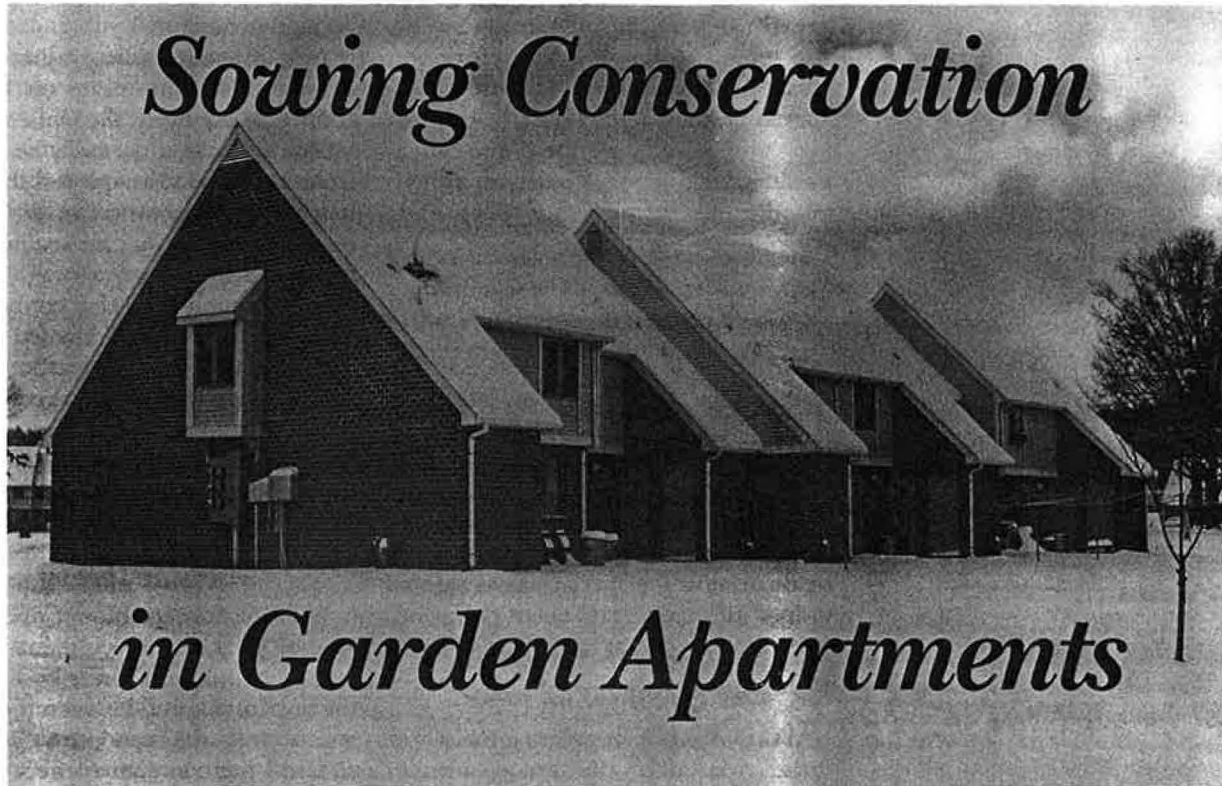
The photo above shows one of the 42 apartment buildings within the 250-unit Penn Vale Housing Complex, where auditors performed energy usage evaluation on ten different apartment types. Thirteen units also received a comprehensive energy audit.

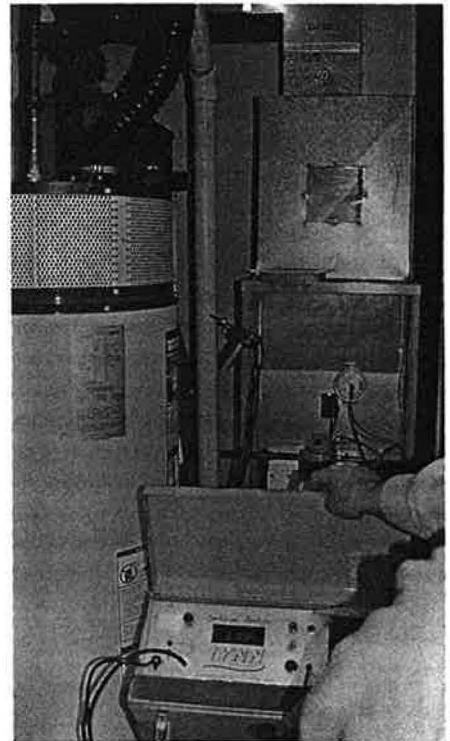
We found from pressure pan testing that the warm air distribution systems leak significantly to the outside. While there are many small leakage sites, the most significant "leak" was a supply register in each apartment's vented mechanical room.

Combustion analysis is performed on a 90%+ efficient furnace inside the mechanical room of one unit. Note the register on the supply plenum (covered with tape for testing), which provided heat to prevent pipe freeze-ups.

- Insulate all water piping in the mechanical room, including cold water supply pipes. Also verify that all elbows are insulated.
- Remove the supply plenum register and seal the opening.
- Install a reducer plate on existing furnace room door vents, modifying the combustion air openings to fulfill the requirements in the proposed National Fuel Gas Code.

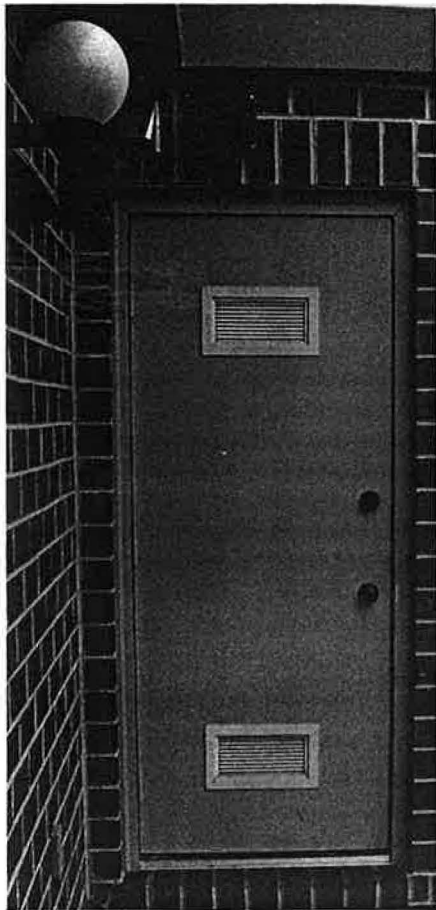
Whenever furnace fans were operating, we found the apartments to be depressurized, suggesting supply duct leakage to the outside. The average amount of depressurization was about 5 Pa, and in the two worst cases, it was as high as 8 Pa.

The pressure imbalances that occurred whenever the furnace fans operated were causing increased air leakage above what we found in our blower door tests. Cold outside air is pulled into any area of the apartment that is depressurized and warm heated air is pushed out of spaces that are pressurized. This increase in the air leakage rate results in higher heating costs. The major cause of the pressure imbalances in these apartments is duct leakage.

Combustion air inlets in the door to the mechanical room. The existence of these intentional openings and a supply duct on the furnace plenum combined to produce significant house depressurization during the blower cycle.

- Thermostat anticipators checked and reset.
- Second-floor bedroom supply registers sealed closed.
- Mechanical room combustion air grille reduced by 50%.
- Supply register in the mechanical room replaced with a dampered 3-inch duct to the pipe area.
- Attic hatch weatherstripped and insulated with 3 inches of extruded polystyrene board.
- Plumbing stack caulked.

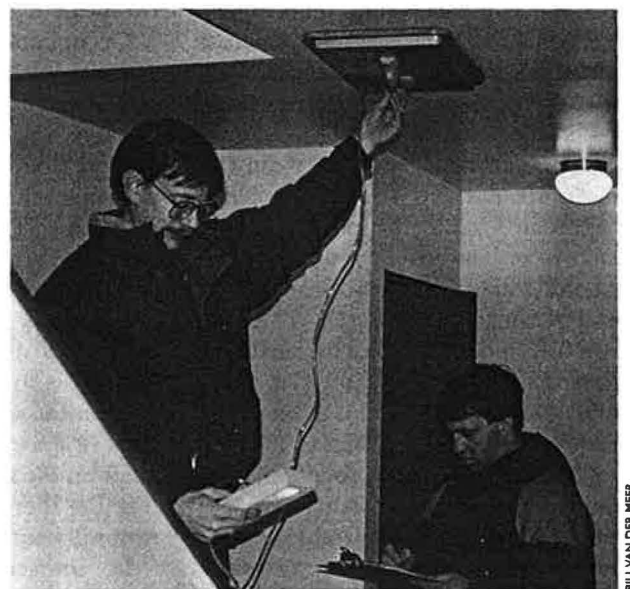
Pressure pan testing revealed significant leakage to the outside. Since the ducts were contained within the building envelope, most of the leakage was attributed to a register supplying heated air to the mechanical room.

We also recommended treatment of accessible sections of the distribution system. We suggested eliminating and sealing all filter slots that have been cut into the ducts, and installing the filter on the return grill or in the furnace cabinet instead.

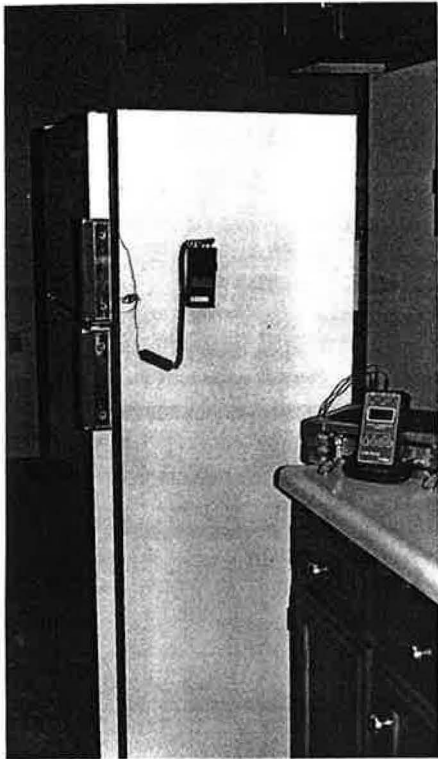
Even though the main emphasis of this study was on gas consumption, auditors also monitored refrigerator electrical consumption and temperatures using a digital thermometer and a watt meter. Most of the refrigerators were deemed to be operating fairly efficiently, although auditors recommended that one guzzler be replaced.
