**AIRTIGHTNESS IN UK DWELLINGS: A REVIEW OF
SOME RECENT MEASUREMENTS.**

Prepared for the
Second International Buildings and the Environment Conference.
Paris June, 9-12 1997

Robert Lowe, David Johnston & Malcolm Bell

Centre for the Built Environment
Leeds Metropolitan University
Leeds, UK.

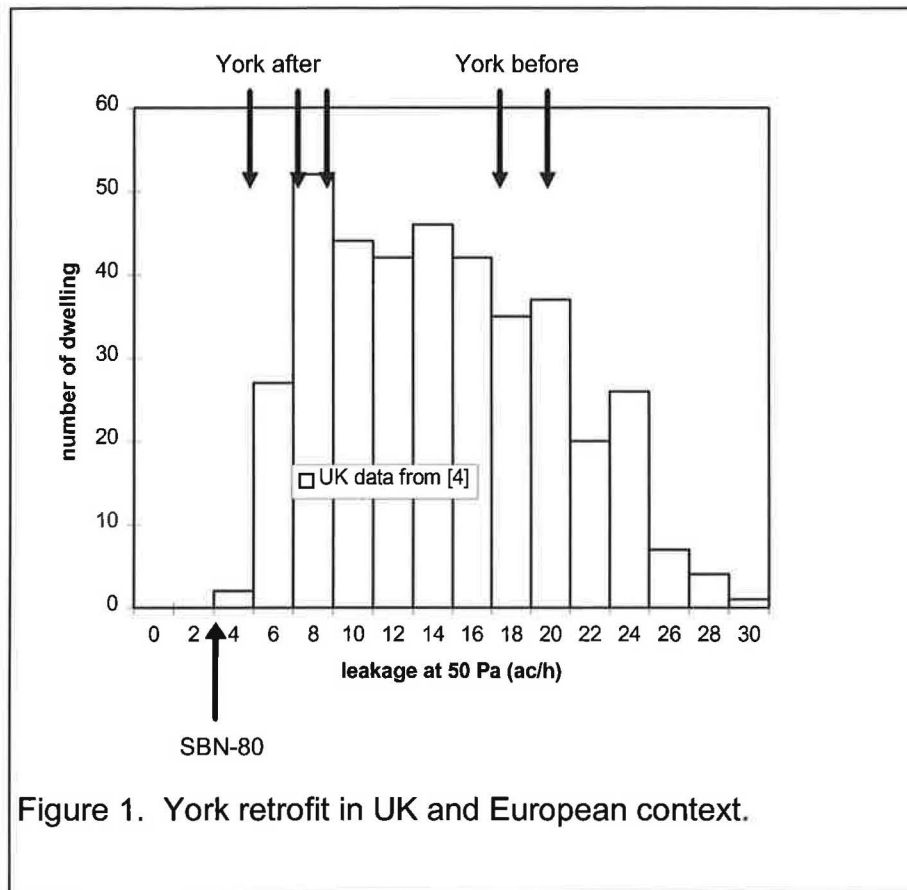
The York Energy Demonstration Project provided an opportunity to investigate the effects of refurbishment on the airtightness of existing, low rise, load bearing masonry housing in the North of England. Fuller descriptions of the York Project have been presented by Bell & Lowe [7][8]. We will note here that the houses were built in the 1930s and 1950s using traditional construction techniques, including wet-plastered walls. In 1992 they were comprehensively renovated, with replacement double glazed windows, new doors and 200 mm of loft insulation. Fan de-pressurisation tests were carried out in three of the houses. The wall cavity of one of the houses, Chapelfield B, was filled with blown mineral fibre, while the wall cavities of the other two houses, Bell Farm A & B were filled with in-situ foamed polyurethane. The tests were undertaken in January 1992, before, and in March and April 1992, after improvement work. In January it was possible to test only two of the houses under near perfect weather conditions, while in the spring it was possible to test all three of the houses, but under adverse wind conditions. The results are shown in table 1 and figure 1 below.

These results show a 2.5 - 3 fold improvement in air tightness in both sets of houses. This was brought about by a combination of measures, including draughtstripped replacement windows and doors, covering of tongued and grooved floors with 3 mm plywood sheeting (not sealed around skirting boards), and repair of obvious damage to plasterwork around doors and windows.

Leakage rates before improvements were higher than the UK average, although by no means extreme. The leakage rates after improvements are in the bottom quartile of a BRE database of 385 UK dwellings [4]. The estimate for Bell Farm A is below 5 air changes per hour¹. This figure was exceeded, in 1992, by just two in the BRE database, and it approaches the 1980 Swedish 3 ac/h standard for new housing [1]. It was achieved without significant attention to detail or workmanship or supervision. Moreover, a number of design and construction defects were evident at the time of testing. The most important of these were:
