Vol 14, March 1997

## THE SOLUTION TO LIFT SHAFT AIR LEAKAGE

## ENVELOPE THERMAL PERFORMANCE - THE ILLUSION AND THE REALITY

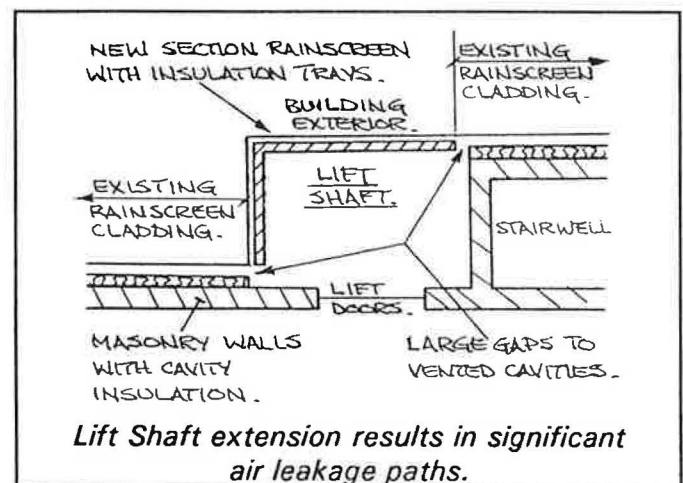
*Lift Shaft extension results in significant air leakage paths.*

In the existing construction the masonry wall acted as the primary air barrier whilst the liner trays formed the barrier around the lift shaft. The air barrier element of the main building envelope had not however been joined to the lift shaft liner trays and this left two very large vertical gaps of approximately 100mm and 220mm wide respectively between the ventilated cavity of the old construction and the lift shaft over the full building height. In addition to the discontinuity in the air barrier this deficiency also resulted in significant gaps in the thermal insulation around the envelope.

Building Sciences produced a report highlighting the defects and put forward a series of remedial work proposals. They were subsequently engaged by the tenant to carry out their remedial work proposals which primarily involved the installation of full building height plywood panel sections across the larger of the two openings which was then oversprayed with a polyurethane foam layer to form a continuous air barrier link between the new and existing construction and to provide continuity of the insulating layer. For the smaller of the two gaps a foam layer was sprayed across the surface of the existing mineral fibre insert to provide air barrier continuity.

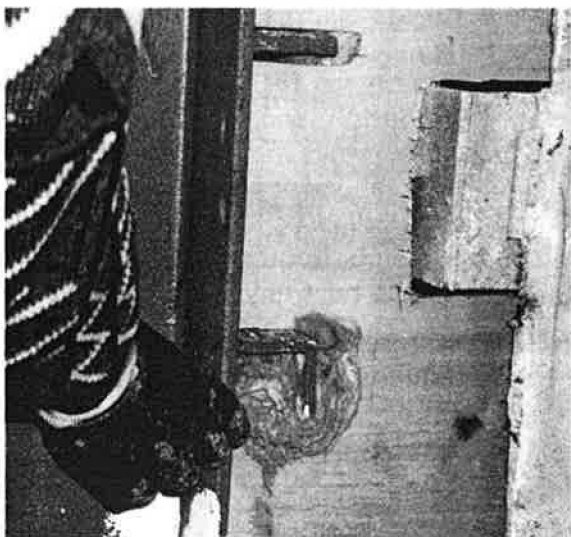
*Large vertical gap covered with plywood panels. Gaps around steelwork sections filled with fibre prior to foaming.*
