**SURVEY OF
BUILDING ENVELOPE FAILURES
IN THE COASTAL CLIMATE
OF BRITISH COLUMBIA**

Morrison Hershfield Limited

November 22, 1996

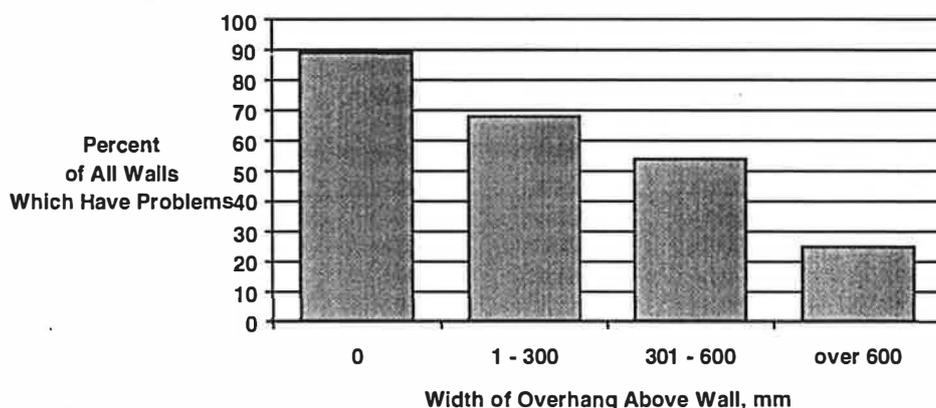
**FIGURE 3.1
EFFECT OF OVERHANGS ON WALL PERFORMANCE**

Lack of overhangs above walls is suggested by some industry members as a contributing factor to moisture damage in wood frame walls. The data on overhangs confirms this view; Figure 3.1 shows that the proportion of walls with problems drops consistently with increase in the width of overhang above them.
