The Interactive Window System was a sterling effort by Colt International, aimed at developing an integrated and modular product for use in naturally ventilated buildings. Milton Park Ltd piloted the system in a passive solar building completed for Marston Book Services. How well has the building performed?

BY THE PROBE TEAM

PROBE

16: Marston Book Services

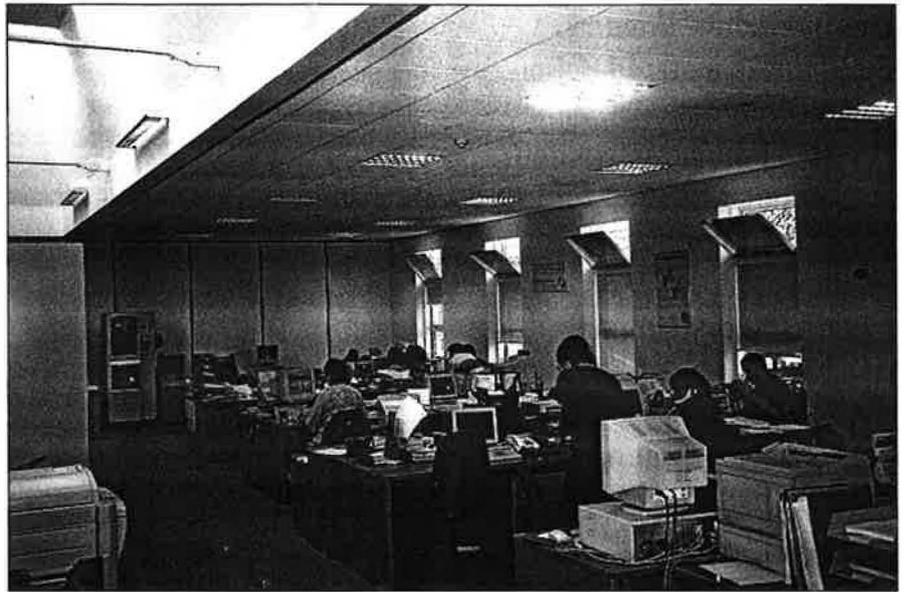
The glare from sun and sky is disappointing in view of the care devoted to the window system. This is due to diagonal sunshine coming past the ends of the light shelves, and bright spots on the blinds in bright sunshine.

The reported glare from sun and sky is disappointing in view of the care devoted to the window system. This seems to be due to diagonal sunshine coming past the ends of the light shelves and bright spots on the translucent blinds in bright sunshine. There are no blinds on the north facade, but bright skies can still cause problems with contrast glare and reflections in computer screens.

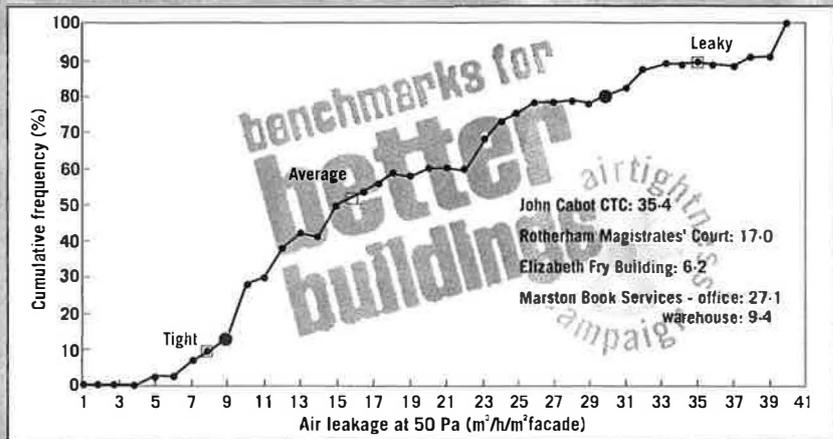
FIGURE 4: The air leakage data for Marston Book Services, plotted on the BRE/BSRIA rolling database.

The Q-value (Q_{50}/S) for the offices was calculated to be 27.1 m³/h/m² of envelope area (calculated at 1366 m²). This puts the building near the 'leaky' group on the BRE/BSRIA database (figure 4).

This indicated significant air leakage through the roof structure of the office building, and at the junction between the office brickwork and the warehouse cladding, which occurs at the smoking room. In depressurisation mode, a ceiling tile was lifted manually, and a severe draught of air was detected from the office roof space.

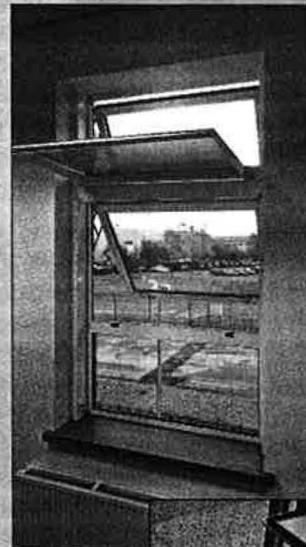
So how has the Interactive Window System performed? Occupants regarded the windows as successful in the main for ventilation, and particularly liked the performance of the upper motorised window, although some tilting occurred in high winds. However, the central window element performed poorly, as only a small wind was required to blow it shut.

The window hinges do not have sufficient resistance, and there is no slit-catch position.

Consequently, people sitting by the windows cannot control the draught, and feel that too much of the air goes over their heads.

Occupants liked the upper motorised window, but the central window elements close under only a small wind, leading to...
