Building and Environment 34 (1999) 57-69

## Improvement of indoor air quality in four problem homes

C. Y. Shaw<sup>a,\*</sup>, V. Salares<sup>b</sup>, R. J. Magee<sup>a</sup>, M. Kanabus-Kaminska<sup>a</sup>

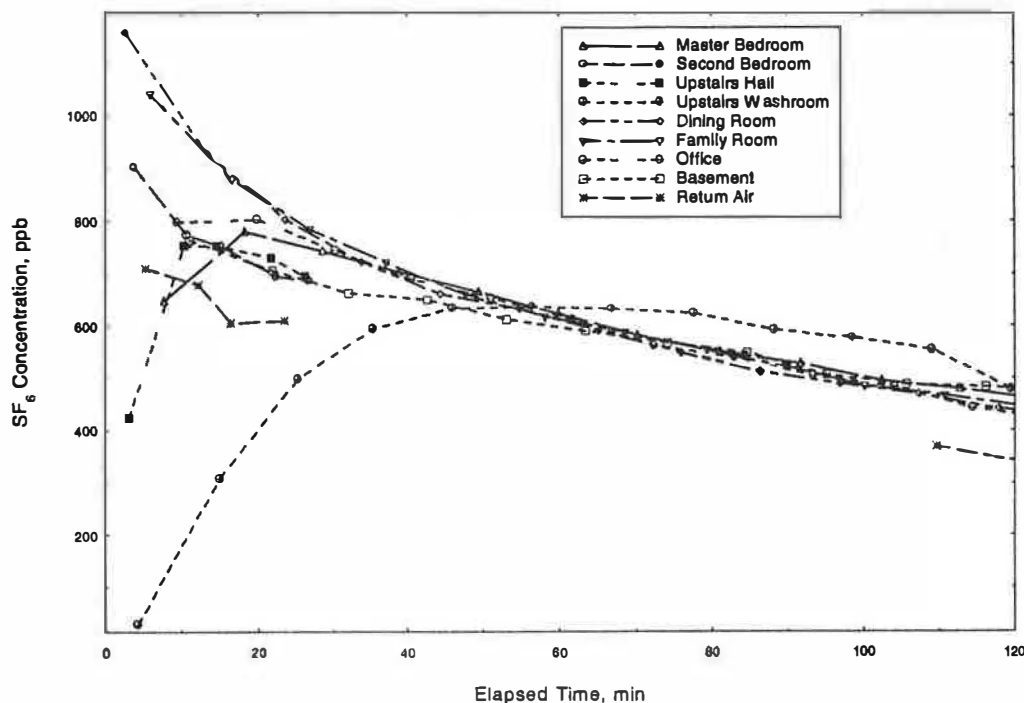
Fig. 1. Air distribution test: House II, POST-renovation.

The air temperatures in the occupied area before renovation, were between 21°C and 23°C, and the relative humidity ranged from 32% to 40%. After renovation, the air temperatures decreased slightly to between 19 and 21°C and the relative humidity ranged from 35 to 40%. The measured air change rates (ventilation rates) were between 0.34 and 0.37 ach, and between 0.28 and 0.3 ach, before and after renovation, respectively. The ventilation

air was well mixed with the indoor air. The mixing time for both the pre- and post-renovation periods was about 30 minutes. The results were expected because no special effort was made to increase the air change rate.

Major renovation measures included the replacement of carpeting in the family room, office, and basement with ceramic tiles. Carpeting was removed and hardwood flooring installed in the upstairs bedrooms. The flexible plastic ducting of the HRV was replaced with metal ducting. The fiberglass insulation was removed from the furnace room ceiling. The central vacuum unit originally installed in the furnace room was moved to the garage.

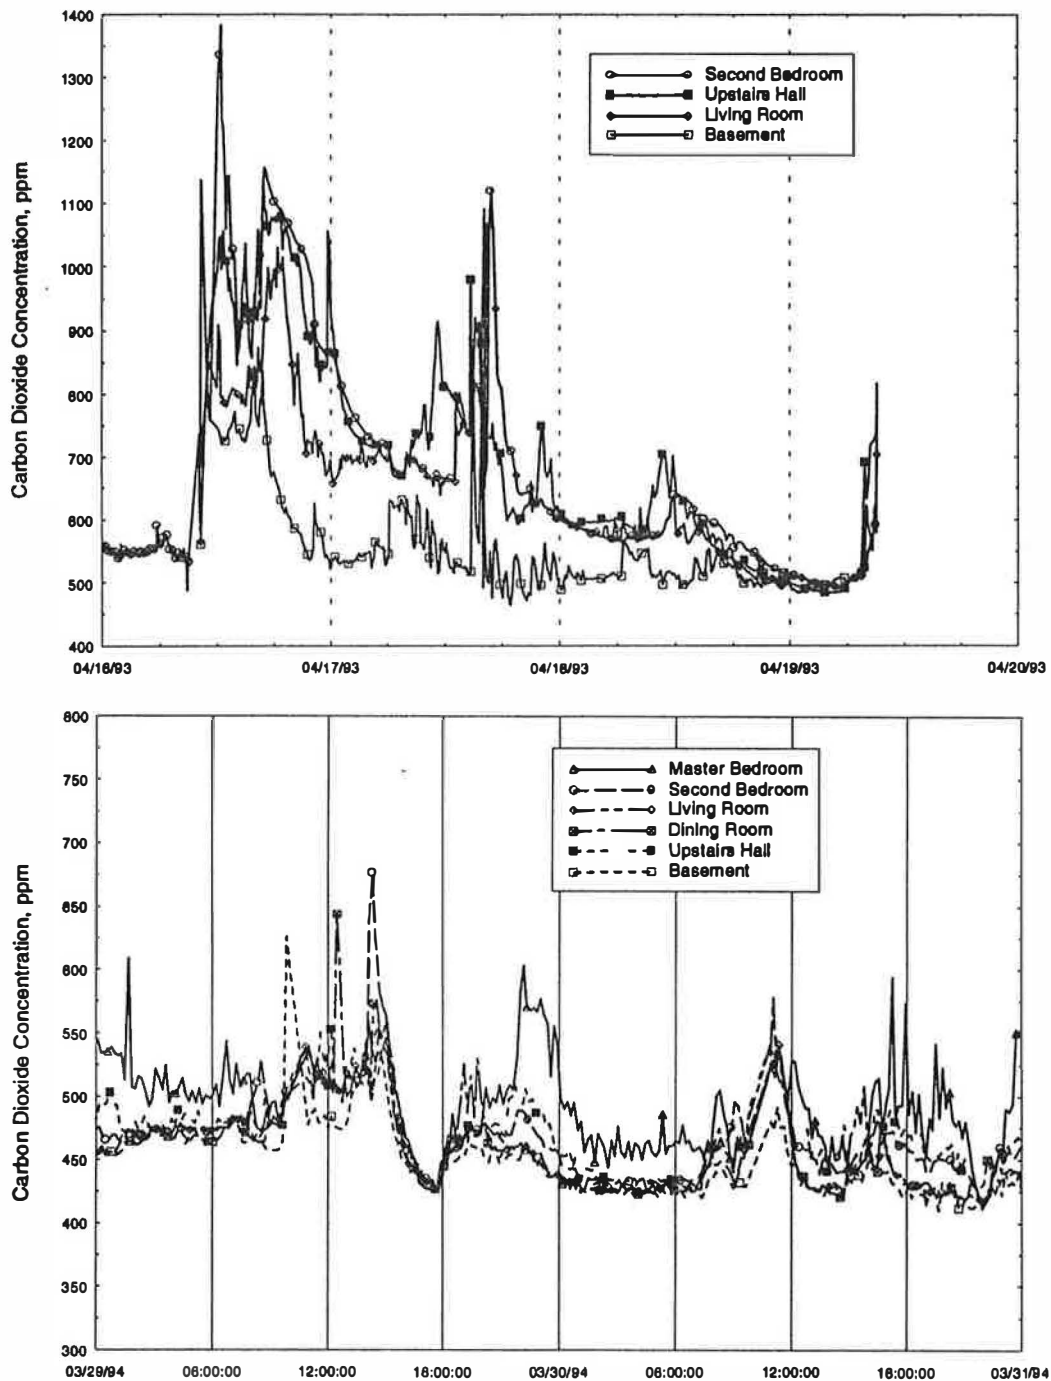
Fig. 2. (a) Carbon dioxide observations, Hose I, PRE-renovation. (b) Carbon dioxide observations, Hose I, POST-renovation.

Before renovation, the formaldehyde levels in the house ranged between 0.01 and 0.02 ppm and the CO<sub>2</sub> concentrations were between 460 and 1350 ppm. After renovation, the formaldehyde levels were not changed but the CO<sub>2</sub> concentrations were between 440 and 660 ppm. Figure 2 shows, as an example, the CO<sub>2</sub> profiles measured in this house before and after renovation.

Major renovation measures included the modification of the main supply and return ducts in the basement by turning the existing electric furnace from its original upright position to a horizontal position. Joints in the ductwork in the basement were also sealed. A heat recovery ventilator (HRV) was installed with exhaust pick-ups

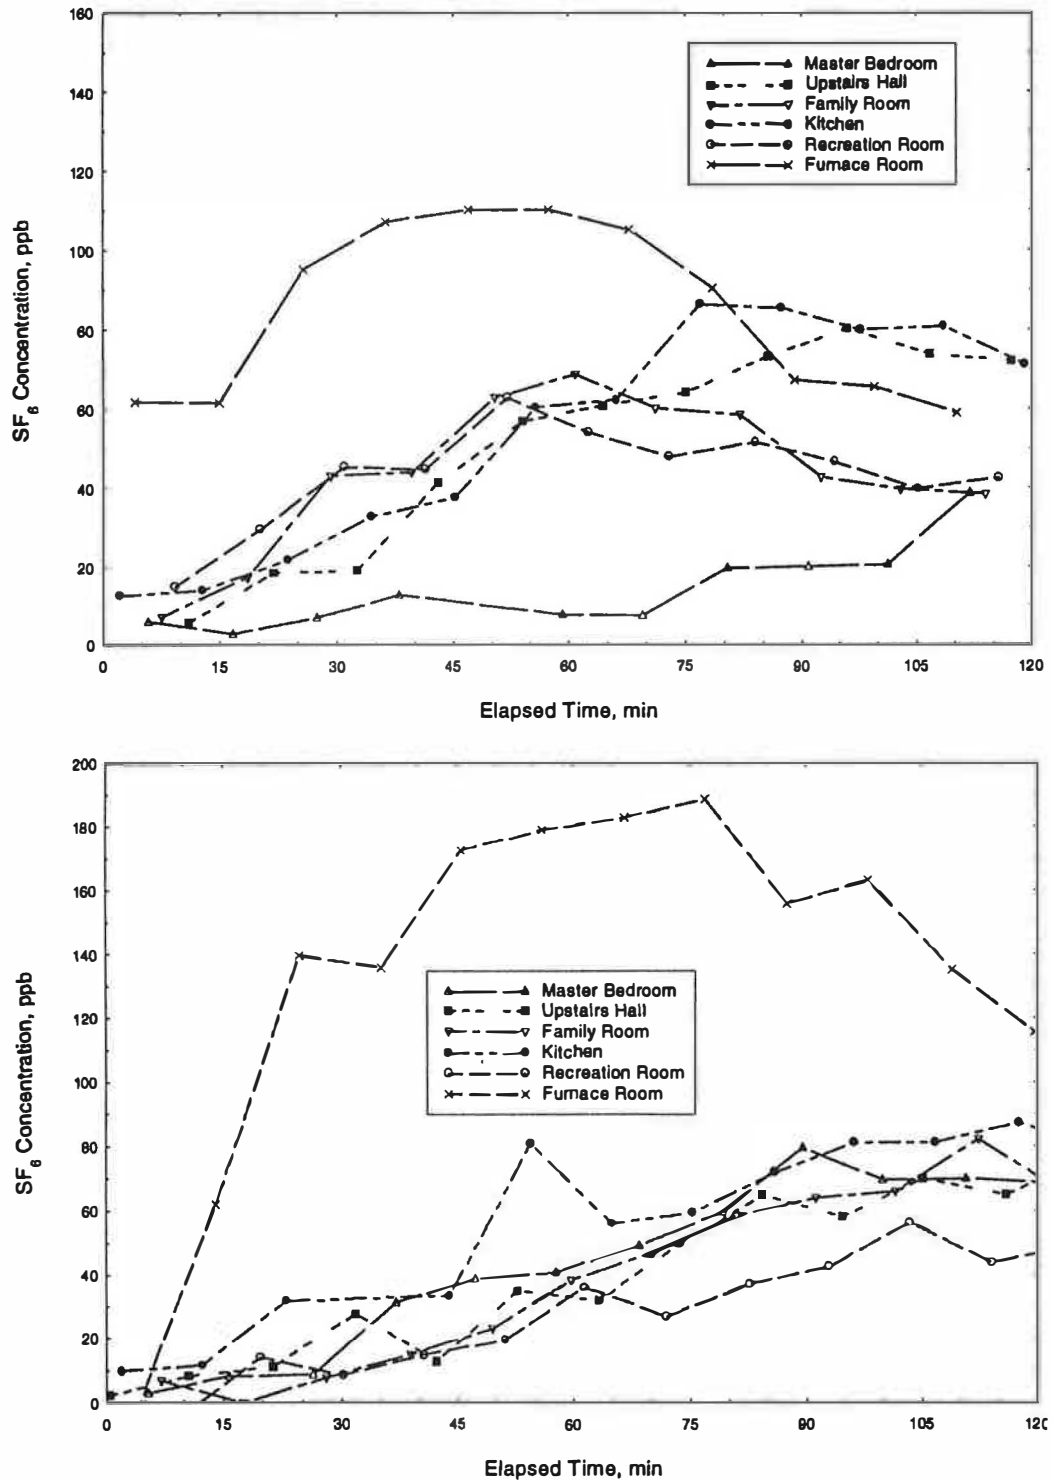
Fig. 3. (a) Air distribution test VI-D2 (Garage injection): House VI, PRE-renovation. (b) Air distribution test VI-D5 (Garage injection): House VI, POST-renovation.

The air temperatures in the occupied area before renovation, were between 20°C and 25°C, and the relative humidity ranged from 20% to 29%. After renovation air temperatures were between 20°C and 22°C, and the relative humidity increased to approximately 54%. The measured air change rates (ventilation rates) were between 0.73 and 0.81 ach, and between 0.3 and 0.33 ach, before and after renovation, respectively. As the house did not have a HRV, the reduction in the air change rates after renovation was mainly caused by increased outdoor air temperatures. Air distribution tests conducted during the pre-renovation period revealed a noticeable air movement from the furnace room to the living area. Also, a significant amount of air movement from the garage to the house. The air inflows from the furnace room and particularly, from the garage to the house were not stopped after significant efforts were made to seal the air leakage openings. Figure 3 shows the tracer gas test results, before and after renovation, which indicate that as soon as the tracer gas was injected in the garage, the tracer gas, and hence, the garage air, reached all the sampling locations in the house.

House VI—The applied renovation measures did not seem to produce the expected results. The leakage of the furnace room air and the garage air into the house was not stopped. Nor the removal of the carpet resulted in a reduction of the VOC levels in the house.

Major renovation measures included the replacement of the boiler and gas water heater with a single high efficiency sealed-combustion unit. Carpeting in the family room was replaced with hardwood flooring. A new countertop was installed in the kitchen. The exterior cedar siding on the kitchen addition was sealed with acrylic urethane in an attempt to prevent off-gassing from the previously applied wood preservatives. Attempts had been made to seal the electrical outlets located in the kitchen exterior wall to prevent infiltration of VOCs from the exterior siding. At the front of the house, a new step was added to the mud/laundry room entrance to cover a hole in the foundation that had been allowing infiltration of outside air. The clothes dryer hose was repaired and a

properly dampered exhaust vent installed. Caulking was added to the garage door.
