Energy and Buildings 29 (1999) 179–187

## Study on environmental quality of a surgical block

This article presents the study of a surgical block with serious deficiencies of Indoor Air Quality (IAQ) located in the Hospital del Rio Hortega (Valladolid, Spain). Block characteristics were identified and symptoms reports collected from 118 workers. At the end of the initial investigation, it was concluded that there was Sick Building Syndrome. Measurements of ventilation and contaminants were made of indoor air (CO, CO<sub>2</sub>, TVOC, anaesthetic gases, at six different points simultaneously) and outdoor air (hospital incinerator). Studies with trace vapors (Xylene) were also performed on installations which crossed the surgical area to see whether a relationship existed between the different surgical areas studied and other areas of the health centre. Actions on contaminating foci, climatization–ventilation and personnel training were finally recommended to Administration to solve the problem. © 1999 Elsevier Science S.A. All rights reserved.

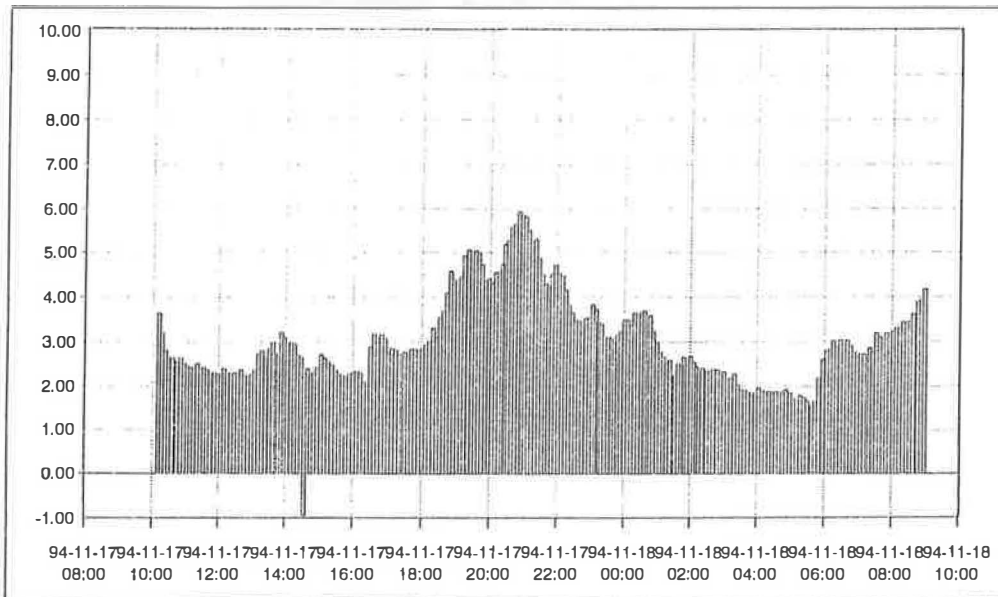
All measurements showed negative toxic levels. However, variations in gas and vapour levels during surgery appeared. For example, Fig. 2 presents the evolution of TVO's in one of the six measurements taken.

Fig. 2. Evolution of TVO's in a 24 h measurement.

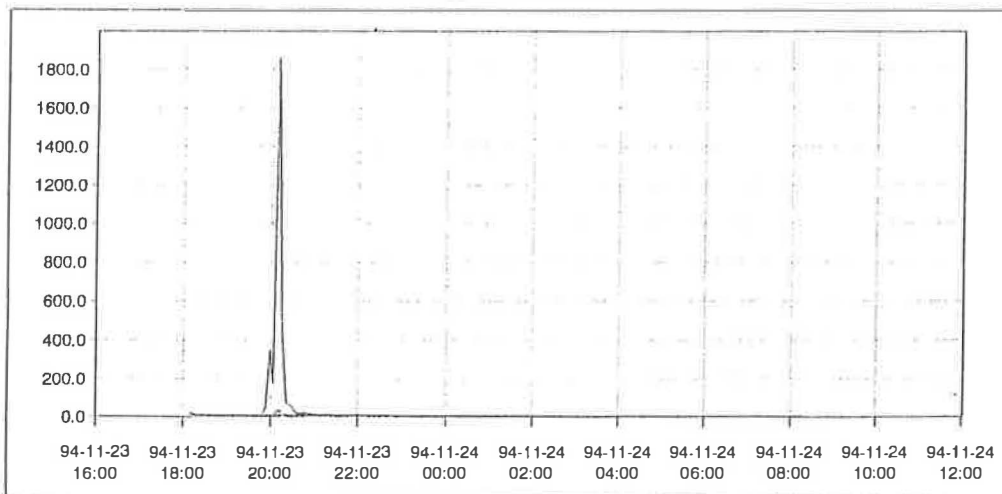
The study was quite effective. There turned out to be a sharp peak in the wash-up room next to the surgical room in the fourth pouring. Following the tests, an inspection of this room by hospital maintenance personnel found that there was no siphon in the basin of that room and that there were cracks in the drain. Fig. 3 presents the peak detected in the drain flow corresponding to the wash-up room.

Fig. 3. Peak of trace vapor detection in the drain flow corresponding to the wash-up room.

The first focus is eliminated by using mechanical extractors applied to the patients. Such equipment is connected to the vacuum net. The second focus involves a much more complex intervention, due to the existence of covered registers and small yards which are difficult to control. Nevertheless, revision of the ventilation columns, the sewage boxes, the siphones corresponding to the drainage pipes which crossed the area and of the drainage pipe shunts was proposed.

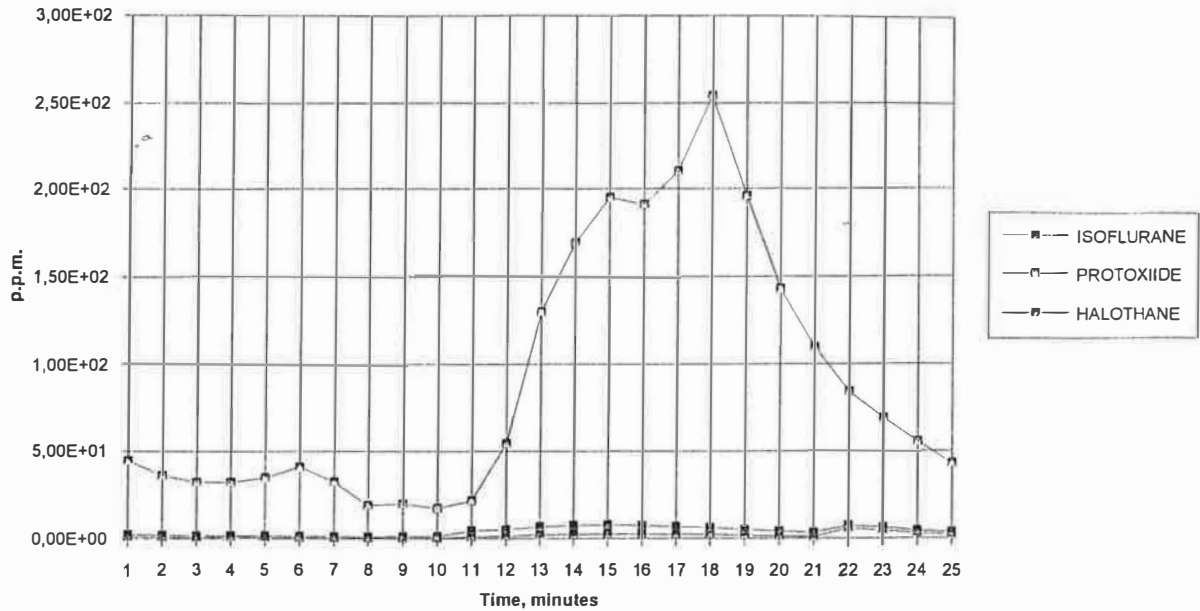
Monitoring the anaesthetic gases during a surgical operation, it was found that although these gases were mechanically introduced into the patient, afterwards they were not extracted and led to the exterior, but were exhaled by the patient within the operating room. This non-standard practice was already viewed with suspicion by the personnel, but no objective quantification of its incidence existed. This information was gained by photoacoustic spectroscopy. The results obtained during a surgical operation without mechanical gas extraction are shown in Fig. 4, while results with mechanical extraction are presented in Fig. 5. Given that the Threshold Limit Value adopted by American Conference of Government Industrial Hygienists in 1994 [1] for an 8-h exposure to nitrogen protoxide are 25 ppm (no Short-Time Exposure Limit value exists for this gas), the importance of the extraction of patient gas exhalations in an operating room is evident. This is even more true in that the simultaneous presence of various gases may result in an additive or multiplying effect, with a more marked symptomatology.

Fig. 4. Evolution of anaesthetic gases during a surgical operation without mechanical gas extraction

- (e) The nitrogen protoxide levels present during operations surpassed acceptable limits.

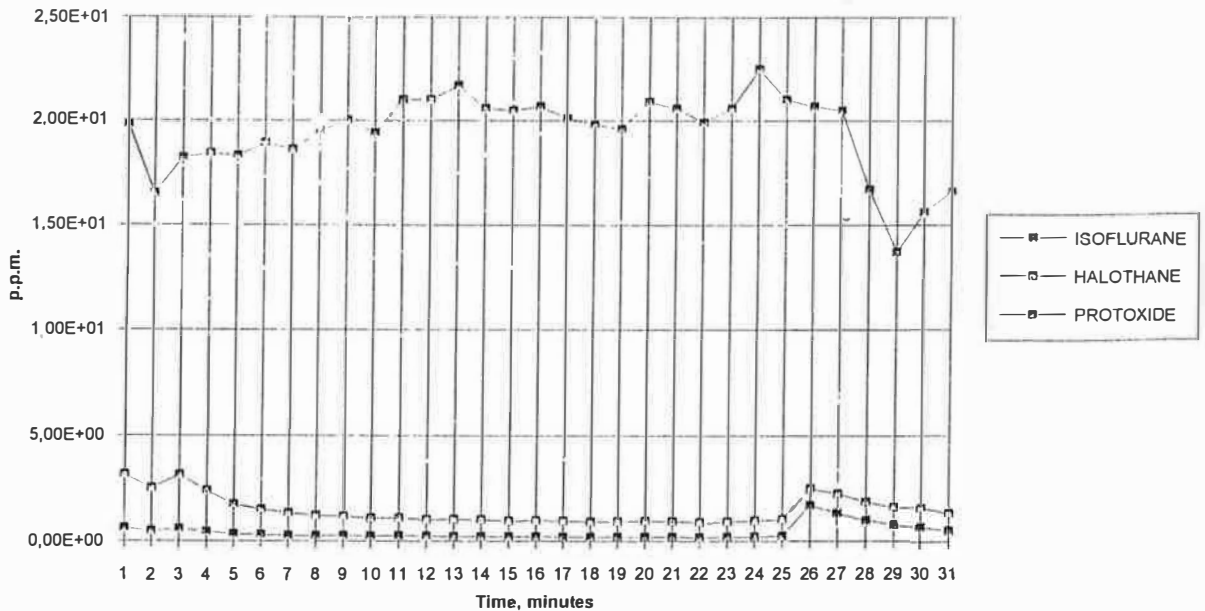
Fig. 5. Evolution of anaesthetic gases during a surgical operation with mechanical gas extraction
