PROBE

18: Portland Building

The Portland Building is the fifth educational building to be surveyed by the PROBE Team, and the last in the current PROBE series of building investigations.

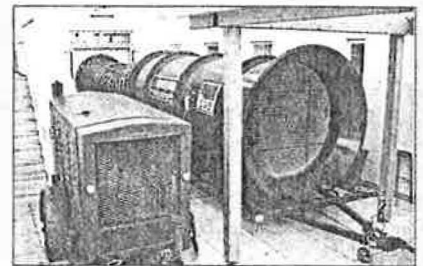
The air leakage audit showed that the roof/wall junctions on the third floor were very leaky. The junctions between the RSJs and timber beams were also found to be very leaky, with large gaps visible. Air was detected coming from the ventilation towers, indicating that these structures were not airtight.

The windows were found to be generally quite good, with minimal air leakage through them. However, there was significant air leakage around the south-facing timber bay windows, especially along the floor joint. The stairwell windows were also found to be slightly leaky at the frame wall junction.

All of the external doors had significant air leakage through them. The fire doors on the ground floor in the small lecture theatre leaked badly, both at the bottom and along the right-hand sides.

The double fire door at the bottom of the stairwell leaked very badly along the bottom and between the doors. The doors in the student common room also leaked down the middle. Significant air leakage was evident in all other external doors.

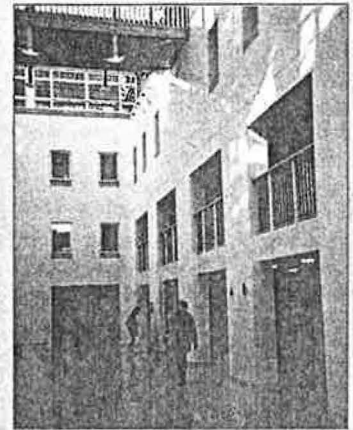
There have been several other difficulties with the Forum's rooflights. On occasions they have stuck open, and a special cherry picker has had to be used to reach them. Motors have also been failing. The Estates Department thinks they may be over-stressed and that pneumatic actuators might have worked better.

Time lags in rain detection and actuator response mean that rooflights can take two minutes to close. In a downpour, this can let in a lot of water. Bird droppings on the rain sensor have also sometimes prevented the windows from opening.

ABOVE: The Forum. A welcome circulation space, albeit with dysfunctional rooflight actuators (LEFT) and some reported noise problems.

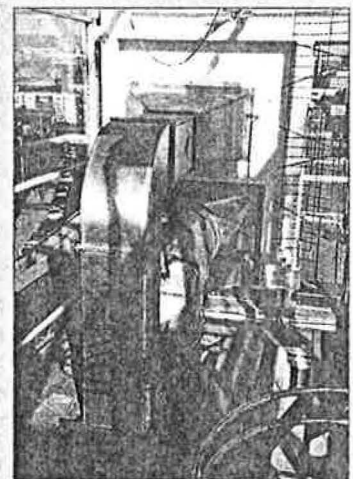
ABOVE: The turret plantrooms. Attractive, but difficult to access and not airtight.

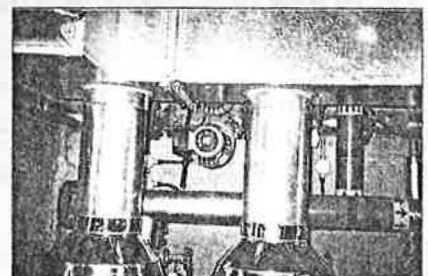
cramped plantrooms are at the top of cat ladders, and fixed but fragile panels cover many of the underfloor heating manifolds and circulation pumps.

ABOVE: So often a sacrifice on the high altar of 'architecture', cramped plantrooms can create a maintenance headache for the end user.
