Roof Ventilation to Prevent Problematic Icings at Eaves

James Buska

ABSTRACT

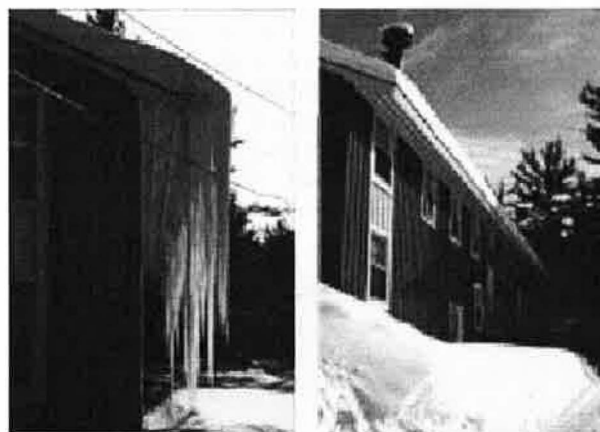
dams that form along their eaves. Icicles and ice dams can also form on unheated buildings, but they are usually small and infrequent. Chronic, problematic icings are much more likely to form on heated buildings. Figure 1 shows two adjacent identical buildings photographed at the same time. The eaves of one are festooned with ice while the eaves of the other are clear. As the snow on the chimney of the roof with clear eaves indicates, that building was not heated. Figure 1 serves to illustrate that chronic, problematic icings are caused by building heat, not by the sun.

Figure 1 Two identically constructed roofs photographed at the same time. The building on the right, with no icings, was unheated.

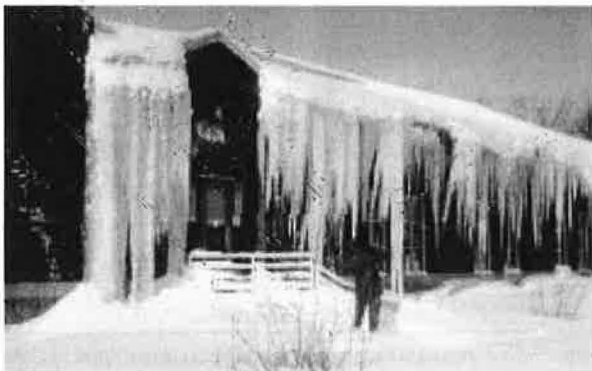
Figure 2. Severe problematic icings developed all along the eaves of this dining facility.

These design guidelines were used by others to increase the amount of attic ventilation in 57 buildings suffering a range of icing problems from slight to severe (Figure 2). We had recommended attic ventilation improvements in conjunction with increased ceiling and duct insulation and reduction of air exfiltration. The designers chose to only improve attic ventilation for 51 of the buildings. Some insulation was added to HVAC ducts in the other six attics but that reduced the total heat losses into those attics only slightly. The improvements, essentially all of which were to the ventilation, eliminated chronic icing for 56 of the 57 buildings. Only a few small icicles formed on them occasionally after the new work. Some icing problems persisted along portions of the 57th building, where air intakes at the eaves could not be easily enlarged. We feel that this localized problem can be solved by increasing the size of air intakes in these areas. Improved attic ventilation, sized to meet the peak ventilation needs defined above, consistently eliminated the chronic icing problems suffered by these buildings.

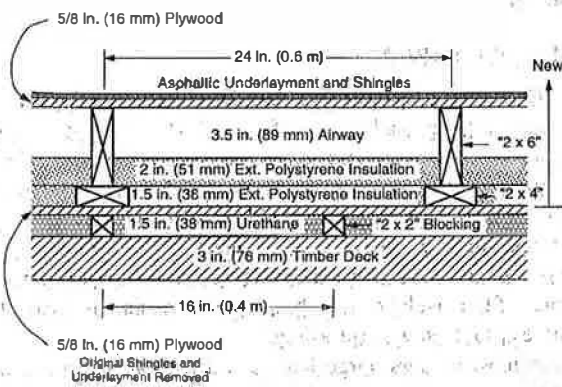
Figure 3 Cross section showing the Howe Library roof ventilation modifications as constructed.

adding more insulation only. We advised against that for the reasons mentioned above. Based on our recommendations, the warm, unventilated roof was changed to a cold, ventilated roof with improved insulation. Figure 3 shows a cross section of the roof after these changes were made.

As an aside, the as-built roof cross section shown in Figure 3 was not our primary recommendation. We felt that a tighter, and thus a better insulating/waterproofing system, could have been achieved by using about 2½ in. (64 mm) of monolithic spray foam instead of numerous insulation boards. Our spray foam recommendation is shown in Figure 7. The curved uninterrupted upper surface of the spray foam would serve as a secondary drainage trough for any moisture that might get by the primary waterproofing system. Such moisture would work its way deep into any system of individual boards. While the extruded polystyrene boards themselves would remain dry, that moisture could do harm to other components of the roof in time. We estimated that the spray foam alternative, with 2x4 verticals, not 2x6 verticals, would be only a bit more expensive, and, considering the “insurance” it would add, we recommended it. However, these secondary benefits were not enough to convince the owners to spend the extra money.

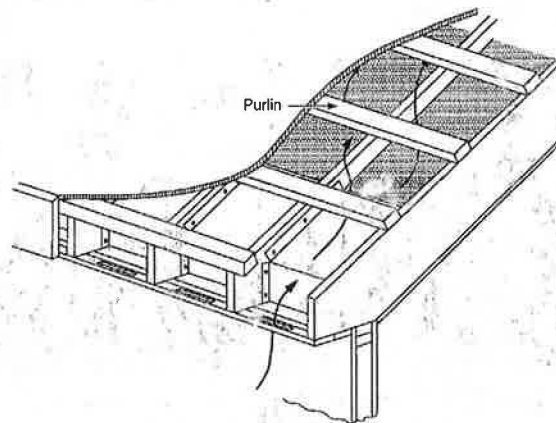
Figure 4 Use of cross-purlins to interconnect the airways of a low-slope roof.

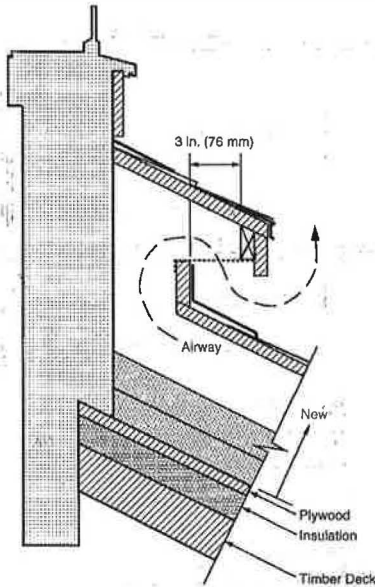
Figure 5 Large roof exhaust structure used where airways terminated at clerestory wall.

This building has clerestory windows that cause the upper ends of the airways on one slope to terminate at the base of the clerestory wall, not at the ridge. A large roof exhaust structure (Figure 5) was needed for the airways all along that intersection. Since we had some concerns that snow drifts would form in this area, reducing ventilation, we and the architect involved gave that structure a rather wide brim. Large hoods for build-

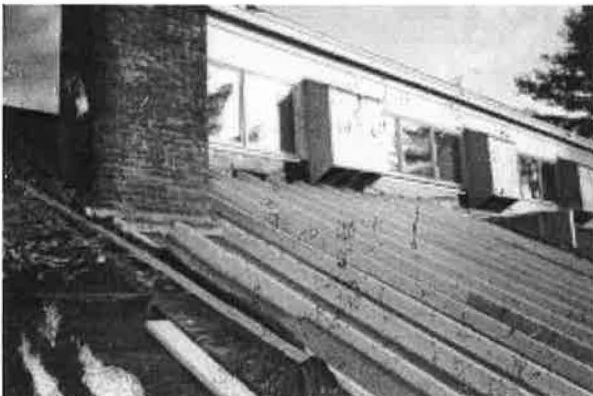
Figure 6 Notches in 2x6's allow cross-ventilation, at chimney and at large building exhaust hoods. Exhaust structure shown in Figure 5, not altered.

ing exhaust fans interrupted our new roof exhaust structure in several places. The 2x6's were notched in these area, as shown in Figure 6, to allow air in the dead-ended airways to gain access to adjacent airways that lead to our new exhaust structure. Similar notching was used to open airways that dead ended at the chimney (Figure 6).

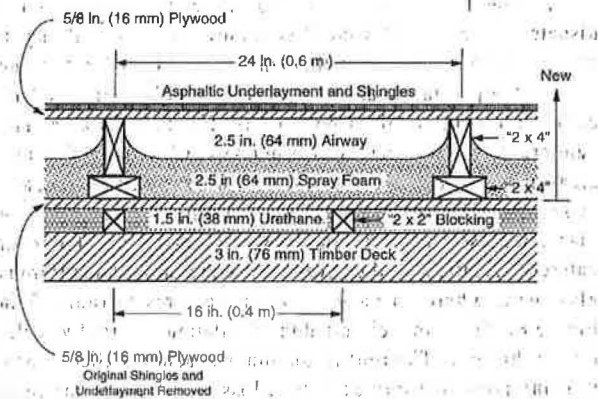
Figure 7 Spray foam recommendation for improving roof ventilation of Howe Library.

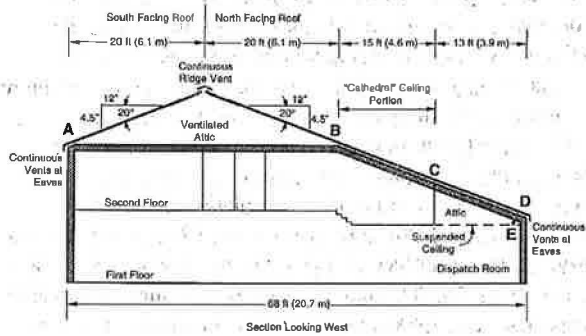
Figure 8 Cross section through east-west wing of the Hanover Police Facility.

Figure 8 shows the complicated ventilation pathways through a cross section of this facility. A ventilated attic, containing a large amount of HVAC equipment, exists below the upper portion of the north roof and the entire south roof. The attic has intakes all along its south eaves (at A in Figure 8), a small gable vent at its west end, and a continuous ridge vent. The middle portion of the north roof has a sloped, cathedral ceiling with a 2 in. (51 mm) ventilated air space above the insulation (between points B and C in Figure 8). The lower portion between point C and the continuous vents along the north eaves (at D in Figure 8) also had a 2 in. (51 mm) air space above the roof insulation and a warm unventilated attic below. In this attic area the insulation was placed between the roof rafters, and a clear polyethylene vapor retarder was stapled below.

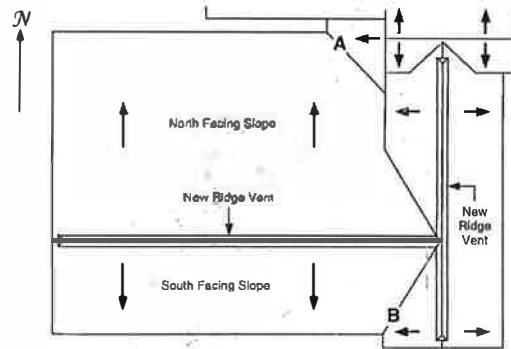
Figure 9 Plan view of Hanover Police Facility showing slopes and location of roof leaks (A and B) at valleys.

two winters near the two roof valleys (Points A and B in Figure 9). Large icings (Figure 10) and roof leaks were causing serious problems in the dispatch center located below point A in Figure 9. The occupants complained of cold drafts. They also had to chop ice off the eaves and shovel snow from the roof to minimize hazards and leaks. Figure 11 shows the paths of meltwater that is produced on several roofs, then drains into this problematic valley.

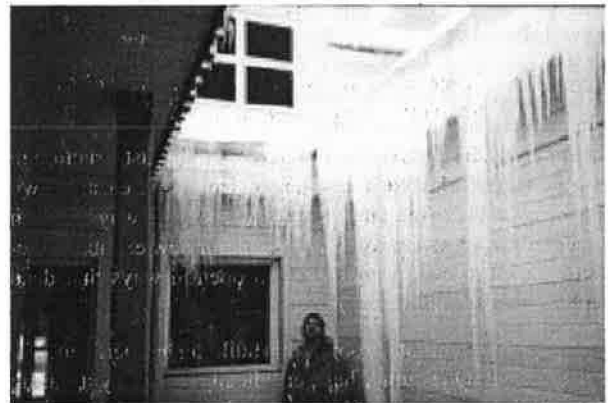
Figure 10 Icings and ice dam at eaves of problematic valley over dispatch center. Icicles in the valley were removed, the day before this picture was taken.

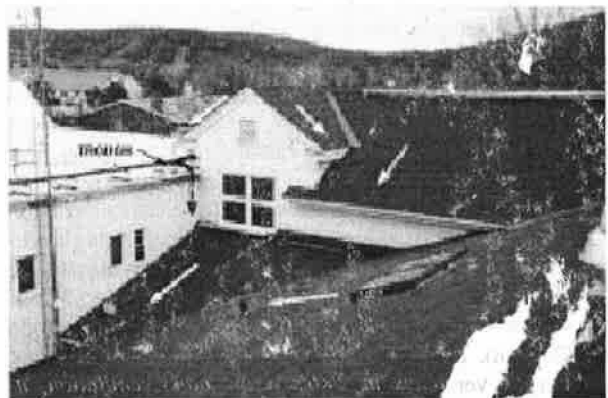
Figure 11 Roof surfaces that drain valley over dispatch center.

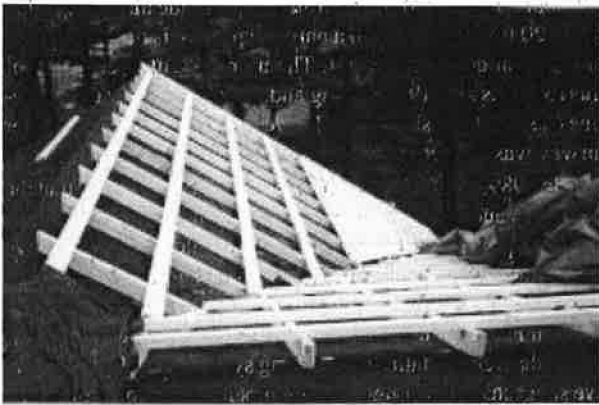
Figure 12 Cross-ventilation provided by sleepers and cross-purlins in valleys.

airways. Cross-purlins are a very effective method of providing ventilation in valleys, as shown in Figure 12. The continuous ridge vent structure (Figure 13) exhausted both the existing ventilated attic and the new airways created by the sleepers and cross-purlins. It was framed to interconnect each individual airway.

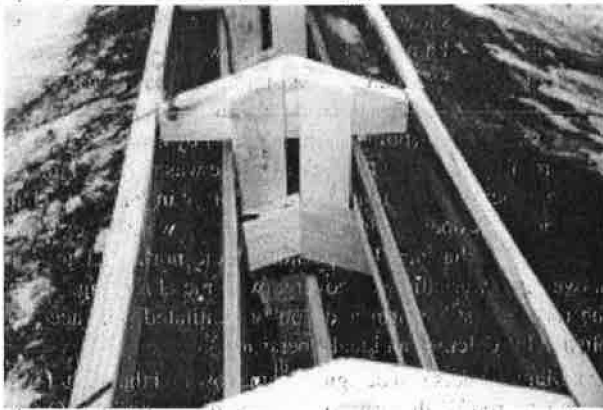
Figure 13 Continuous ridge vent structure ventilates both the old attic and the new airways.

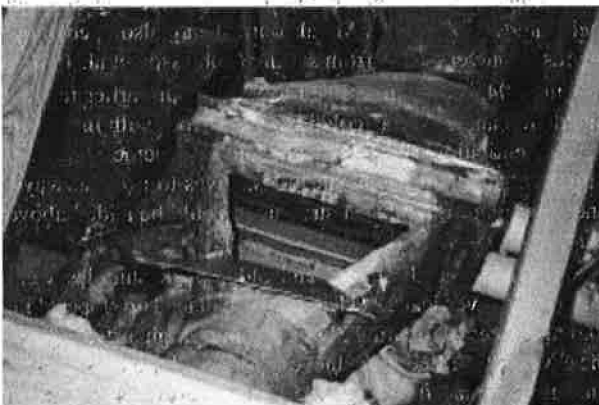
Figure 14 Inspection opening on heating duct. It was "only" open about 2 in. at the top. We bent it back further to show it better.

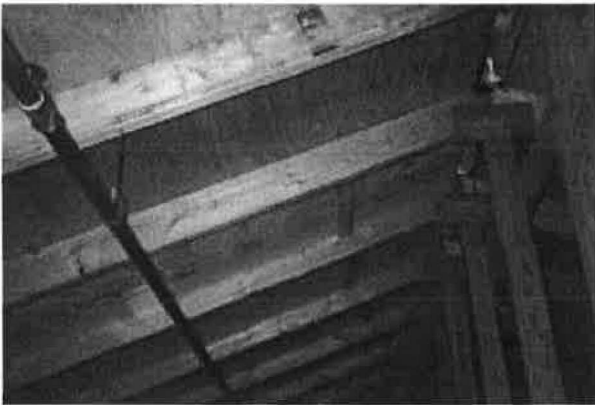
Figure 15 Extruded polystyrene insulation added to the underside of a portion of the original roof deck.

While we felt that correcting these deficiencies would solve the icing problem, we also recommended that a small test section be installed on the south-facing slope of the attic. One and one half inches (38 mm) of extruded polystyrene insulation were added to the underside of the original roof deck to further reduce attic heat losses up into the new ventilated space above (Figure 15). This is a somewhat inefficient place to add insulation since the attic below is ventilated with cold outdoor air. However, all the timber trusses and HVAC equipment in the attic made it quite difficult to add insulation to that already on the attic floor and on the hot HVAC equipment in the attic.
