Stack-Driven Moisture Problems in a Multi-Family Residential Building

ABSTRACT

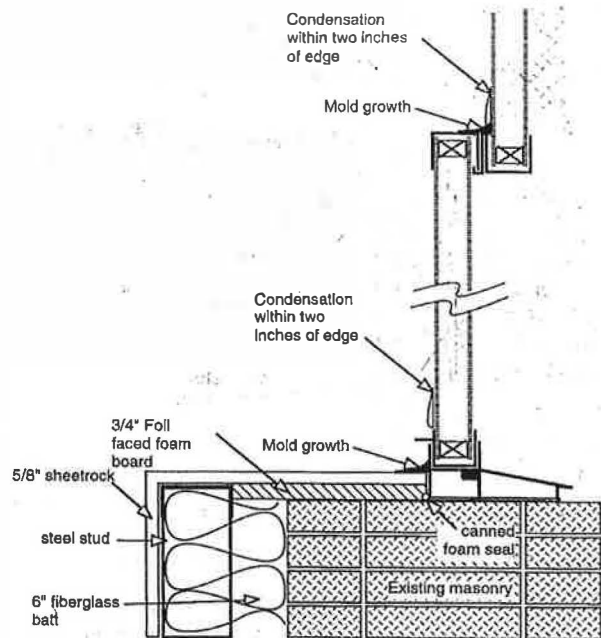
The surface temperatures of the window and sheetrock returns were measured in an unoccupied apartment. The windows faced north and west. The measurements were made using a surface temperature probe. During the visit, condensation, frost, and fungal growth were observed on portions of the window and sheetrock. Condensation occurred at the window within a few inches of the lower edge of the upper and lower lites. Condensation was also observed on the inner face of the PVC-coated sash. Frost was observed on a piece of aluminum extrusion that frames the interior perimeter of the window jambs and inside the track portion of the jamb that holds the window in place. Fungal growth was observed at the bottom of each lite and in the corners where the frosted aluminum extrusion and sheetrock returns meet. The locations of condensation, frost, and fungal growth are shown in Figure 1.

Figure 1 Section through window installation showing location of condensation and fungal growth.

1. Raise the neutral pressure plane to ventilate and dry the upper floors.
- Install either a central exhaust system or individual bath exhaust fans to depressurize the affected floors (The third floor should be included as part of the affected area).
2. Raise the surface temperatures of the window components.
- Cover the aluminum extrusion around the interior of the windows that was covered with frost with an insulating

material and a material to prevent contact with room air water vapor.

- Clean all hard-surfaced materials (aluminum, PVC) that have fungal growth and replace all soft materials (sheet-rock, foam) that have fungal growth with new materials. The materials may be treated as nonhazardous construction waste.
- In the event that problems persist, apply interior storm windows.

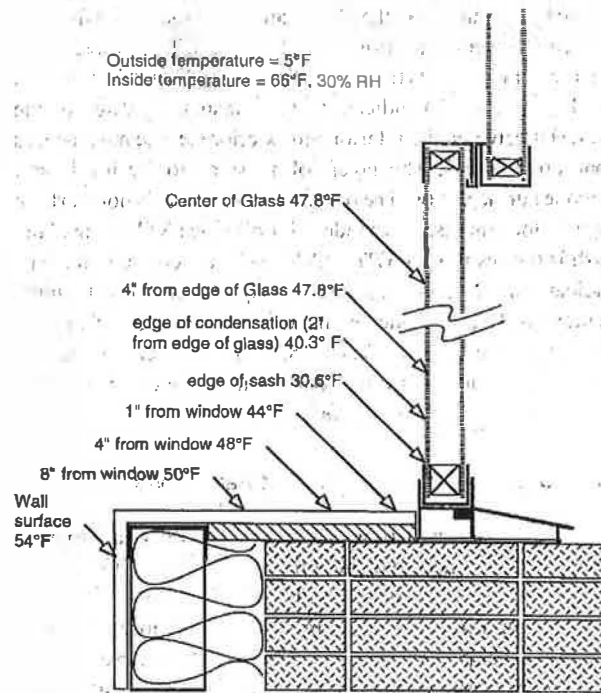
The temperatures measured during the visit are shown in Figures 2 and 3. A north-facing window was selected because it did not receive any direct sunshine, which changes the temperature profile of the window elements. The room air was 66°F (19°C) and 33% relative humidity. Under these conditions, it is expected that dew point will occur at around 36°F (2°C). A measurement of the surface temperature of the

Figure 2 Surface temperatures of window components and surrounding sheetrock.

window glass at the edge of the condensation (2 in. from the edge of the glass unit) was 40°F (4°C), close to what was expected. All surfaces with condensation were cooler than

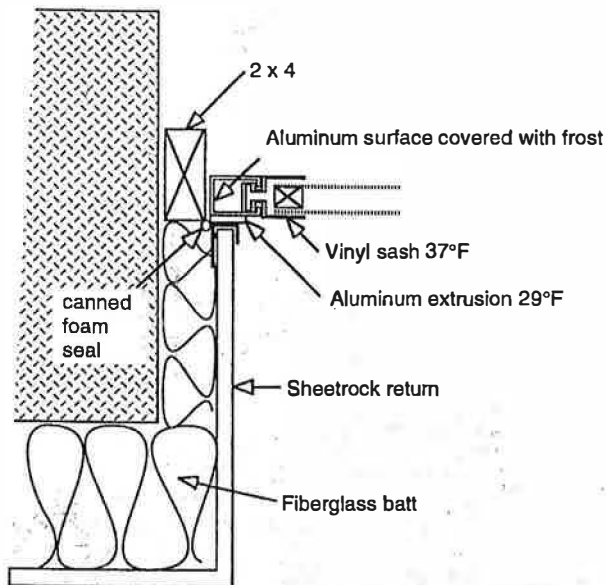
Figure 3 Surface temperature of window sash and aluminum extrusion.

this. All surfaces with frost were below 32°F (0°C). The window performs as expected except for the cold temperatures of the frosted areas on the aluminum extrusion and in the sash track and the condensation on the PVC sash. The temperatures on the aluminum extrusion (29°F, -1.7°C) and in the sash track (26°F, -3°C) indicate that the insulating value of the material between the interior and exterior surface must be less than an R of 1.5. The layers of air stuck to the inside and outside surfaces would be over R-1. Something is not working right in these areas. The condensation on the PVC facing of the sash is the result of a 37°F (2.8°C) surface temperature. This indicates an R-value less than 1.7, significantly less than the center-of-glass R-value of the window (R-2.15) where the surface temperature is 47.8°F (8.8°C). The thermal analysis program Window 4.0 was used to calculate a center-of-glass R-value of 2.0 for this window.

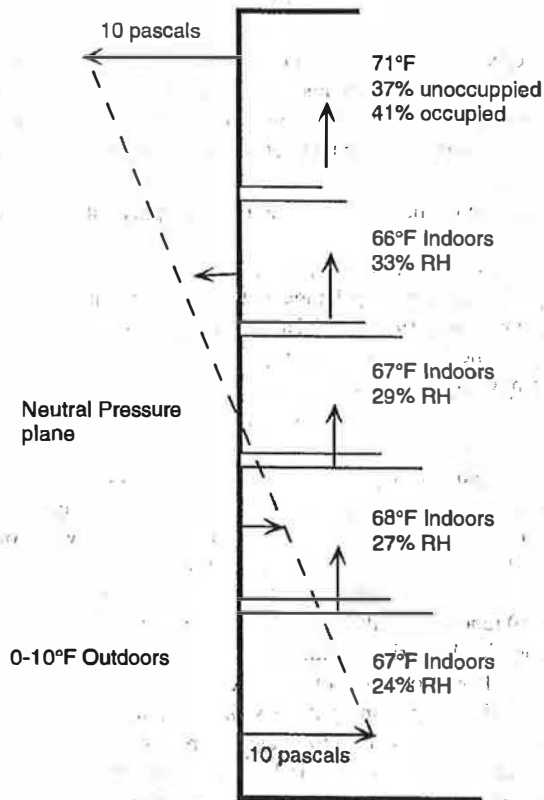
The relative humidity was lowest on the first floor (24%) and progressively increased on each successive floor, peaking on the top floor at 35%. This was expected because the makeup air for the bottom two floors was cold outdoor air at a low relative humidity. As this cold, dry outdoor air was warmed up after entering the building, it could then hold considerably more moisture than could the cold air; therefore, it "picked up" moisture generated by the building occupants. This increased the relative humidity in the air. As it rose to the upper floors, the air picked up more moisture, and the relative humidity continued to increase, until it reached the top floor and the highest relative humidity. The significance of this becomes apparent when the indoor-to-outdoor air pressures are also considered. The first and second floors are below the neutral pressure plane; therefore, the outdoor air enters the building and essentially dries out the air on those two floors. The neutral pressure plane is located on the third floor. The fourth and fifth floors are above the neutral pressure plane, making it impossible for outdoor air to enter through envelope leaks. Figure 4 illustrates the results of the measurements as well as the dynamics involved.

Figure 4 Temperature, relative humidity, and pressure differences.
