# Resolving Duct Leakage Claims

By Ernest E. Choat, P.E.  
Fellow/Life Member ASHRAE

**T**his report is from a study of the performance of eight exhaust systems of a large medical center in Tennessee. The mechanical contractor of the project initiated this study when confronted with a claim of unacceptable deficiencies in all building exhaust systems. These systems were reportedly exhausting 32% to 43% less than design airflow as a consequence of excessive leakage in the duct system.

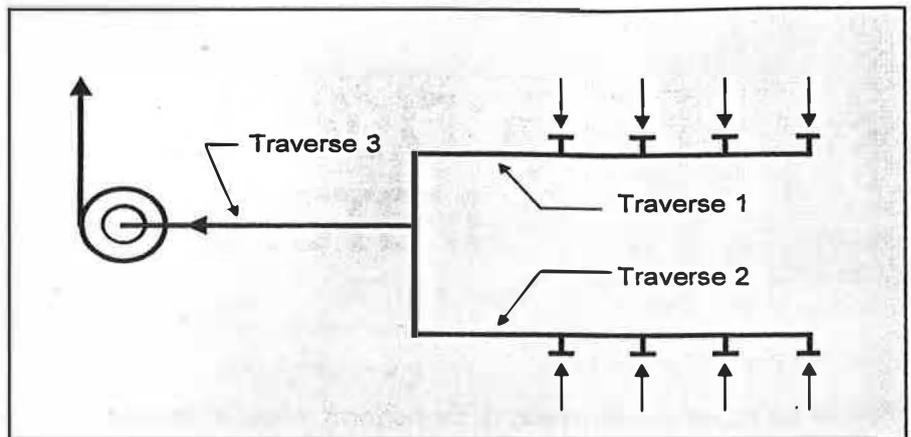
Figure 1: System EF-29.

The analysis of EF-29 was initiated by taking measurements of the airflow in the two major branch ducts (Traverse 1 and 2, Figure 1) on the first floor. These measurements were made with a Pitot tube connected to an electronic micro-manometer (Meter B) that was provided by the independent investigator. Meter B is produced by the same company that manufactured Meter A and has the same alleged accuracy. This meter was a working piece of instrumentation that recently had been "field calibrated" but had not been "factory" calibrated in more than one year.

The sum of the airflows at these locations was slightly more than 50% of design. Because this measurement agreed with the test report, it was concluded that a major leak must exist somewhere between the measuring location and the fan inlet. It also was believed that a measurement at the fan inlet would be at design airflow in accordance with the test report, and would verify the conclusion that a large leak existed in the duct segment in question.

1. Openings for making a duct traverse were not found in the fan inlet duct, but some were subsequently provided.
2. Fan static pressure was measured and found to be very low as compared to the specified design, and also the test report.
3. Motor amps were found to be near design values and also in agreement with values recorded in the test report.
4. Total airflow—as measured by duct traversing (Traverse 3, Figure 1)—was about 50% of design.
5. The fan was running backwards.
6. The arrow that indicates the direction of fan rotation had been modified with a pen to indicate an incorrect rotation for the fan.

From this data, it was concluded that the major problem with EF-29 was the rotation of the fan. In addition, a comparison of the branch airflow measurements with the total measured at the fan inlet indicated that duct leakage was not a major problem. Those present agreed that this system—except for balancing of the inlets—seemed to be satisfactory. Consequently, no further tests were made on this system.

The rotation of the fan was then corrected and measurements were repeated. Findings were:

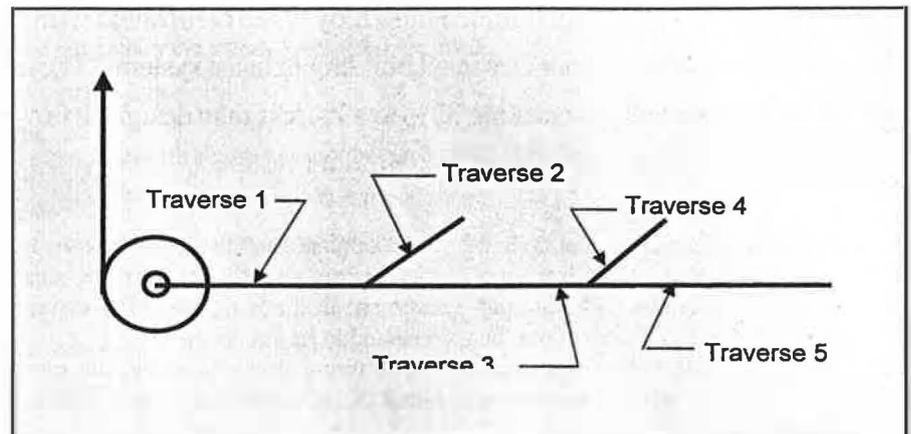
Figure 2: System EF-21.

As illustrated in Figure 2, several traverses were made in both branch and main ducts, and a comparison of these measurements was made to determine if leakage existed. For example:

- It was found that the combined flow at the locations of Traverse 2 and Traverse 3 (Figure 2) was equal to the airflow at Traverse 1. Therefore, no significant leak existed between these measuring points.
- Similarly, it was found that the combined flow at the location of Traverse 4 and Traverse 5 (Figure 2) was equal to the flow at Traverse Point 3. Therefore, no significant leak existed between these measuring points.

This process was continued to the end of the system, but failed to reveal a significant leak. Because no leakage was found, the question arose as to the accuracy of measurements made at inlets. It was speculated that perhaps the flow hood used by the test crew might have been out of calibration.
