IDENTIFYING AND REMOVING  
POLLUTANTS FROM HEAT  
RECOVERY VENTILATORS

**By: Terry Watters  
Sustainable Housing and Education Consultants Ltd.**

**February 1999**

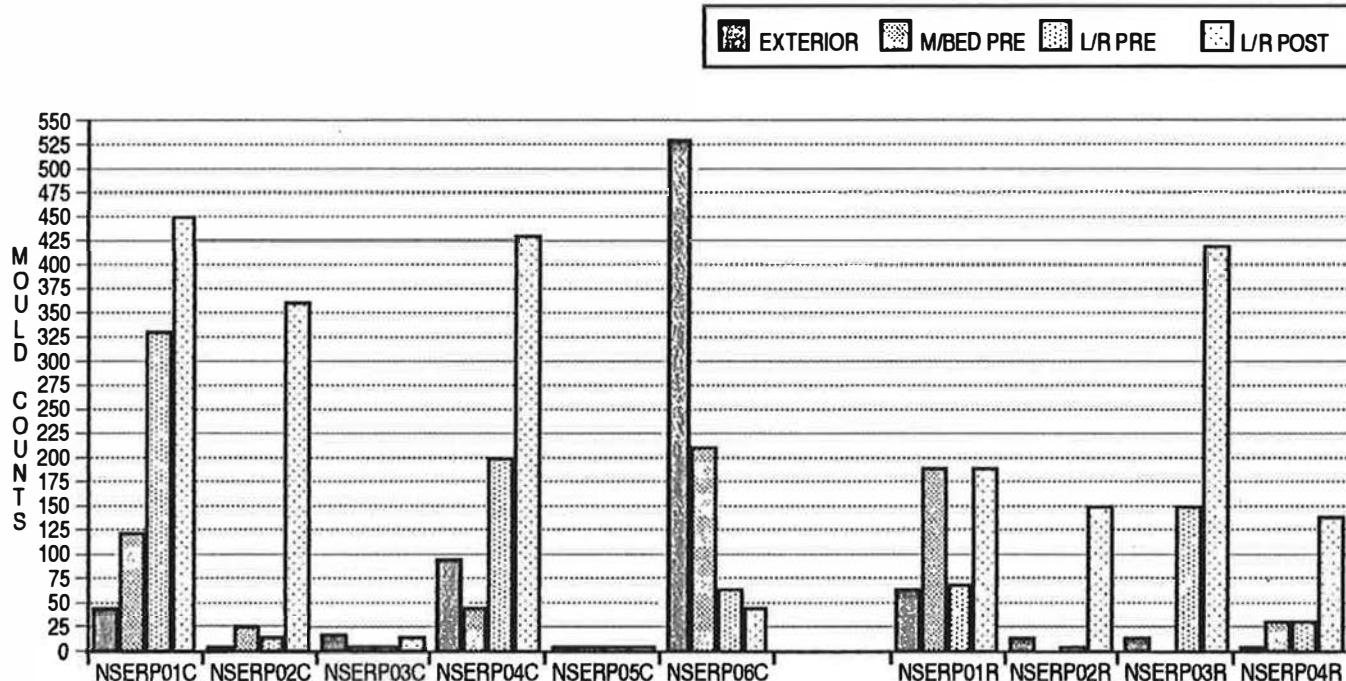
CHART III.B: AIR SAMPLE RESULTS BY HOUSE, COMMON TEST SITES

Reuter Centrifugal Sampler (RCS) air sampler results indicate a wide range of colony forming units per cubic metre (CFU/m<sup>3</sup>), both within houses and between the different houses. Taking four common sites from all houses (some were tested in other areas by request of homeowner or by consultant), the results are as shown in the table below. The exterior samples (first column) were used as a control. These exterior samples were taken close to the intake hood of the ventilation system, 120mm (4 ft.) above grade.

The analysis of RCS strips was done through InnovaCorp, Dartmouth, NS. Total colony forming units per cubic metre (CFU/m<sup>3</sup>) for each sample were supplied, along with a percentage breakdown of the mold genera present. The genera noted were: *Alternaria/Ulocladium*; *Aspergillus*; *Cladosporium*; *Penicillium*; *Scopulariopsis*; yeast; and non-sporing isolates. The tables in Section V, Appendix, show the RCS strip results by house with the above mold genera identified by percentage. Table III.A indicates overall CFU/m<sup>3</sup> per sample, with levels of <sup>3</sup>150 CFU/m<sup>3</sup> in shaded areas. Table III.B shows a synopsis of the samples where individual genera counts were <sup>3</sup>50 CFU/m<sup>3</sup>. In all other cases <50 CFU/m<sup>3</sup> of any given genera were present.

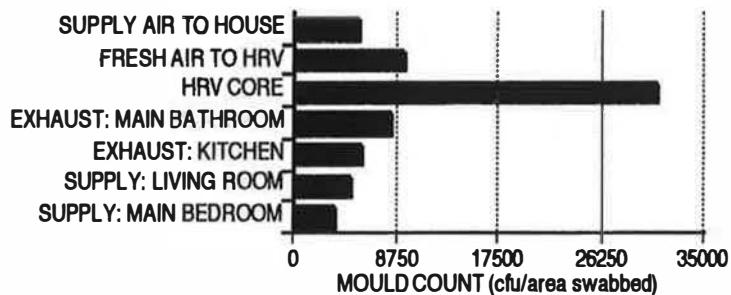
CHART III.C: PRE CLEANING AVERAGE SWAB MOULD COUNTS BY LOCATION

Precleaning testing indicated that, on average, the highest surface mold counts at common sites were at the HRV core (30959 CFU/area swabbed) and at the fresh air intake to the HRV (9322 CFU/area swabbed). Prior to cleaning, on average, the lowest counts were found in the main bedroom supply duct (3411 CFU/area swabbed), although the living room supply, kitchen exhaust and supply air to house were within 3% of the main bedroom supply. Post cleaning results indicated that, on average, the highest surface mold counts were at supply air to house (11309 CFU/area swabbed), and the lowest counts were at the living room supply (188 CFU/area swabbed). The average overall reduction of discernible mold counts was 29189 CFU/area swabbed. All swab sites showed a reduction in CFU/area swabbed after cleaning except the main bedroom supply and the supply air to house. Post cleaning swabs showed a redistribution of mold counts (see charts III.D and III.E).
