## field notes

# Solving a Chimney Moisture Problem

by Joe Ponessa

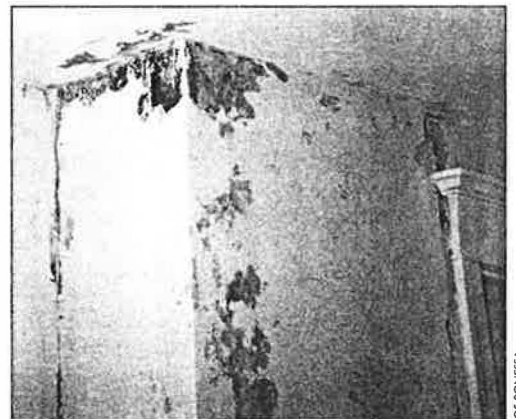
Wall damage that had appeared on the second floor around the chimney gradually worsened over time. It would reappear, even after the new roof was put on.

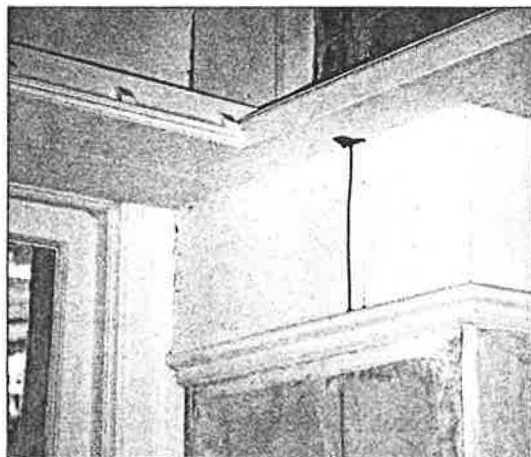
When ceiling damage appeared on the first floor, reinforcements were called in to help.

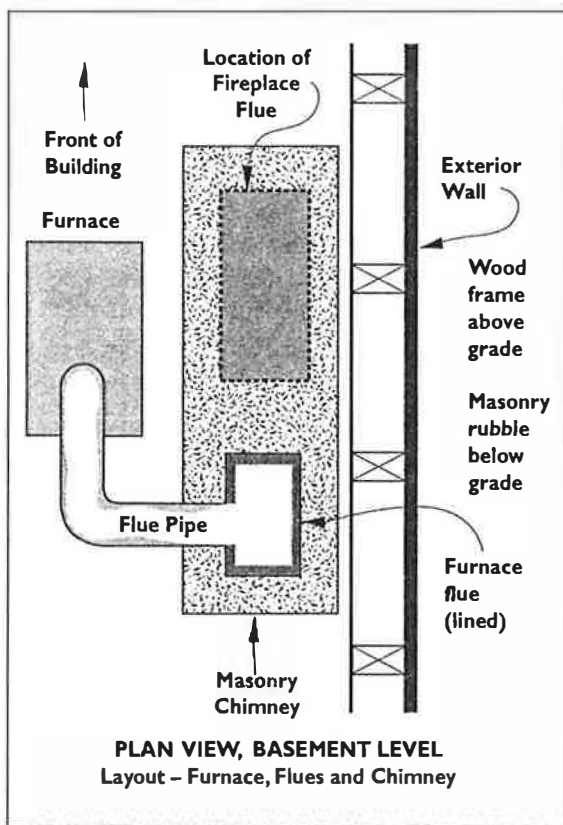
The chimney contains two exhaust flues, one serving the fireplace on the first floor and one serving the furnace and water heater in the basement.

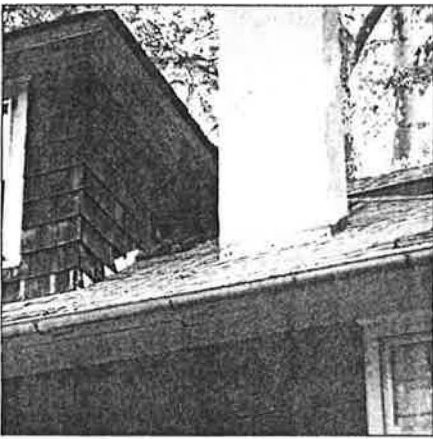
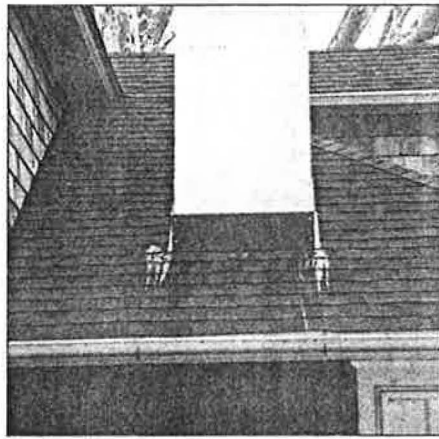
After the leaky roof (left) had been repaired (right), ice was visible emerging from beneath the flashing on the chimney exterior. This occurred even during a relatively dry period.

A few days after this precipitation, a cold front moved in, with nighttime temperatures in the teens and daytime temperatures in the low to mid-20s. Observing the chimney exterior at the roofline on the second morning of this cold spell, I noticed a couple of small streams of ice creeping out from beneath the flashing. This ice continued to form and enlarge throughout that day and into the next, while still there was no rain. The continuing accumulation of ice, in the absence of rain,

was pretty strong evidence that condensation, and not rainwater, was the source of the moisture.

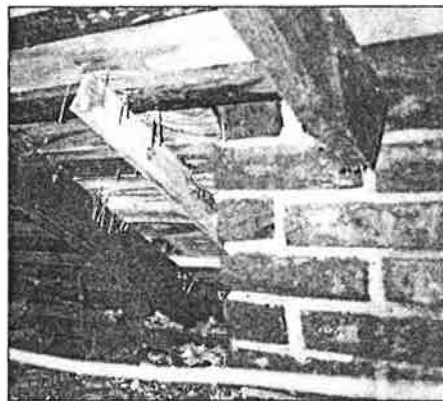
We returned to the attic—and then we saw it! A droplight had been placed on top of the insulation next to the chimney, the better to observe the chimney and sheathing. In this raking sidelight, shining at a right angle to our line of vision, we happened to notice a small but unmistakable jet of steam blowing out from a small void between the bricks! The vapor was formed as the moist combustion gas met the cold attic air. This was a pretty definite sign of an obstruction in the flue backing up combustion gas and increasing the pressure inside.

Deteriorated mortar can be seen in this inside view of the chimney at the attic level. The new sheathing and old framing are also visible. A small stream of steam, not visible in this photo, was emerging from the chimney.

It turned out that the chimney was absorbing all the condensate from the inside—that is, because of the blockage, the flue gas moisture was building up inside the brick furnace flue, which basically absorbed it like a sponge (the brick was porous, and the flue liner and mortar were both somewhat degraded). Thus it leaked out, through the bricks, into the walls.

At this point, the owner decided to have a metal liner installed in the furnace flue. During this work, an obstruction was found in the flue. The chimney workers described it as an assemblage of sticks and twigs, along with some leaves. In all likelihood, it was a squirrel's nest.
