Orchard Learning Resources Centre

The Orchard Learning Resources Centre at the University of Birmingham attempted to develop the genre for low energy, naturally ventilated academic buildings. Did the design and construction team succeed?

BY THE PROBE TEAM

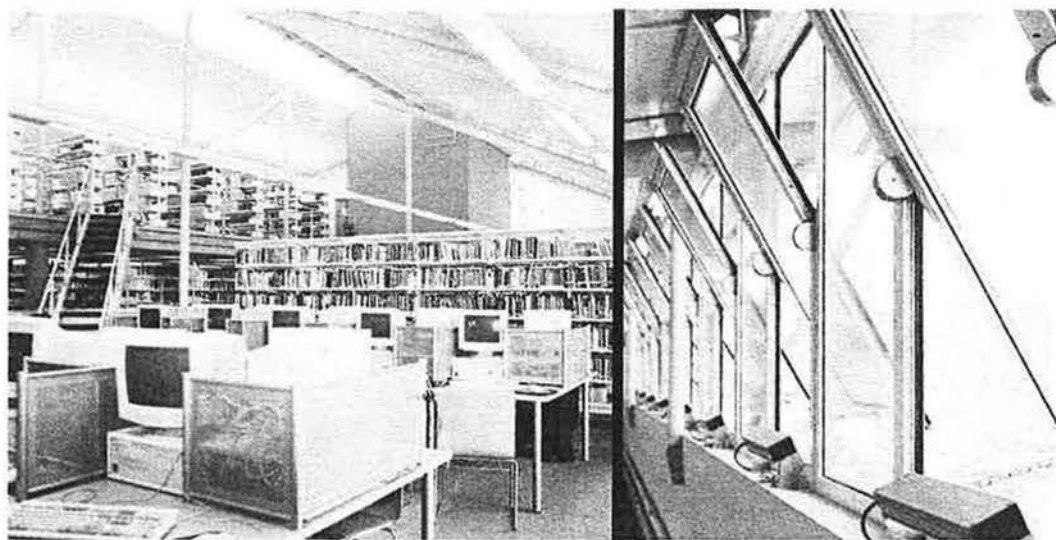
FAR LEFT: One of the computer study areas on the ground floor. These pcs tend to be left in standby-mode all night, which still adds to the building's energy consumption.

LEFT: While the window actuators have been generally trouble-free, the operating strategy for the motorised windows is not well understood by the staff. There are no instructions in the operating manuals and staff were unaware of the user guides issued at project completion.

The building has around 100 desktop pcs, 60 of these located in three clusters of 20 on the ground floor. A further 10 pcs are located in the IT training room. Most pcs do not have their power-save facilities enabled as this has caused confusion in the past as to whether the machines are on or off.

Apparently, many pcs are left running all night as the shut down procedure at the end of the day is regarded as taking too long for the few staff available. On top of that, the project manager for the establishment of the Centre advised that pcs should be left on overnight.

Despite early concerns, the window actuators have been generally trouble-free. A couple have been replaced and on the day of the PROBE visit a set of four toplights were stuck open. However, the operating strategy for the motorised windows did not appear to be well understood or even known by the staff. Some thought ventilation only occurred at night, others that some automatic temperature control applies at all times. The PROBE team could not find instructions in the operating manuals and staff were unaware of any user guides.

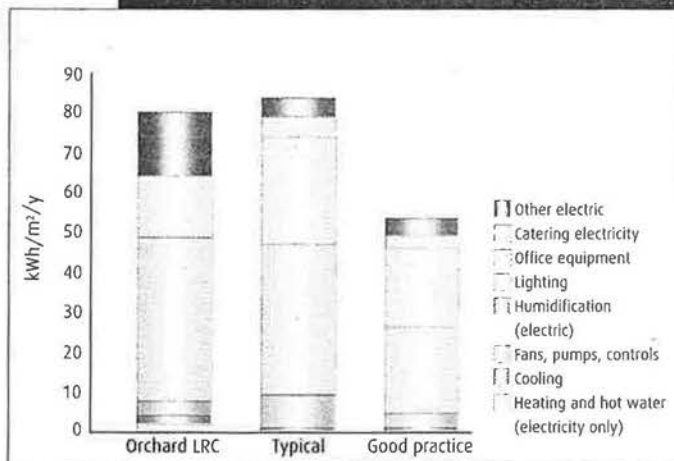
FIGURE 1: End-use electricity breakdown at the Orchard Learning Resources Centre.

An analysis of electricity bills shows that in the year from April 1999 to March 2000, actual total electricity consumption was 356 MWh or 80 kWh/m² (tfa). Total unadjusted electricity consumption is about 50% above the Type 2 good practice benchmark of 54 kWh/m² and 6% below the typical figure of 85 kWh/m², (figure 1).

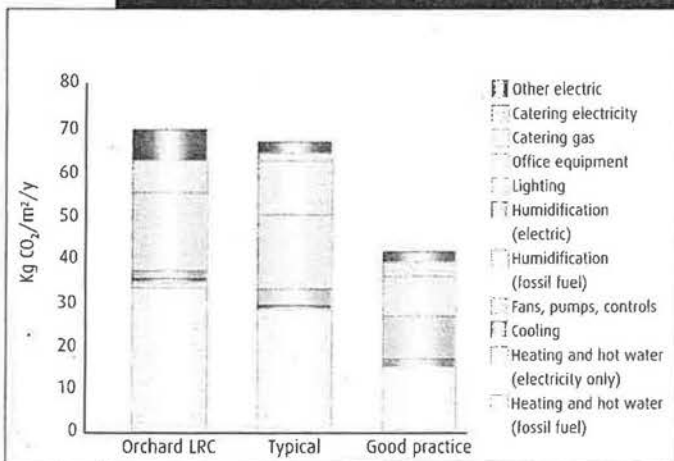
FIGURE 2: Carbon dioxide emissions at the Orchard Learning Resources Centre by end use. The conversion factors are 0.46 kg CO₂/kWh for electricity and 0.19 kg CO₂/kWh for natural gas (Econ 19, January 2000).

Total annual carbon emissions (before adjustments) are 71 kg CO₂/m²/y, 4% above the typical level (figure 2). In comparison with the Anglia Polytechnic University Learning Resources Centre, examined by the PROBE team in 1996⁴, the Orchard Learning Resources Centre uses twice the amount of gas, 50% more electricity and emits 82% more CO₂.

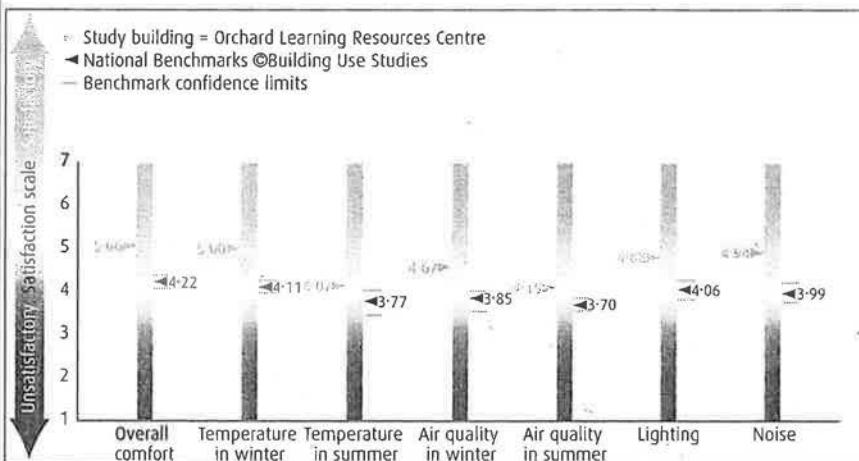
FIGURE 3: Overall satisfaction with comfort conditions at the Orchard Learning Resources Centre. A green arrow signifies a performance at or better than benchmark, a red arrow below benchmark. These scores are relative to a benchmark dataset of 50 buildings. Therefore they are not absolute.

On temperature and air quality, the building is perceived to be neither too hot nor too cold, although there were localised complaints. In winter it is considered stable, still, dry, fresh and odourless. Winter air quality is also perceived to be satisfactory. For summer, the building is comfortable overall, but too hot, stable, still, dry and stuffy. Air quality is satisfactory (figure 3).

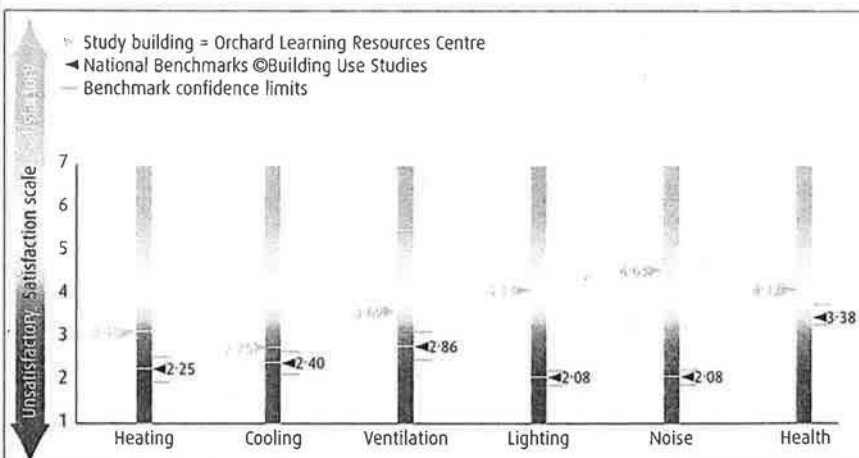
FIGURE 4: Occupants' perceived control over their environment, plus scores for their perception of the building as a healthy place to be.

Every one of the scores for perceived control and quickness of response is significantly better than the dataset benchmarks. The score for occupants' view of the building as a healthy environment are also high (figure 4).

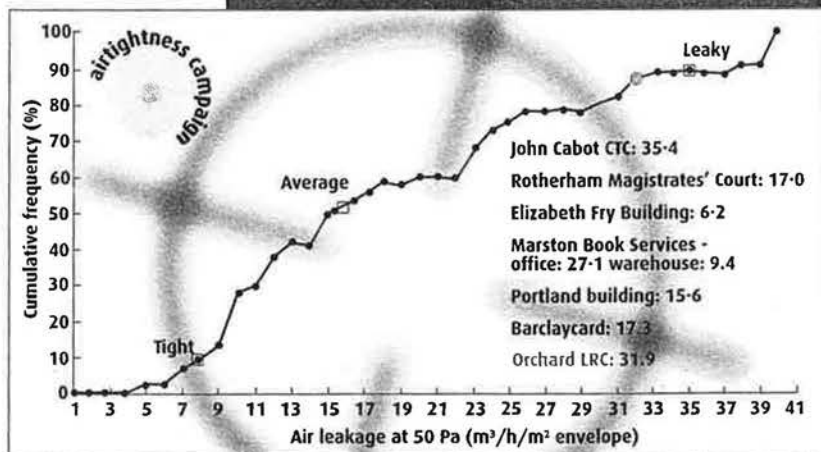
FIGURE 5: The air leakage data for the Orchard Learning Resources Centre, plotted on the BRE/BSRIA database. The cumulative distribution represents a sample of three building types: those designed to be airtight, buildings designed without airtightness as a design criteria, and some older buildings.

The resulting air leakage (at a reference pressure of 50 Pa) was calculated to be 31.9 m³/h per m² of envelope area. As a tight non-domestic building would have an air leakage index of less than 7.5 m³/h per m² of envelope area, and a leaky one 34 m³/h per m² of envelope area, then the Orchard Learning Resources Centre can be considered to be close to the leaky benchmark on the BRE/BSRIA database.

A brief air leakage audit using hand-held smoke tubes identified the leakage paths in the envelope. Significant air leakage occurred at the coffered ceiling/external wall junction. The top and bottom of the columns also leaked.

- 4. Air leakage** The poor results from the pressure test (of 31.9 m³/m²/h) demonstrates that merely registering concern with a contractor is not enough. The only surefire way to achieve an airtightness standard is to include in the main contract a requirement to demonstrate compliance by means of a pressure test. That said, the design team needs to provide air tight construction details for the contractor to follow, and effective site supervision will be necessary until the principles become second nature for builders.

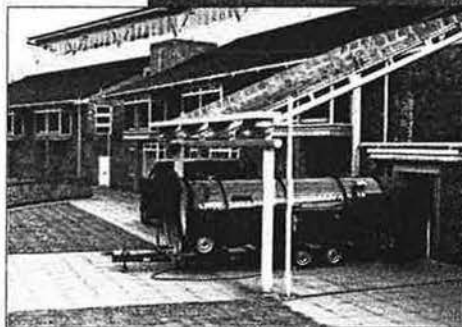
The BREFAN Large Fan Pressurisation System during the BRE pressure test at the Orchard Learning Resources Centre.

The BRE carried out a pressure test of the Orchard Learning Resources Centre using the Large Fan Pressurisation System, BREFAN.
