# Temperature and Moisture Performance of Wall Assemblies with Fiberglass and Cellulose Insulation

William B. Rose  
Member ASHRAE

David J. McCaa, Ph.D.

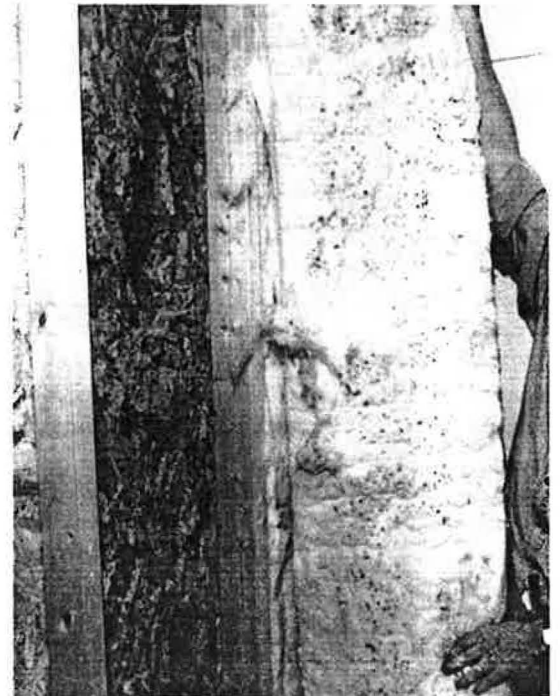
1. The three cavities with no vapor protection—3, 5, and 11—showed mold on the sheathing, uniformly distributed top to bottom and among the three sample cavities. The uniformity of the mold distribution is a strong indication of diffusion/capillary moisture transport and not air leakage in these cavities. Figure 10 shows the worst case of fiberglass without any vapor protection. Figure 11 shows the severe corrosion and mild mold growth in the cellulose-insulated cavity with no vapor protection.

*Figure 10 Surface of unfaced R-13 batt insulation showing evenly distributed fungal growth.*

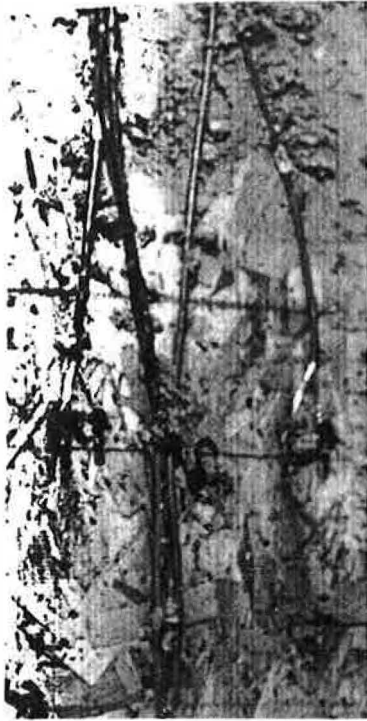
**Figure 11** Rust on metal fasteners in cellulose cavity without vapor diffusion protection.

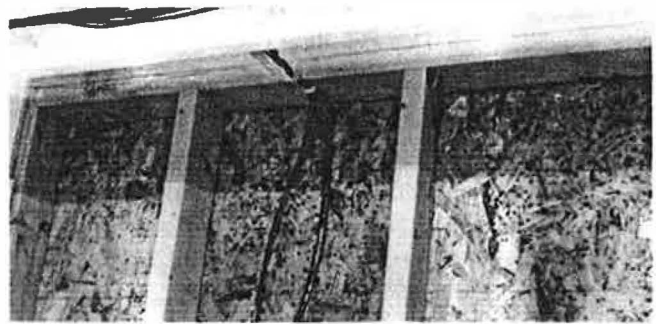
2. The four cavities with polyethylene showed no mold growth at all.
3. All of the fiberglass-insulated cavities with facings showed some mold growth at the tops of the cavities. The mold growth was consistently worse in the middle cavity where the cable penetration would allow moisture entry. However, the adjacent cavities also rather consistently showed some mold growth at the top of the inside of the sheathing. Figure 12 shows mold growth at the top of the cavity, associated with presumed cavity air leakage.

**Figure 12** Fungal growth at top of cavity with faced insulation.
