Carbon Monoxide Exposure from a Vehicle in a Garage

Thomas H. Greiner, Ph.D., P.E.
Member ASHRAE

Charles V. Schwab, Ph.D.

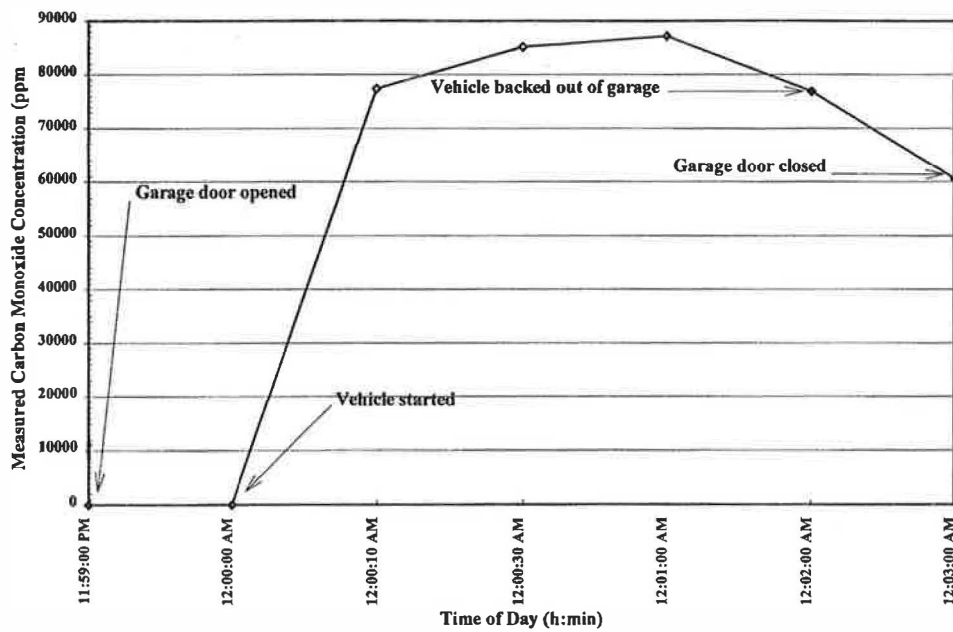
Figure 2 Measurement of CO concentrations in vehicle tailpipe.

Vehicles produce higher carbon monoxide concentrations on a cold start due to cold engine surface, a rich fuel/air mixture, and a cold catalytic converter (ASHRAE 1995). Figure 2 shows the CO tailpipe concentrations. The concentrations reached 87,200 ppm one minute after starting and dropped to 76,900 ppm after two minutes. The tail pipe concentration when the garage door closed was 60,000 ppm. After the vehicle was driven at 20 mph to 30 mph for 15 minutes, tailpipe CO concentrations decreased to 300 ppm.

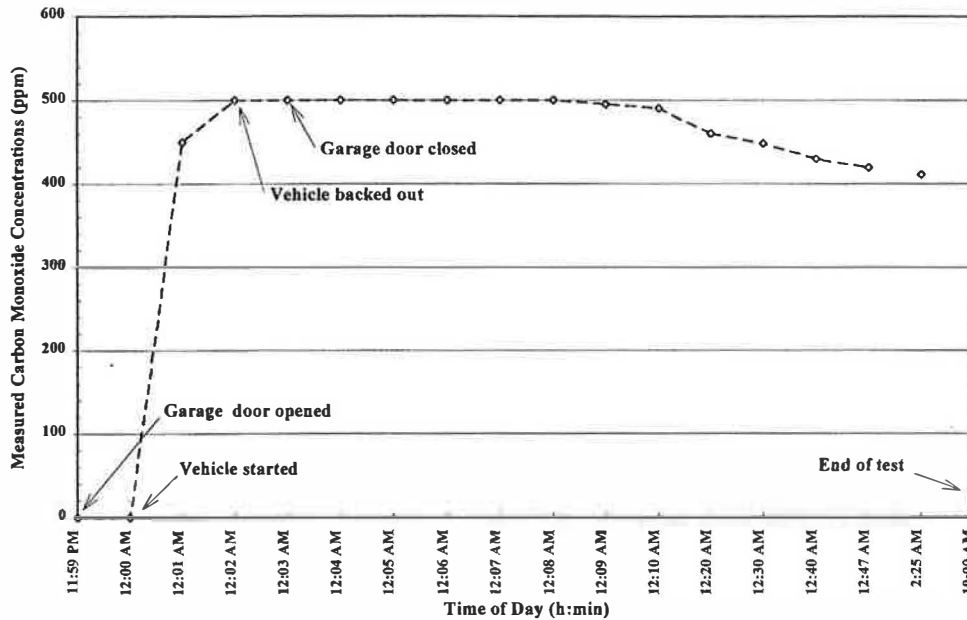
Figure 3 Measured CO concentrations in the garage.

Carbon monoxide concentrations increased rapidly in the garage, even though the overhead garage door was opened (Figure 3). The CO concentrations in the garage increased to 450 ppm after one minute of operation of a cold engine started in the garage. Another minute of operation raised the concentration to 500 ppm. The vehicle was removed from the garage after two minutes and the garage door shut. Carbon monoxide concentrations remained at 500 ppm for six minutes, then began falling to 420 ppm after 47 minutes. Concentrations in the garage remained elevated for several hours after the vehicle was removed from the garage, with 411 ppm after 2 hours, 25 minutes, and 30 ppm after 10 hours. Using a probe from outdoors, no carbon monoxide was detected around the overhead door cracks.

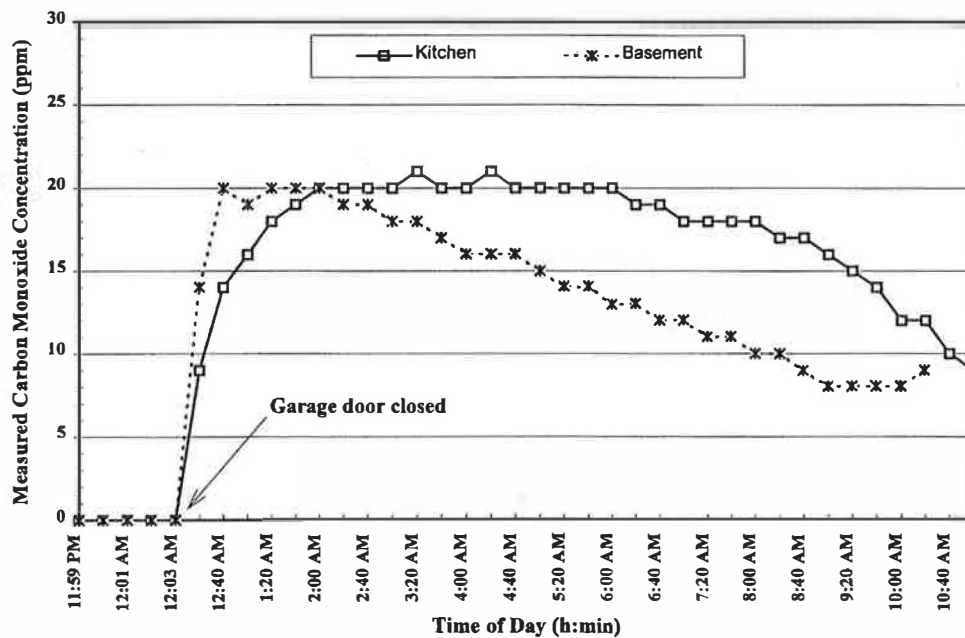
Figure 4 Measured CO concentrations in the kitchen and basement.

Carbon monoxide concentrations in the basement rose to a peak value of 20 ppm after 40 minutes. Figure 4 shows that

concentrations in the kitchen rose more slowly, reaching 14 ppm after 40 minutes. The peak CO concentration for the kitchen was 20 ppm after 117 minutes. Furnace and blower operated as controlled by a thermostat set at 70°F (21°C).

Two hours after first starting the car, concentrations in the kitchen and basement were equal. Concentrations then decreased more quickly in the basement room. At 11 a.m. (11 hours after the car was first started), several doors and windows in the garage and house were opened. Within ten minutes, CO concentrations decreased to an undetectable level.

To avoid future exposures from the garage, an exhaust fan in the garage was designed and installed. The system was sized to slowly remove low-level CO concentrations from the garage and to depressurize the garage relative to the house. Depressurization causes air to flow from the house to the garage, thus preventing garage contaminants from entering the house. An 8 in. (203 mm) diameter, centrifugal in-line duct fan rated at 492 cfm (232 L/s) at 0.125 in. wc (31.3 Pa) static pressure was used. A variable-speed fan controller was installed. Fan speed was increased until the pressure difference between

the garage and house was 16.0×10^{-3} in. wc (4.0 Pa) relative to the house. Flow through the fan was measured at 278 cfm (131 L/s). Operation of the fan effectively reverses flow direction from the garage to the house, as verified using theatrical smoke, pressure measurements, and a tracer gas test. Carbon monoxide, produced by briefly operating a lawn mower in the garage, was used as the tracer gas. Carbon monoxide concentrations in the garage increased to above 600 ppm. After two hours, no carbon monoxide was detected in the house. The garage was then thoroughly aired out by opening outside doors.
