Case Study—Ice Dam Remediation for Northeast Ski-Area Condominiums

Henri C. Fennell

ABSTRACT

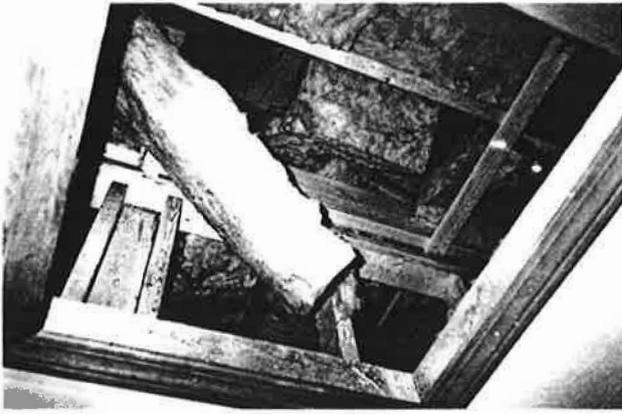
Existing attic insulation over closet dropped ceiling—no air barrier.

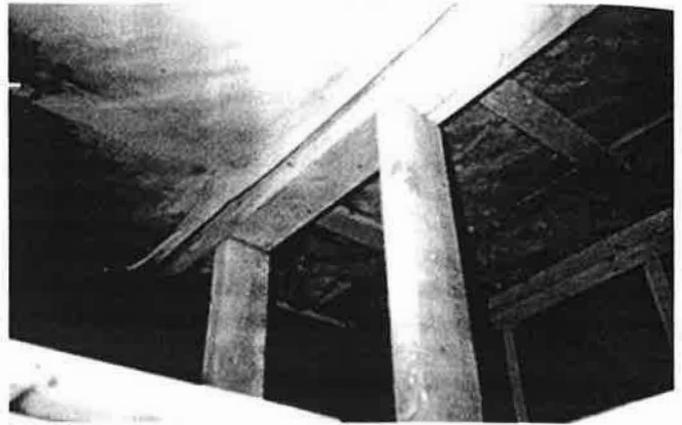
Attic insulation along I-beam on right over second floor hallway—incomplete air barrier.

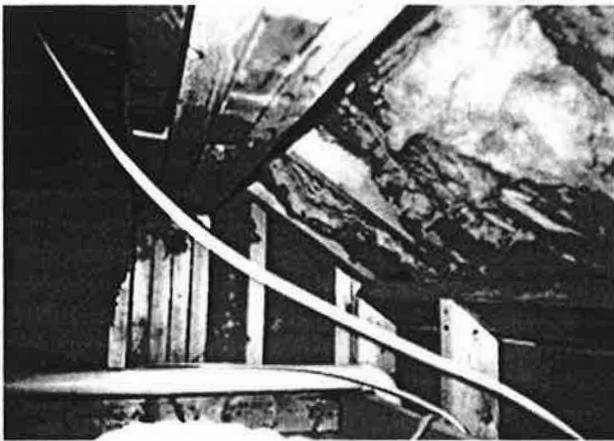
Attic insulation over bathroom—no air barrier in slopes or cap.

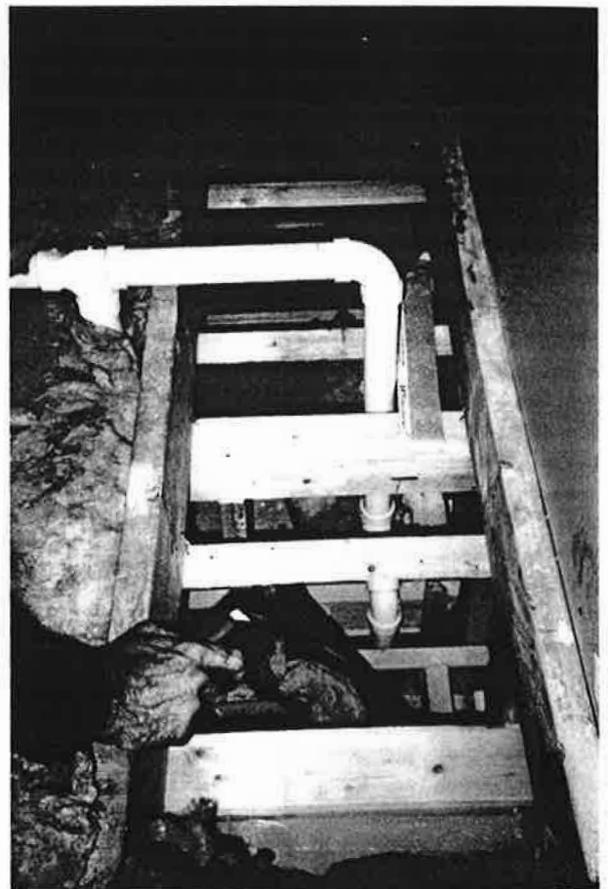
View down into dropped ceiling along party wall—no air barrier under batts or on party wall framing.

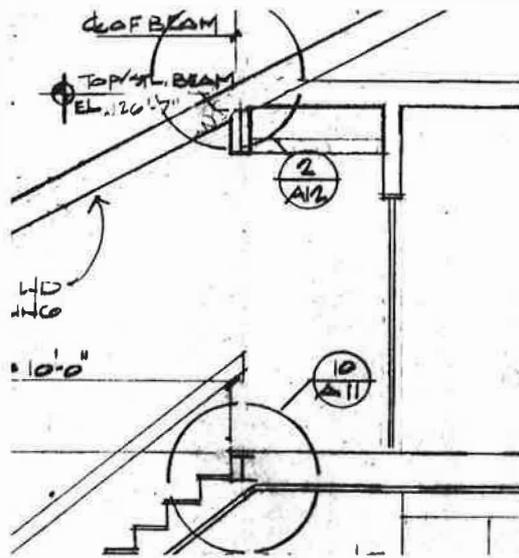
Section in middle unit at dropped ceiling over second floor hallway.

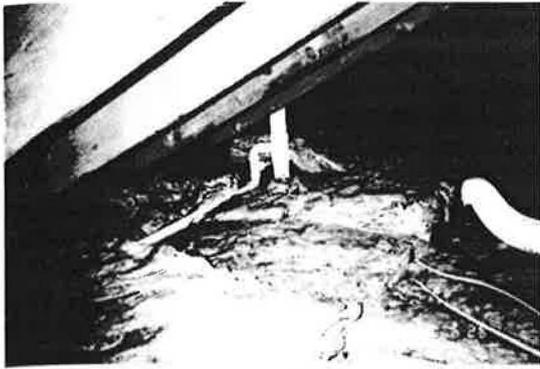
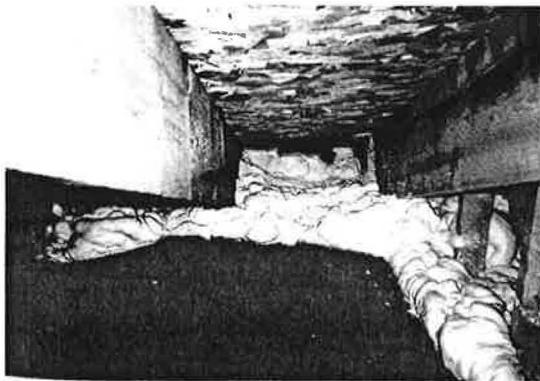
Attic batt insulation showing gaps and unsealed penetrations.

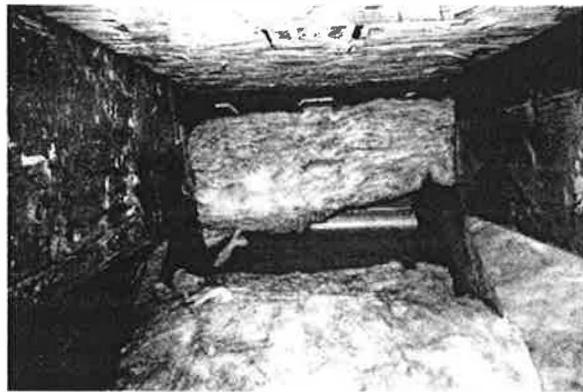
Example of the voids found in the attic insulation.

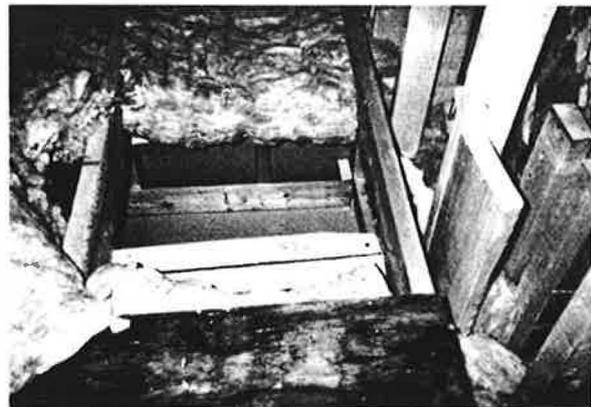
Unsealed spaces below attic batt insulation are open to partition and party wall stud bays.

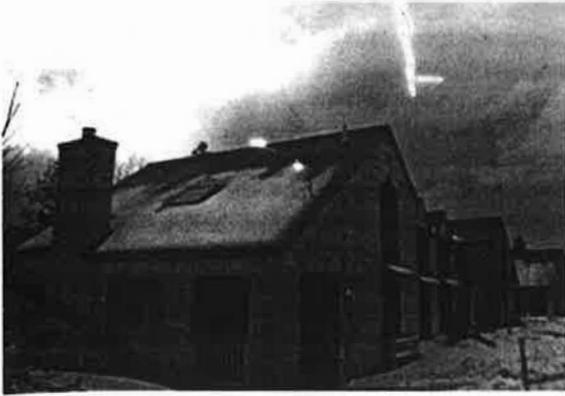
Snow melt pattern on end units showing melt on attic roofs above cathedral slopes—foreground and background units, same pattern.

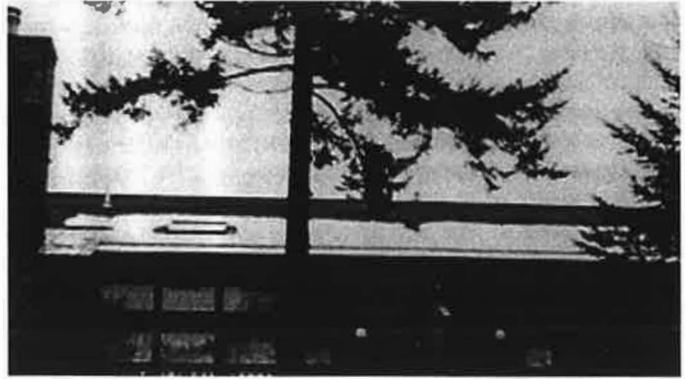
Snow melt pattern on middle units showing melt on attic roofs above cathedral slopes—melt spots at party wall, behind chimney, and at bath vent.

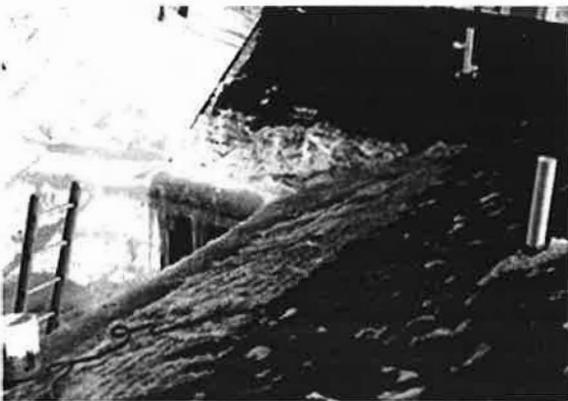
Most of the ice dams were located along the lower vented cathedral ceiling eaves and behind the zero-clearance fireplace boxes. Ice was concentrated at the valleys where the runoff from both roofs combines. In spite of the ice buildup and water infiltration, these lower roof areas were performing the best thermally. It was observed that the outside surfaces of the cathedral roof areas were generally cooler than the attic roofs above. This was indicated on the outside by snow and frost patterns. Typically, after light snowfalls (6 in. or less) or on frosty spring or fall mornings, the upper attic roofs were melted bare. Under the same conditions, the lower cathedral slopes were covered with snow or frost, showing only “spot” melt areas related to specific interior conditions. These patterns were constant from bottom to top on cathedral spans as long as 20 ft, stopping abruptly at a line where the vented attics began (see Figure 4).

Roof with snow removed showing ice on entire cathedral area and ice dams along eave edge.

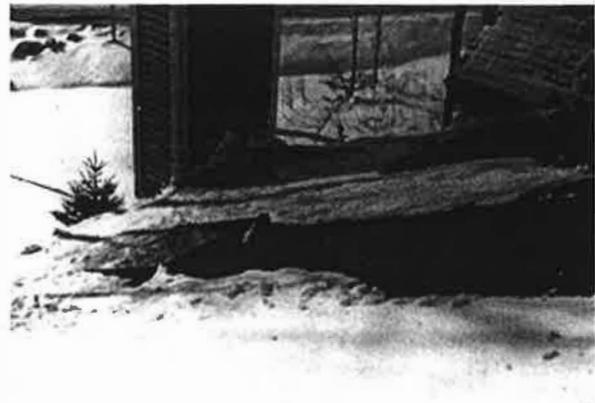
Cathedral roof area showing melt above skylight rough opening leakage and above fireplace vents.

3. The interior roof slope perimeter was sealed in the wood paneled units. The skylight casings were removed and the jambs sealed to the rough openings to prevent cold air infiltration at the bottom and warm air leakage into the roof above them. The beams at the top of the cathedral slopes were air sealed from below.

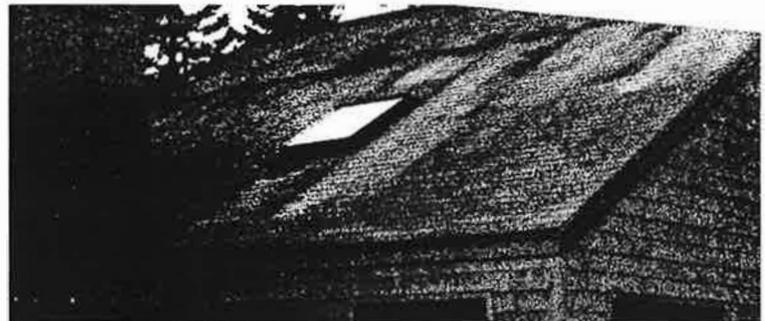
Frost melt pattern showing melt line along beam at top of cathedral slope.

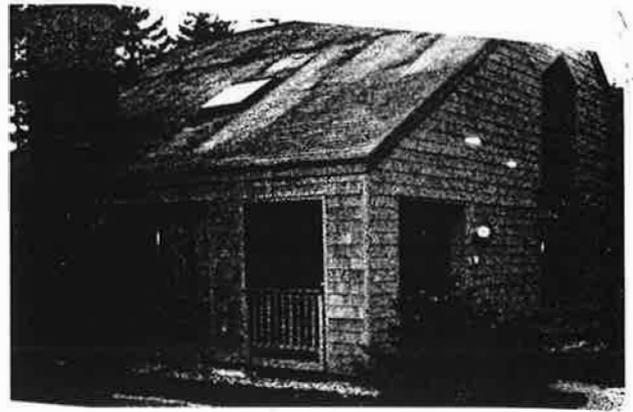
Frost pattern above entry at bathroom kneewall attic.

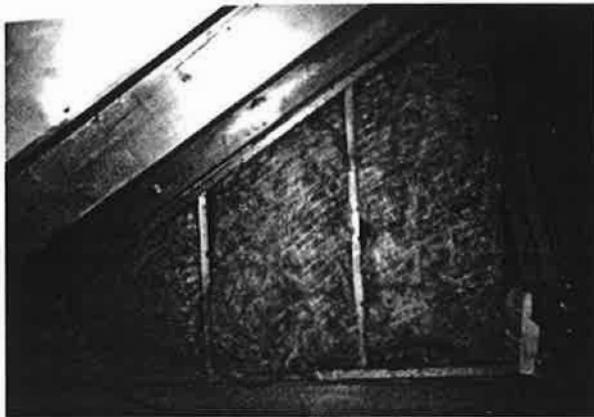
2. The attics behind the bathroom knee walls and the boxed down soffit walls (see Figures 5 and 6) were unsheathed on the attic (cold) side. These attic-type roofs melted sooner than the surrounding cathedral slopes. Some were uninsulated or the insulation had fallen out of the stud bays. There was no air barrier in the plane of the knee walls between the floor and ceiling below. There were uninsulated recessed fixtures in the floor of this attic. While none of these surfaces were in the roof slopes themselves, they were assumed to be the causes of the warmed roof surfaces in

Original kneewall insulation without sheathing—none in floor thickness.

4. Insulation defects in the knee wall and boxed chases were repaired. Sheathing was installed and sealed on the second side of each of these one-sided conditions, and unblocked floor-to-floor rim joist areas were sheathed to prevent heat loss in these lower attic spaces from flowing up into the roof vents above. It was recommended that the recessed light in the floor of this attic be changed to a fluorescent surface-mounted fixture.

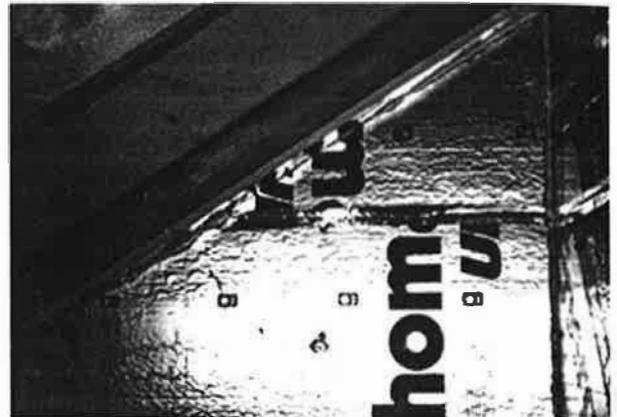
Kneewall insulation after air barrier sheathing retrofit.

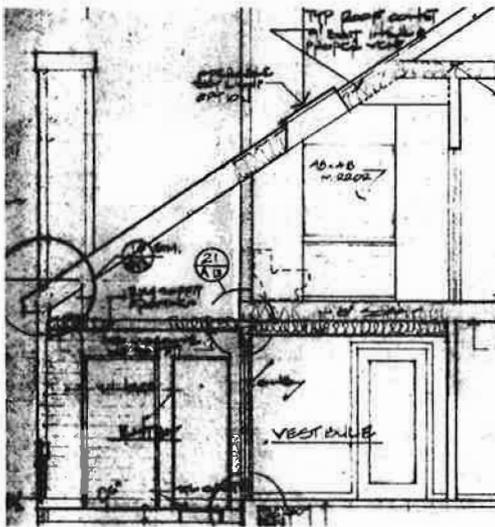
Section showing unsheathed kneewall attic cover entry—fan/light usually in skylight location.

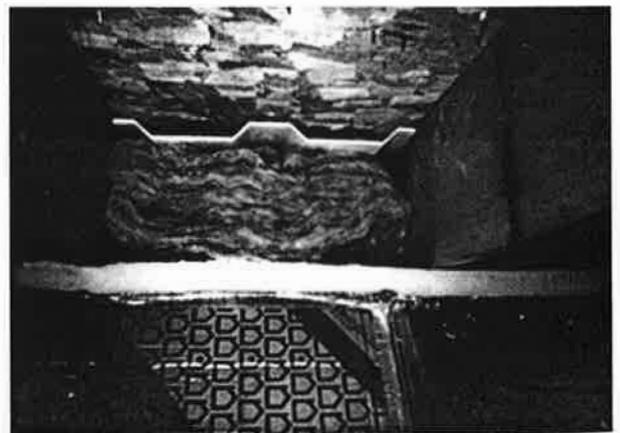
Insulation above knee wall open to wind washing through and under batts.

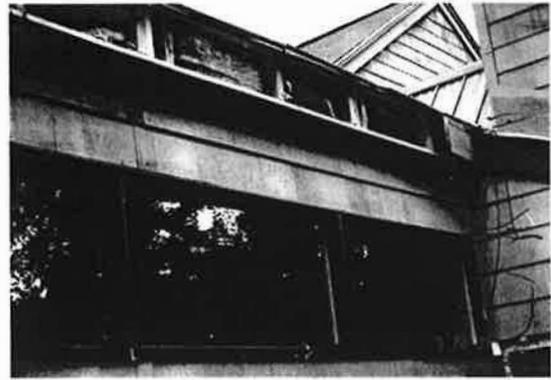
Typical existing soffit bays including uninsulated narrow skylight double rafter bays—note inaccessible bays at top of fireplace box.

1. The eave soffits on all units were opened, and blocking was installed between the rafters above the walls to eliminate wind washing. Unsheathed walls were covered with rigid foam and air sealed. Narrow empty roof bays at the gable ends, skylight double rafters, and party walls were insulated as far up as possible from the bottom access and sealed to reduce infiltration (see Figure 6).

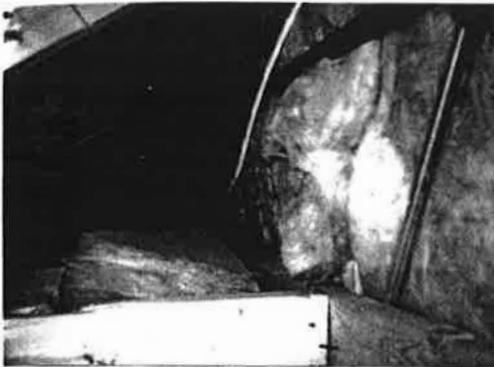
Unsheathed wall inside soffit.

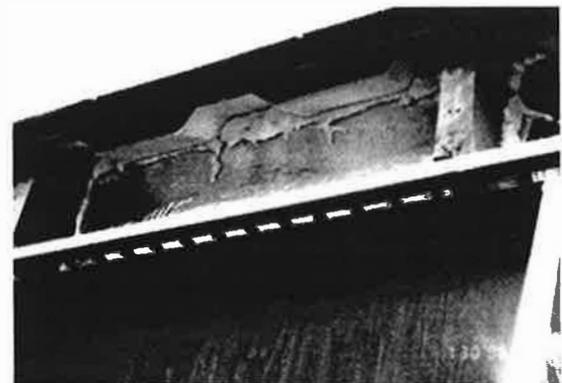
Typical soffit bay after blocking and sealant.

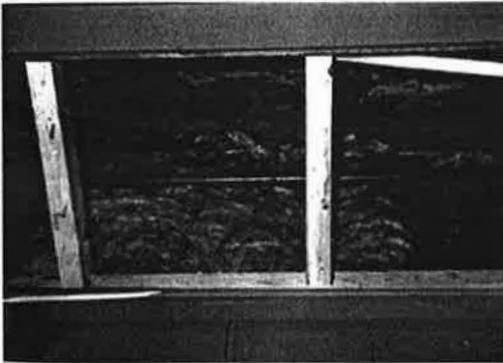
Open soffit and rafters—before.

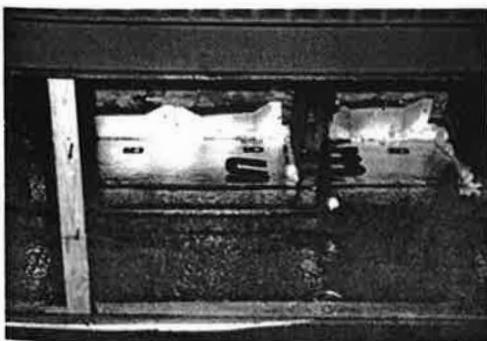
Soffit walls and blocked rafters—after.

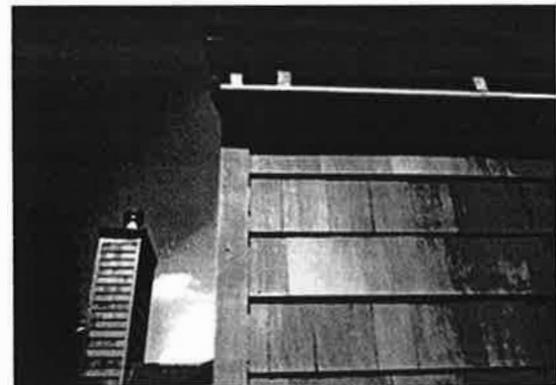
Uninsulated rake bay over gable end wall before retrofit of insulation and air sealing.

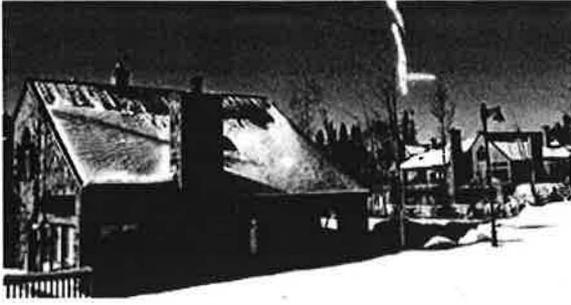
Multiple units with common pattern of melted attics above snow-covered cathedral slopes.

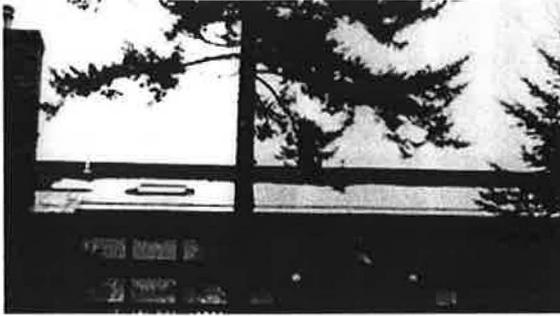
Original melt pattern showing attic melt above cathedral slopes.

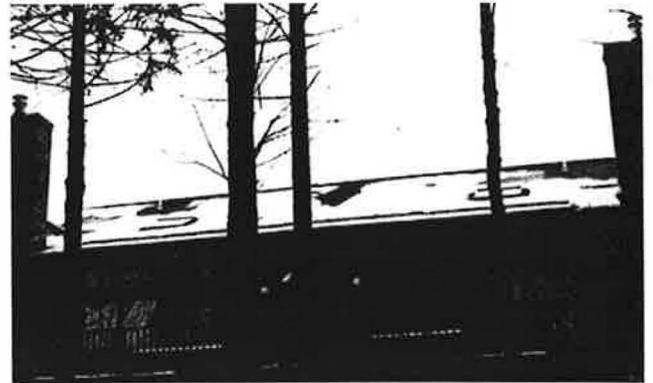
Attic melt pattern reduced to spots after the Phase I repairs.

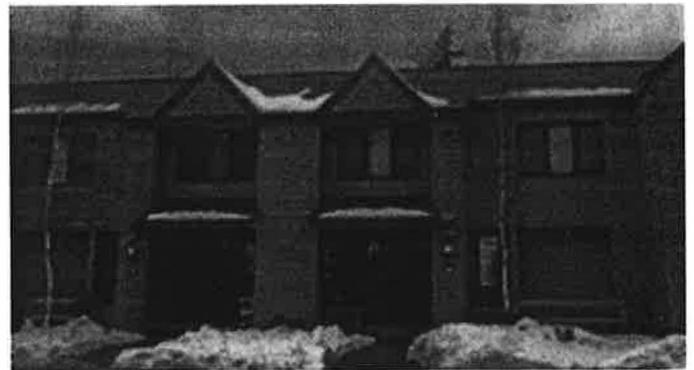
Attic melt pattern with snow remaining on short cathedral slopes.

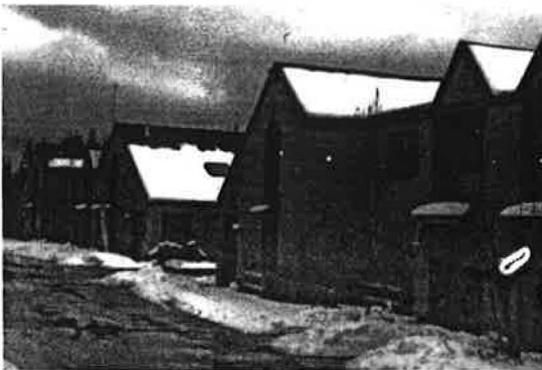
Background—unmodified units with attic melt. Foreground—modified with none.

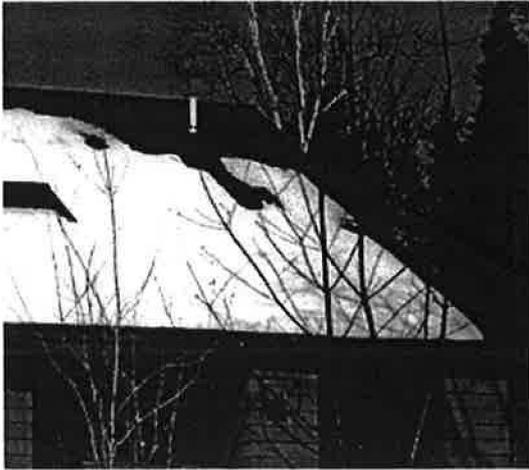
- d. The light fixture had a high-wattage incandescent bulb that created a hot spot where there was little or no roof insulation. The infrared tests clearly showed the infiltration of cold air into the fixture; the outside melt pattern showed the fixture location and the warm air travel path in the roof's vent space above the fan.

Melt pattern showing location of bathroom fan/light and heat flow in vent space above.

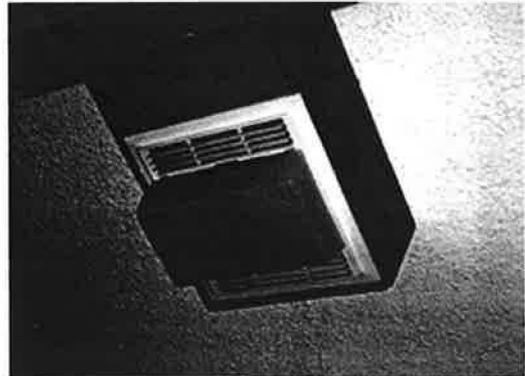
4. The fan/light in the guest bathroom showed no infiltration on the infrared scan, and the melt area in the roof had been significantly reduced considering that the duct was still routed through the roof bay. While totally relocating this fan would have been the optimal solution, the degree of improvement achieved without major renovations was acceptable.

Recessed fan/light after being relocated to a surface-mount position.

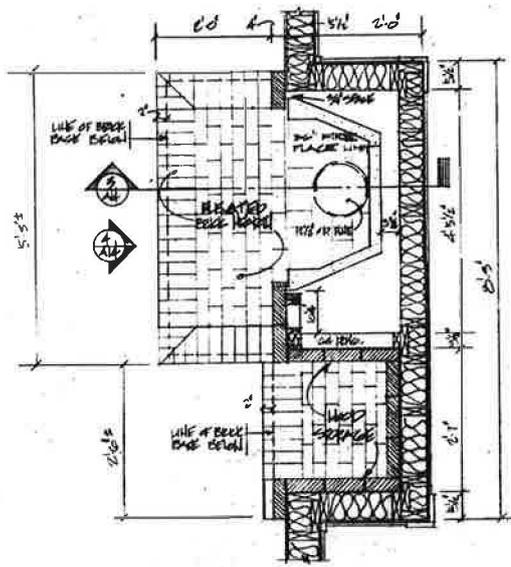
Plan of end-unit fireplace showing unsheathed and unsealed wall insulation.

2. The large zero clearance chimney boxes were opened, and the inside of the exterior walls were sheathed and sealed with rigid foam; the roof slopes were insulated and sheathed along the plane of the slope to continue the insulation over the box to the outside wall. These procedures prevented the infiltration of cold air into the box and the flow of warm air up into the roof slope vent chutes.

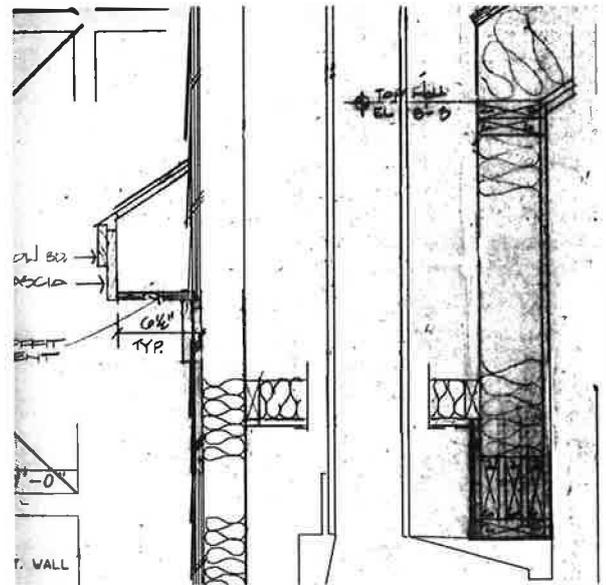
Section at fireplace box showing warm air paths to roof vent space.

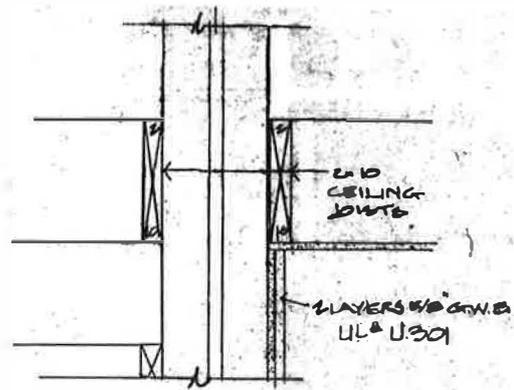
6. The flat cap (attic) areas showed conductive and warm air leakage losses at the butt joints in the batts and around the framing members at the flat to slope transitions. Light fixtures, bathroom fans, and duct runs also created gaps in the insulation. This was true in both single-layer and crossed double-layer configurations. The insulation did not extend into the party walls (approximately 10 in. wide) or out to meet the top of the roof slope insulation. At the intersection of adjoining middle and end units where the roofs overlapped (termed the "cricket" area), the vents of the end unit slopes originated at the unsealed tops of these party walls (see Figure 8).

Party wall detail as built at attic level showing open center.

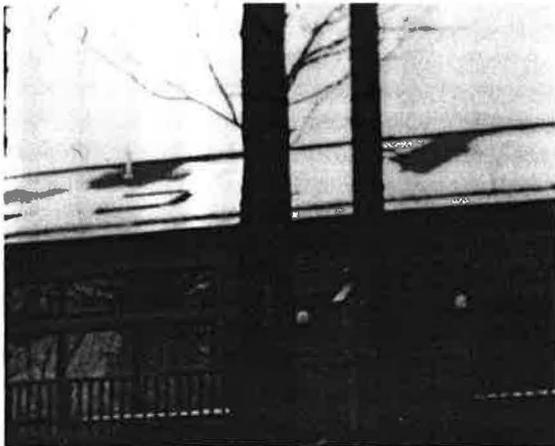
Melt pattern—left side over bathroom vent, right side over center party wall.

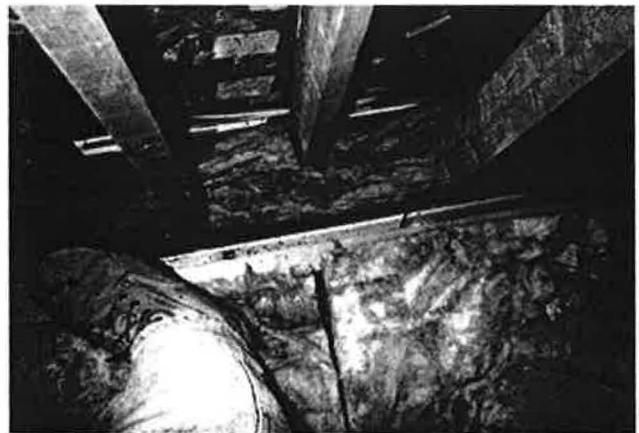
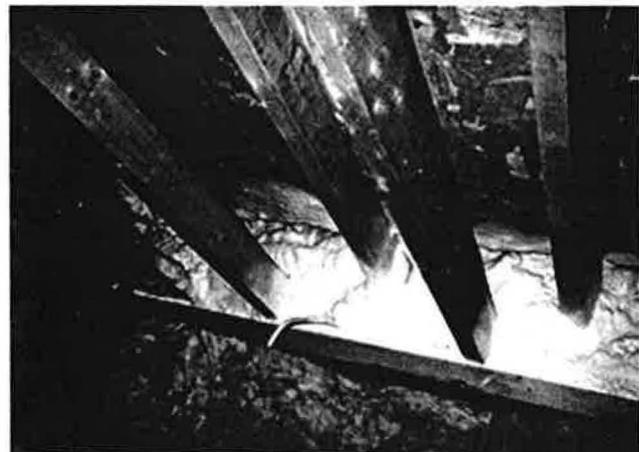
Before (top) and after (bottom) shots of open and sealed party wall tops in attic.

3. In the flat ceilings of the attic, air sealing was done at all accessible penetrations under the batt insulation. The air barrier and insulation were extended into the party walls. Gaps in the batt insulation were to be filled with loose-fill insulation. An additional layer of loose-fill insulation or a continuous vapor-permeable air barrier film was to be installed on top of the batts to reduce convection in the batts.
4. The top of the insulated metal furnace flue was sealed to prevent the heat from flowing into the roof slope vent spaces.
