ASSESSMENT AND CONTROL OF INDOOR AIR QUALITY
IN A SUPER-INSULATED, RETROFIT HOUSE

J.E. Woods, B.C. Krafthefer, L.W. Nelson
Honeywell Inc., Minneapolis MN, USA

C.A. Lane
Minnesota Dept. of Energy and Economic Development, St. Paul Mn, USA

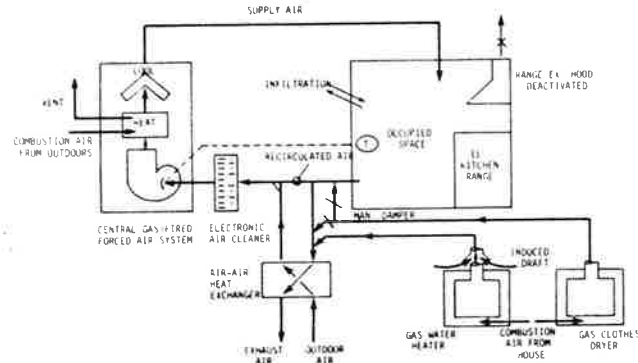
insulated and the vapor barrier was installed. The vents from the gas-fired water heater and clothes dryer were connected to the air-to-air heat exchanger, as shown, including a diversion damper that allowed the vent from the clothes dryer to be directly coupled to the system return air. The capacity of the furnace had been reduced by deactivating one burner, but the supply air flow rate was maintained.

Fig. 1. Schematic of existing (before IAQ modifications)

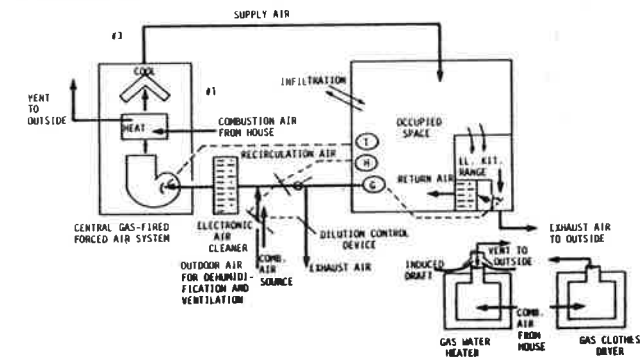
Fig. 2. Schematic of system after IAQ modifications.

Based on results of the air quality assessment, and computer simulations of the system performance, modifications, shown schematically in Fig. 2, were made: 1) replacement of the air-air heat exchanger with a dilution control package that provides adiabatic mixing of outdoor air and return air for thermal and air quality control; 2) redistribution of supply air to the downstairs bedrooms and den; 3) installation of return air grille and ductwork in the child's upstairs bedroom; 4) replacement of kitchen range and deactivated exhaust hood with a unit containing gaseous feedback control for exhaust or recirculation through an electronic air cleaner; 5) relocation of the outdoor air intake to the opposite side of the house from the exhaust grilles to minimize self-contamination of the ventilation air; and 6) revision of control strategies to improve dehumidification in winter by dilution and in summer by refrigeration.

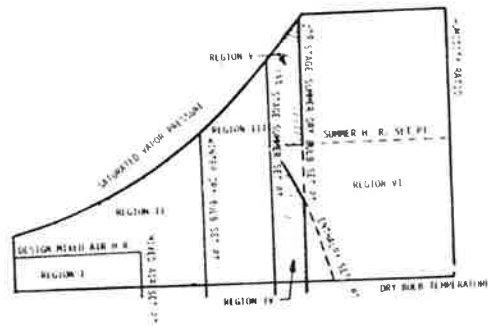
Fig. 3. Psychrometric regions for energy efficient IAQ control strategies.

To provide improved air quality with little or no impact to the annual energy consumption, the control system has been modified to function in six psychrometric regions, as shown in Fig. 3.

Region I: cold-dry outdoor conditions. When the thermostat calls for heating, the furnace is energized; the electronic air cleaner is energized with the supply fan. If the room humidity is below set point, the outdoor damper in the dilution control package remains in the minimally open position for combustion air, the exhaust damper closes and the return damper opens to recirculate the air. If the room humidity is above set point, the outdoor and exhaust air dampers open and the return air damper closes to maintain a mixed air temperature at 12.8°C and humidity ratio of $0.0036 \text{ kg}_w/\text{kg}_a$, or less (i.e. mixed air relative humidity not more than 40% at winter design conditions). If the room humidity is above set point and the thermostat has the furnace de-energized, the supply fan is energized by the humidistat; if recirculation is not sufficient to lower the humidity below the set point in 15 minutes, the dampers modulate to provide mixed air at 12.8°C at $\text{RH} \leq 40\%$.

Region II: cool-humid outdoor conditions. Thermostatic control is the same as for Region I. If the humidity ratio of the outdoor air exceeds $0.0036 \text{ kg}_w/\text{kg}_a$, the minimum amount of dehumidification available through this strategy is limited by the humidity ratio and temperature of the outdoor air. For example, 45% outdoor air (e.g., 125 l/s) is required to maintain a mixed air temperature of 12.8°C if the return and outdoor air temperatures are 21.8 and 1.7°C , respectively. If the outdoor air is saturated with water vapor, the minimum dehumidification available is 0.37 kg/hr ; for colder outdoor temperatures, the difference in humidity ratios increases thus increasing the dehumidification capability although the percentage of outdoor air decreases; for warmer outdoor temperatures, the percentage of outdoor air increases thus increasing the dehumidification rate assuming the outdoor air humidity ratio remains constant. When the humidity ratio of the outdoor exceeds that corresponding to the set point of the humidistat, dehumidification cannot be achieved by dilution.

Region III: isothermal conditions. When the outdoor temperature is above the winter and below the summer set points of the thermostat, the furnace and the refrigeration system are de-energized. However, if set point of the humidistat is set above the humidity of the outdoor air, removal and dilution control with outdoor air is provided.

Region IV: warm-dry outdoor conditions. When the room air temperature exceeds the first-stage summer set point, the humidity is below the set point of the humidistat, and the enthalpy of the outdoor air is below the loci of set points of the economizer control, sensible cooling is provided by dilution control with outdoor air supplied at low fan speed.

Region V: warm-humid outdoor conditions. When the room air temperature exceeds the first-stage summer set point and the humidity is above the set point of the humidistat, the dampers in the dilution package are de-energized (i.e., minimum outdoor air provided), the refrigeration system is energized, and air is supplied at low fan speed to decrease the sensible heat ratio for improved dehumidification and energy efficiency.

Region VI: hot outdoor conditions. When the room air temperature exceeds the second-stage summer set point, the dampers remain de-energized and air is supplied at high fan speed to increase the sensible heat ratio required for sensible and latent cooling at summer design conditions.
