Jack D. Verschoor<sup>1</sup> and John O. Collins<sup>2</sup>

## Demonstration of Air Leakage Reduction Program in Navy Family Housing

**REFERENCE:** Verschoor, J. D. and Collins, J. O., "Demonstration of Air Leakage Reduction Program in Navy Family Housing," *Measured Air Leakage of Buildings, ASTM STP 904*, H. R. Trechsel and P. L. Lagus, Eds., American Society for Testing and Materials, Philadelphia, 1986, pp. 294-303.

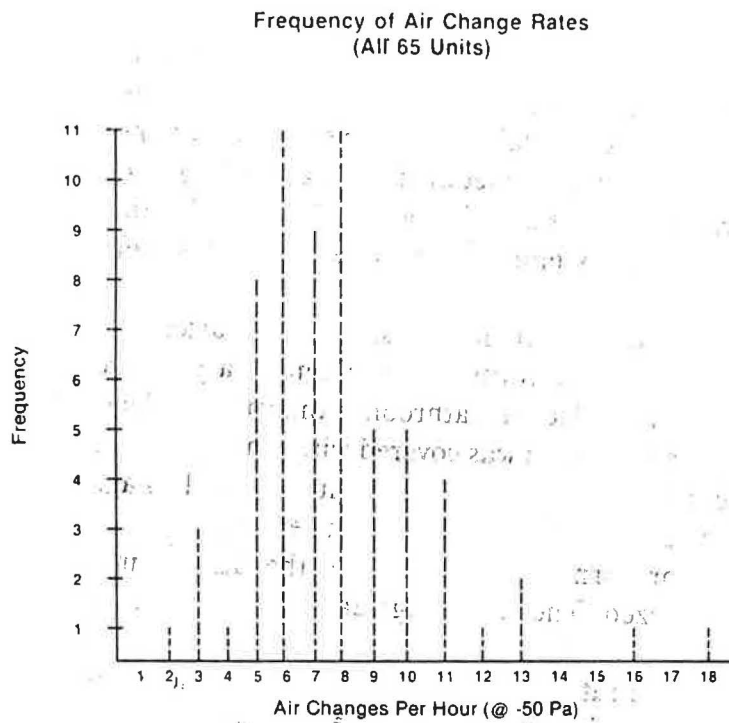
FIG. 3—Air change rate of all 65 units tested.

The average "before" air leakage rates for the 65 units in the demonstration was 7.5 ACH. Figure 3 shows a histogram of the "before" test results.

Average	
All 65 units	7.5 ACH
34 retrofitted units:	
"Before"	9.2 ACH
"After"	7.1 ACH
Frequency analysis of "before" data	
10 units	<5.0 ACH
32 units	5.0 to 7.9 ACH
18 units	8.0 to 11.9 ACH
5 units	>12.0 ACH

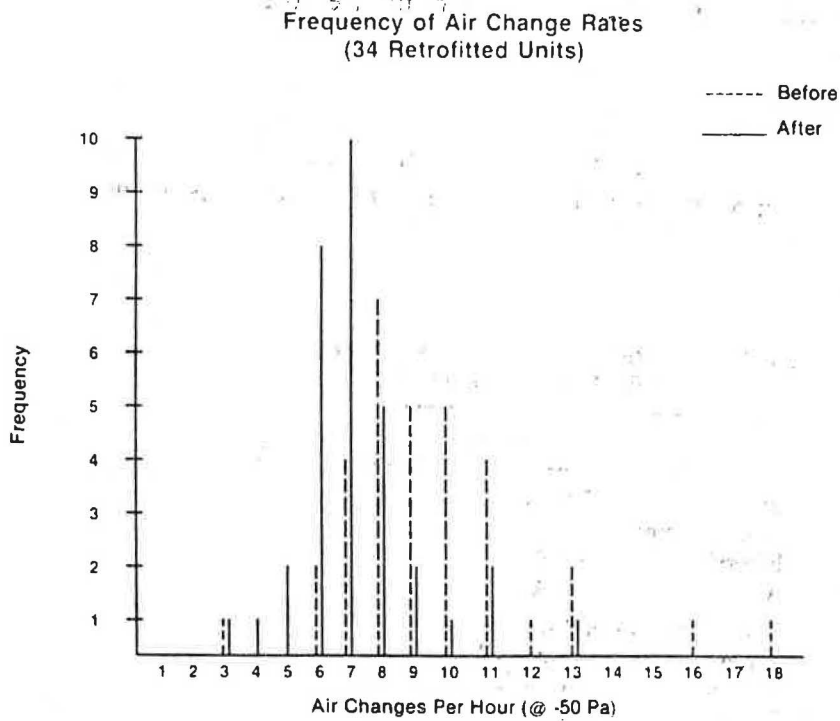
FIG. 4—Air change rate for 34 retrofitted units.

For the 34 units with both "before" and "after" air leakage data, the "after" average was 7.1 ACH compared with 9.2 ACH "before." This represents an average reduction of 23% for those units retrofitted. Figure 4 shows a histogram of the retrofitted units.

A demonstration of the air leakage reduction program was conducted at the GLNTC. The average "before" leakage rate for 65 units tested was 7.5 ACH at  $-50$  Pa. For the 34 units retrofitted, the average leakage rate was reduced from 9.2 to 7.1 ACH. This is an improvement of 23%.

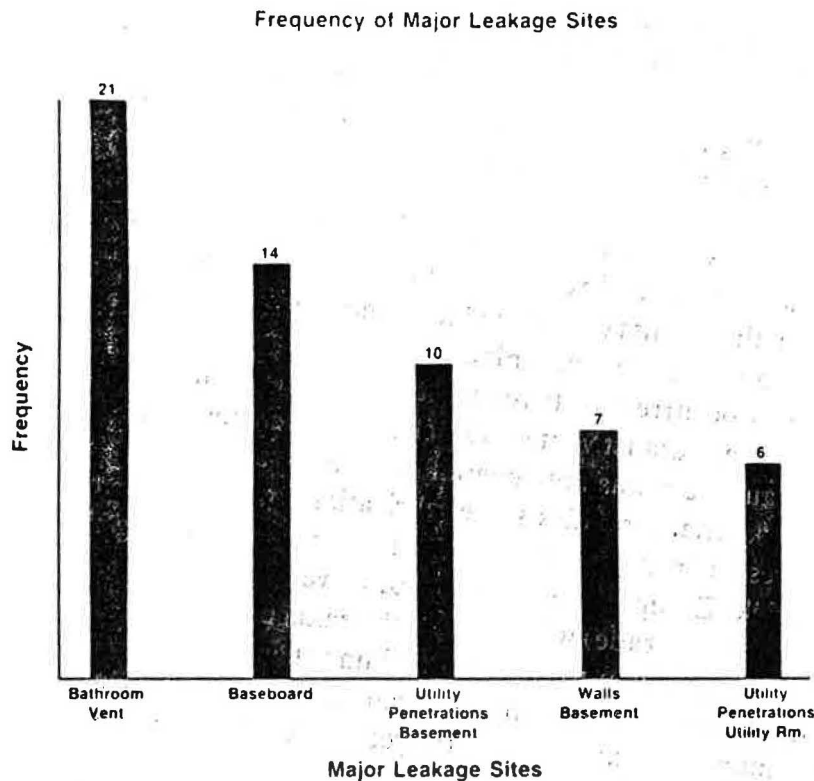
FIG. 5—Major air leakage sites.

The most frequently occurring air leakage sites found are noted in Fig. 5.

Several air leakage sites occurred with regularity. Frequently the back-draft damper in the bathroom exhaust vent was stuck in the open position. By contrast, the kitchen exhaust vent was not generally a problem area. Perhaps the grease present in the kitchen provides some lubrication for the damper, whereas the moisture present in the bathroom causes corrosion resulting in the damper tending to stick. Except for units with a brick veneer exterior, the lower level baseboards (slab-on-grade) were commonly leakage areas. Sliding patio doors were a frequent problem for units containing them.

Frequent air leakage sites noted were bathroom vents, baseboards, utility penetrations in the basements and utility rooms, and basement walls.
