RESIDENTIAL COMBUSTION VENTING FAILURE

FINAL TECHNICAL REPORT

COUNTRY-WIDE SURVEY RESULTS

January, 1987

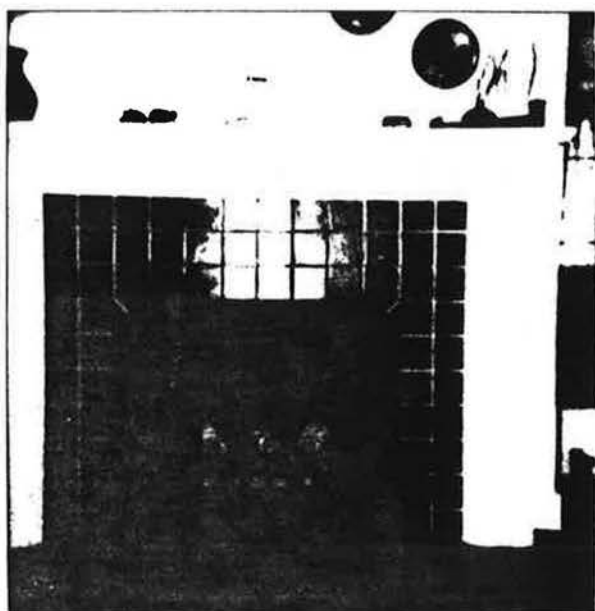
HOUSE NO. 1

Number of spillage events: 2

Duration of spillage: 44 seconds

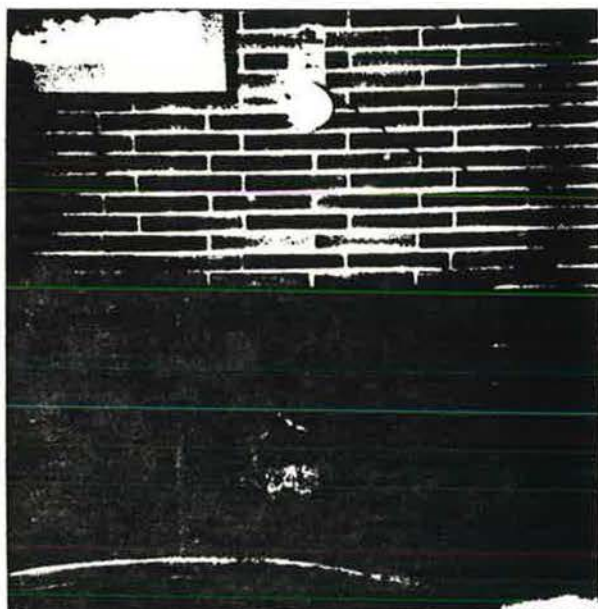
HOUSE NO. 3

Number of spillage events: 6

Duration of spillage: 42 seconds

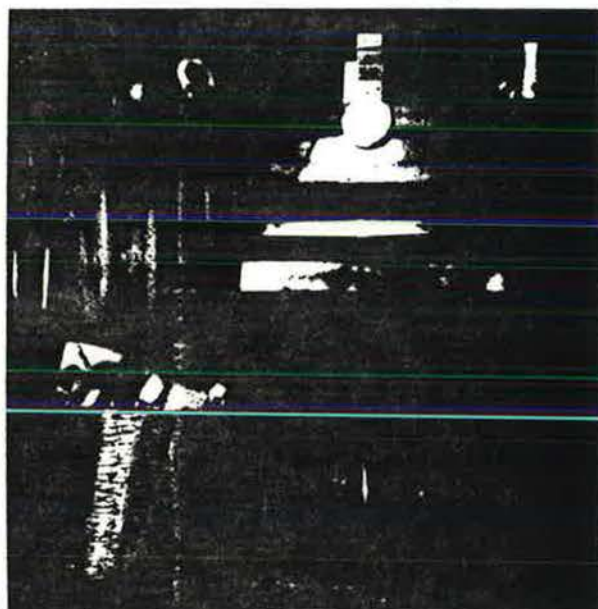
HOUSE NO. 4

Except for a slight clicking noise when counting, the detectors appeared to work well. (In House No. 4, the occupant reported that on one occasion he could hear the clicking from the mechanical counters, and out of curiosity, he opened the door separating the living room from the hallway to improve draft and the counter stopped.) Information on each detector installed can be found in Appendix D, including photographic illustrations of each fireplace, and dimensions of the firebox and chimney. No correlation exists between the fireplace design and the number of spillage events.

Duration of spillage: 841 seconds

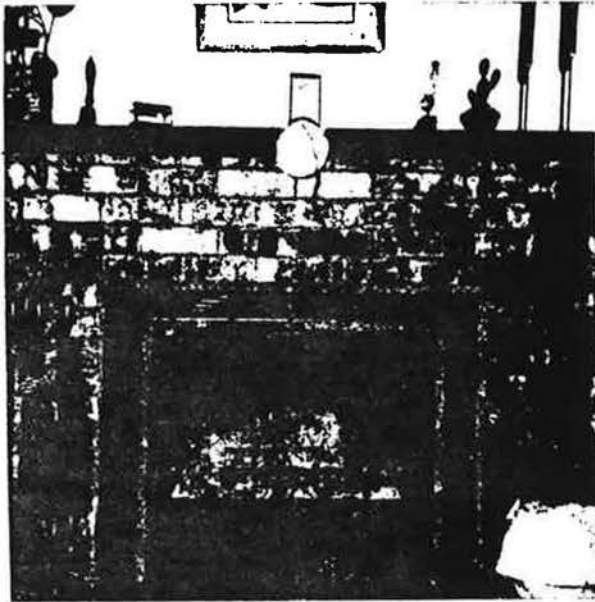
HOUSE NO. 5

The results of the fireplace survey are presented in Table 6. On average, householders burned wood on 6.6 occasions over the monitoring period. The low number of fires in the survey houses is a result of installing the detectors late in the season. Spillage events recorded by the CO and smoke detectors ranged from 2 to 17 events, or from 0.2 to 4.3 events per fire. Spillage was most significant in House No. 4 and House No. 5.
