RESIDENTIAL COMBUSTION VENTING FAILURE

PROJECT 5:

REMEDIAL MEASURES FOR WOOD-BURNING FIREPLACES:

AIRTIGHT DOORS WITH DIRECT AIR SUPPLY

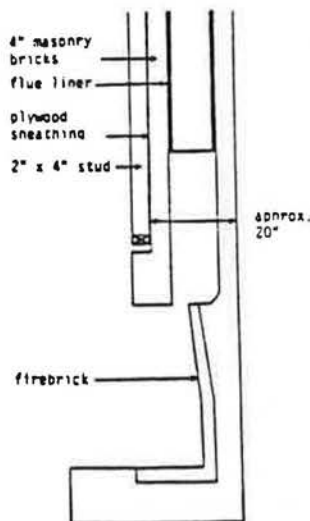
- (1) Plywood sheathing which forms part of the outside wall, is in direct contact with the chimney's masonry blocks. Building code requires a minimum of 1/2" clearance.
- (2) The thickness of masonry in the smoke chamber (the portion above the throat up to the beginning of the tile liner) is only 4". The building code requires 7-1/2" of solid masonry.

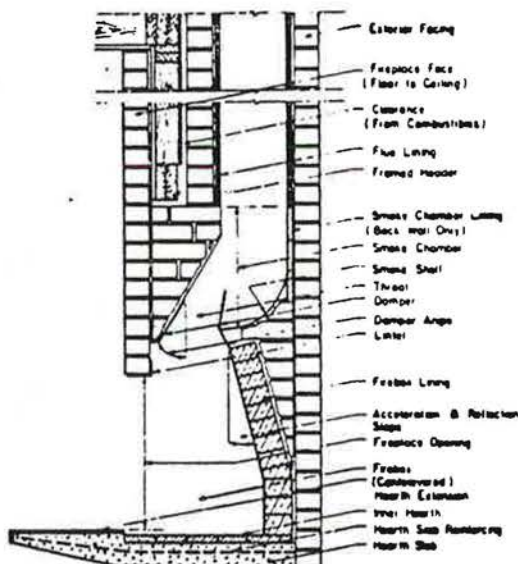
Photo 1 This incident took place in Richmond on December 7, 1983. The fireplace insert had been installed approximately 4 years ago. The unit was purchased second hand and therefore no installation instructions were available to the present owner. The unit was listed by ULI (American) and required 33 inches clearance between the top of the insert and any combustibles - visible or concealed. This clearance apparently was not met. In addition, the unit was modified by the addition of a baffle plate which according to the owner brought the heat forward. The unit did not use a flue connector but the ULI standard did not require one anyway. The Underwriters' Laboratories of Canada standard for fireplace inserts presently requires a flue connector to direct flue gases into the chimney.

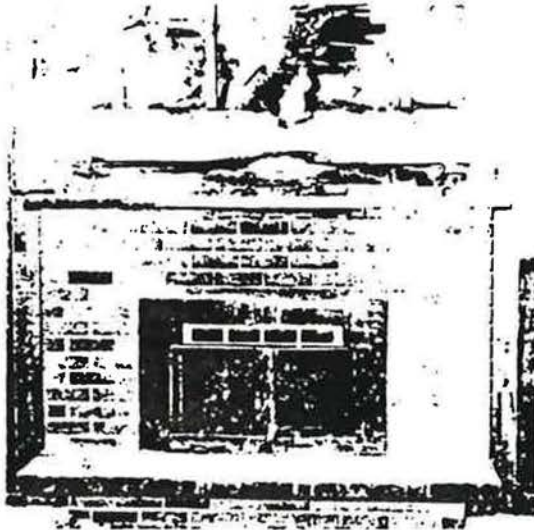
← Photo 2 This case occurred in Prince George on December 18, 1983. A heat exchanger unit with glass doors (manufacturer calls it a converter furnace) was installed a year ago into a masonry fireplace that was built 15 years ago. The unit was listed by Warnock Hersey Professional Services Ltd. Clearance between the sheathing and the chimney appeared to be almost nil and insulation between the sheathing and panelling might have compounded the problem by restricting the dissipation of heat.

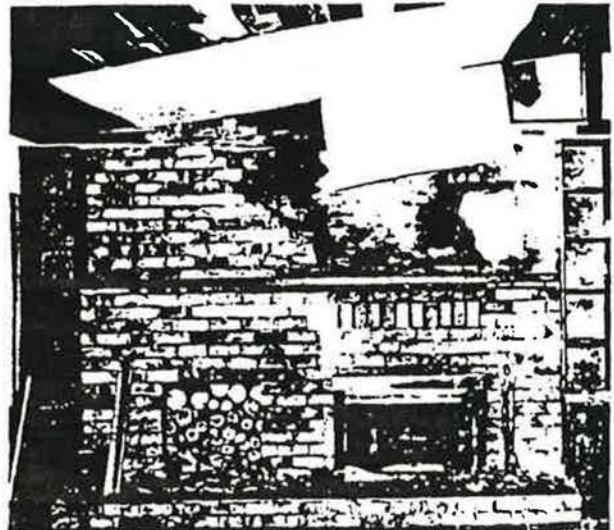
Photo 3 This incident involved glass doors fitted to a heat circulating masonry fireplace. The fireplace was built 5 years ago and the glass doors were fitted 2 years ago when the present owner bought the house. Here again, it didn't appear as if there was any clearance between the chimney and the sheathing.

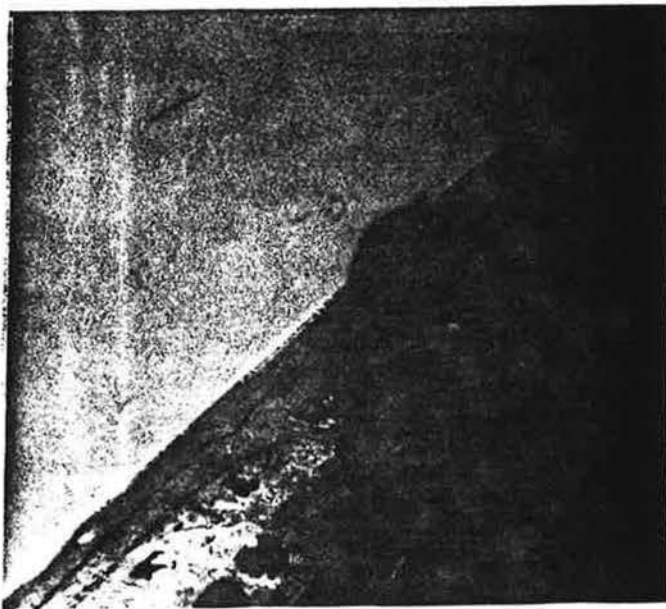
8. Examining bore debris to identify wooden components.

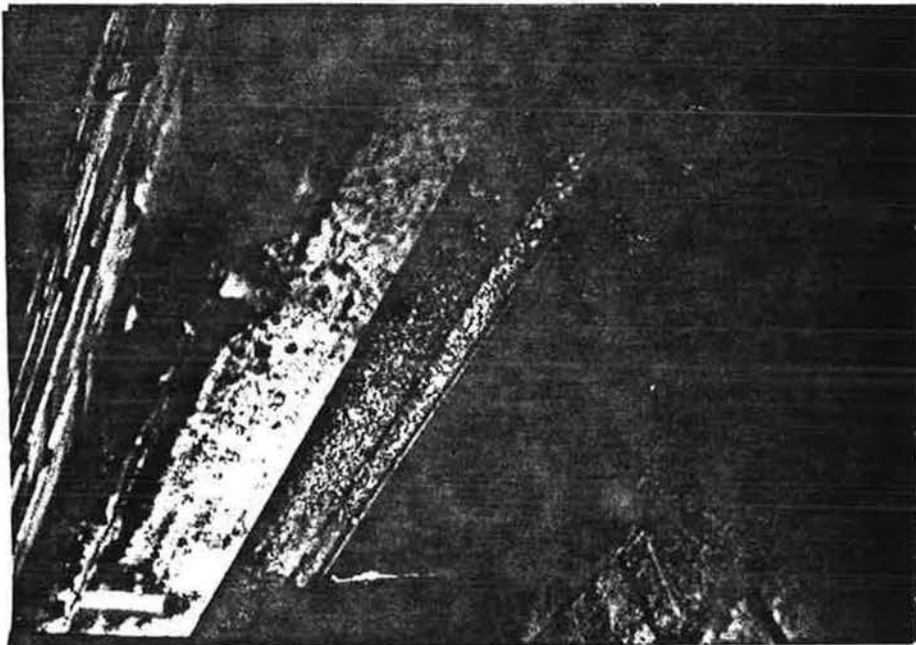
5. Observations made to determine condition of flue, location of flue liner, and construction of smoke chamber.

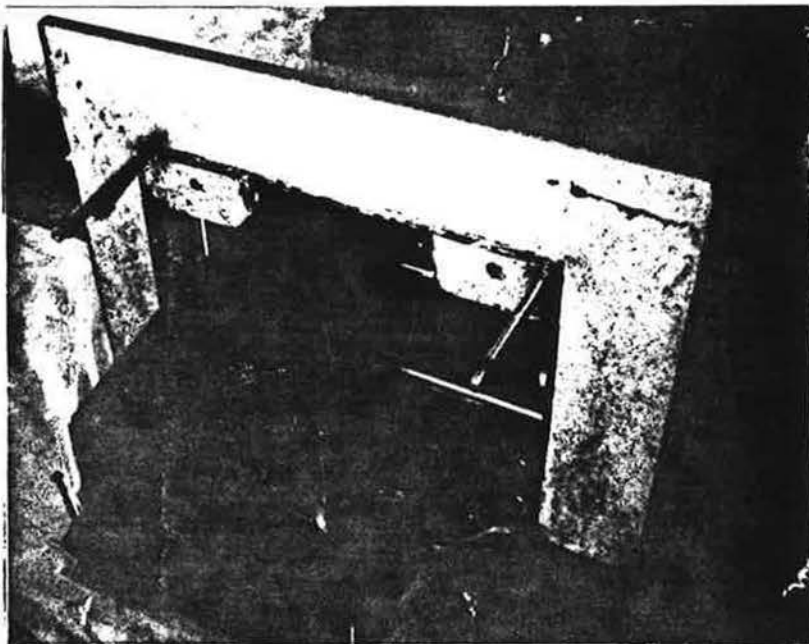
11. Rear view of door unit,
showing insulcast
cement behind frame
to reduce surface
temperatures.

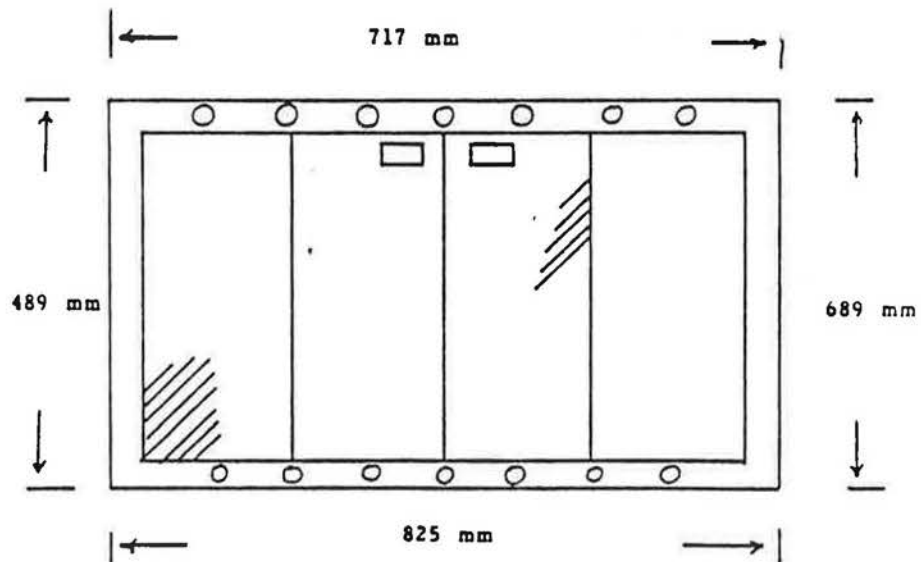
#1 FIRE PLACE GLASS DOOR

- BIFOLD DOORS
- DOUBLE VENTS
- U.S. MADE - PORTLAND - WILLAMETT
A DIVISION OF THOMAS INDUSTRIES

TOTAL LEAKAGE AREA: 123.8 mm

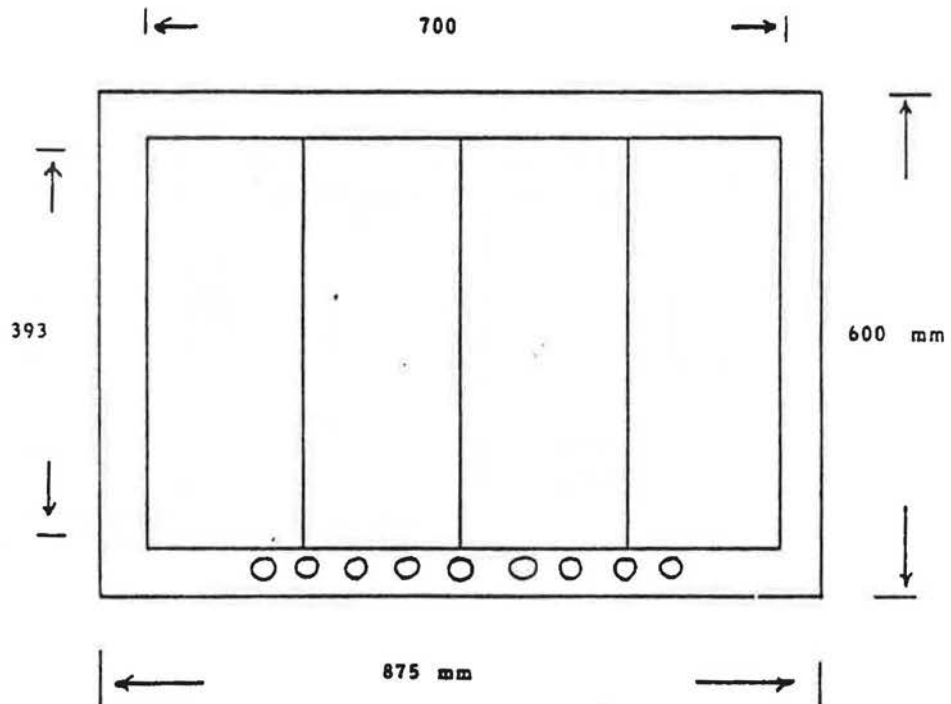
2 FIRE PLACE GLASS DOOR

- BIFOLD
- SINGLE ROW OF VENTS
- MADE BY JUSTESEN (LANGLEY) PRODUCTS CORP.

TOTAL LEAKAGE AREA: 84.0 cm²

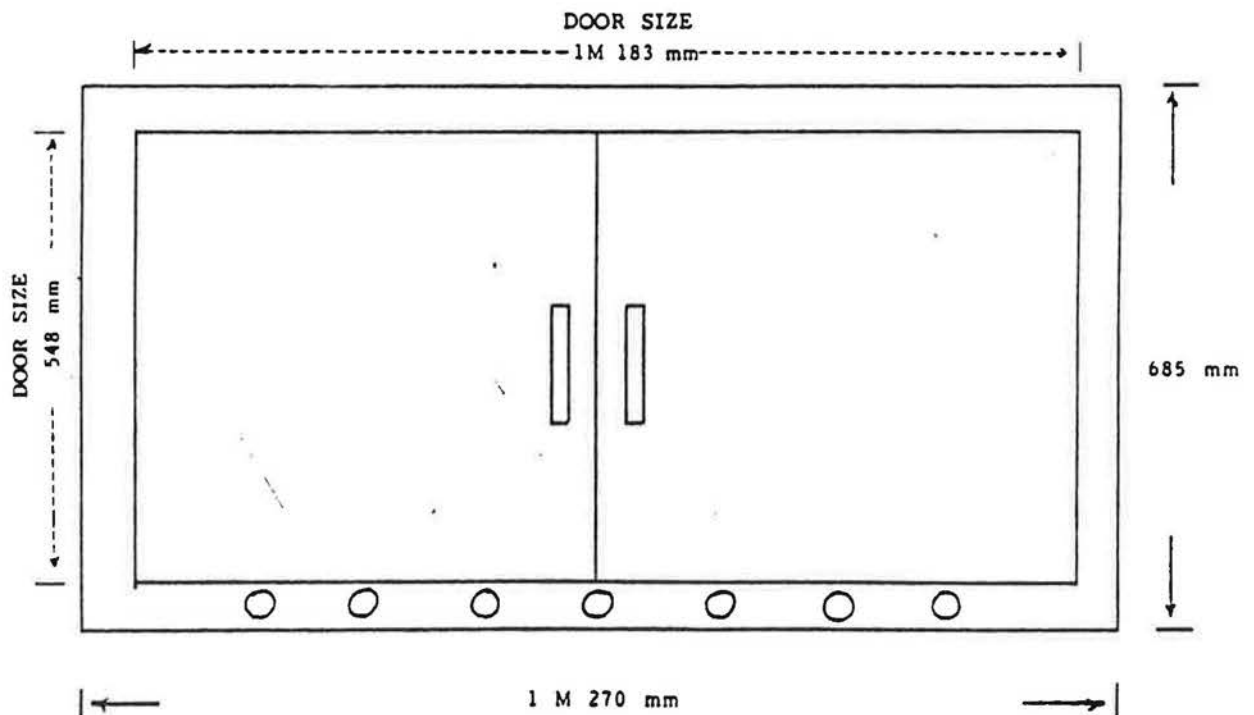
#3 FIRE PLACE GLASS DOOR

- 2-DOOR CUSTOM MADE
- USED
- AVERAGE INEXPENSIVE MODEL
GENERALLY FOUND OF THIS SORT
- ACTUAL MANUFACTURER NOT KNOWN
- ONE ROW VENTS
- LEAKAGE BETWEEN GLASS TO METAL
SEAL AS WELL AS METAL TO METAL

TOTAL LEAKAGE AREA: 95.7 cm²
