**RESIDENTIAL COMBUSTION
VENTING FAILURES -
A SYSTEMS APPROACH**

**A SURVEY OF FIREPLACE
SPILLAGE INCIDENTS IN
TWENTY-FOUR HOUSES**

FINAL REPORT

**Prepared by
Sheltair Scientific Ltd.
Scanada-Sheltair Consortium**

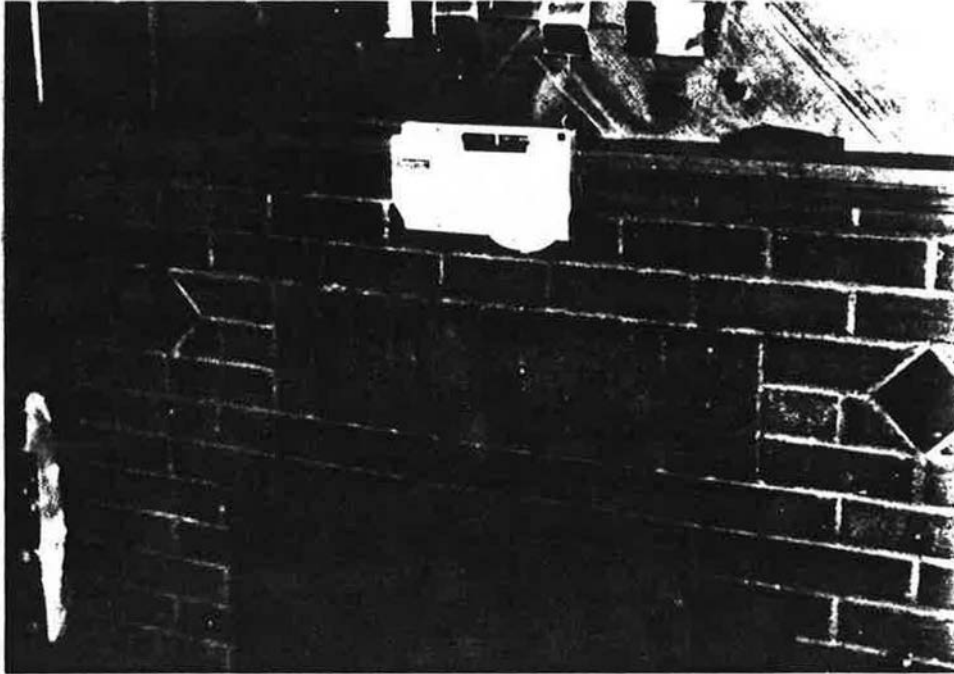
Counter Number: 4

House No. 4 stands out from the rest with a longer spillage length, averaging 0.55 minutes (33 seconds) per event. The heavy staining above this open fireplace (see House Description sheets) suggests a propensity to longer spillage events, and householders claim that wood smoke odours are common.

- Basement: Full
- Stories: 2
- Construction date: 1945 - 1960
- Furnace: N/A
- DHW: N/A
- Furnace Location: Furnace room in basement
- Furnace chimney on outside wall: Yes
- DHW & Furnace share chimney: N/A
- Outdoor portion of chimney is: Brick (or masonry)
- Approximate age of furnace: 10 to 20 years
- Converted from oil heating to gas: No
- Furnace serviced: Less than a year ago
- Type of fireplace: Open brick
- Notice aroma of wood smoke during or after a fire: Common
- Exhaust fans: 3 (Kitchen range hood, bathroom exhaust, and clothes dryer)

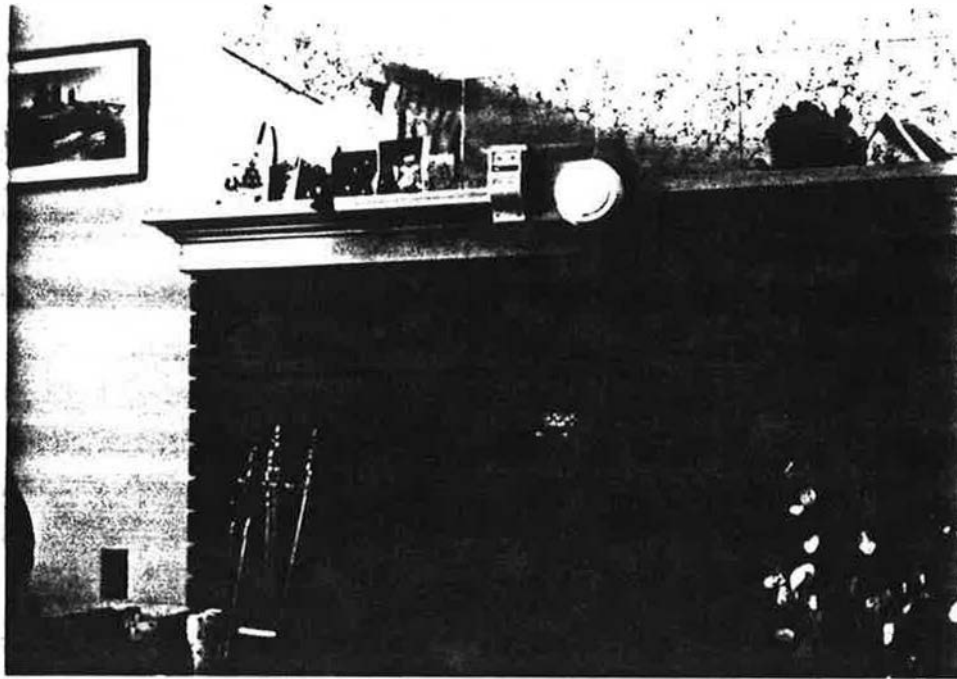
Counter Number: 8
 House Location: Ainsley, Ottawa, Ontario

- Basement: Full
- Stories: 1
- Construction date: 1945 - 1960
- Furnace: N/A
- DHW: Electric
- Furnace Location: Open basement
- Furnace chimney on outside wall: Yes
- DHW & Furnace share chimney: No
- Outdoor portion of chimney is: Brick (or masonry)
- Approximate age of furnace: More than 20 years
- Converted from oil heating to gas: No
- Furnace serviced: Less than a year ago
- Type of fireplace: Open brick
- Notice aroma of wood smoke during or after a fire: Rare (but does occur)
- Exhaust fans: 2 (Kitchen range hood and clothes dryer)
- Comments: 4 instances where owners closed damper "too soon" or forgot to open it before starting fire. Householders also noticed clicking when logs rolled out towards front of fire.

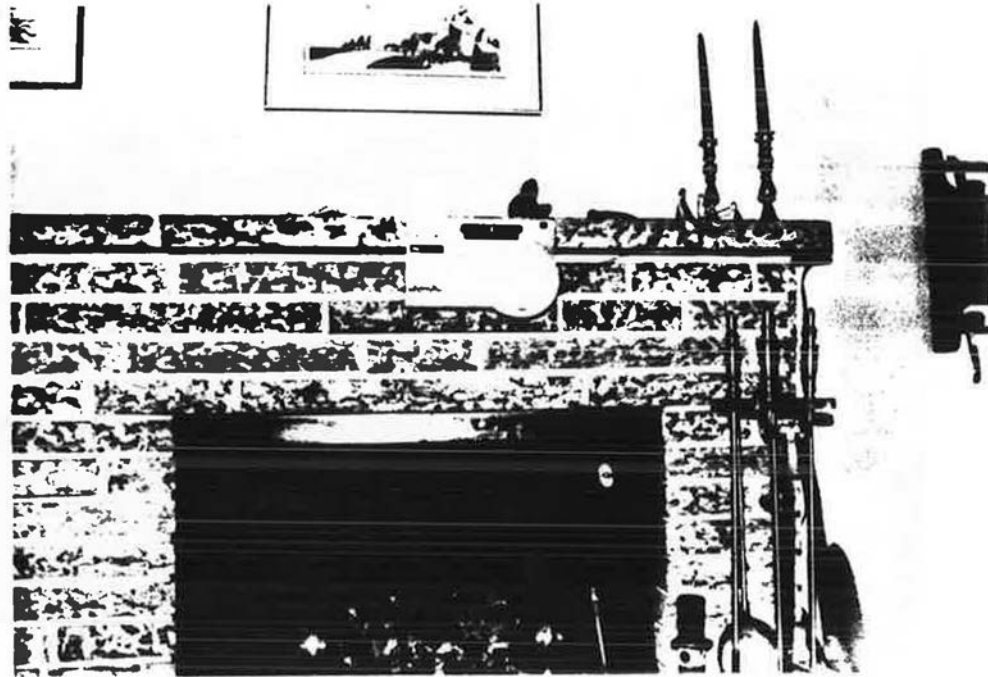
Counter Number: 9

- Basement: Full
- Stories: 2
- Construction date: 1960 - 1975
- Furnace: N/A
- DHW: N/A
- Furnace Location: Furnace room in basement
- Furnace chimney on outside wall: Yes
- DHW & Furnace share chimney: Yes
- Outdoor portion of chimney is: Brick and metal
- Approximate age of furnace: 10 to 20 years
- Converted from oil heating to gas: No
- Furnace serviced: Less than a year ago
- Type of fireplace: Open brick
- Notice aroma of wood smoke during or after a fire: Rare
- Exhaust fans: 4 (Kitchen range hood, 2 bathroom exhausts, and clothes dryer)
- Clicking noticed when burning wet wood.

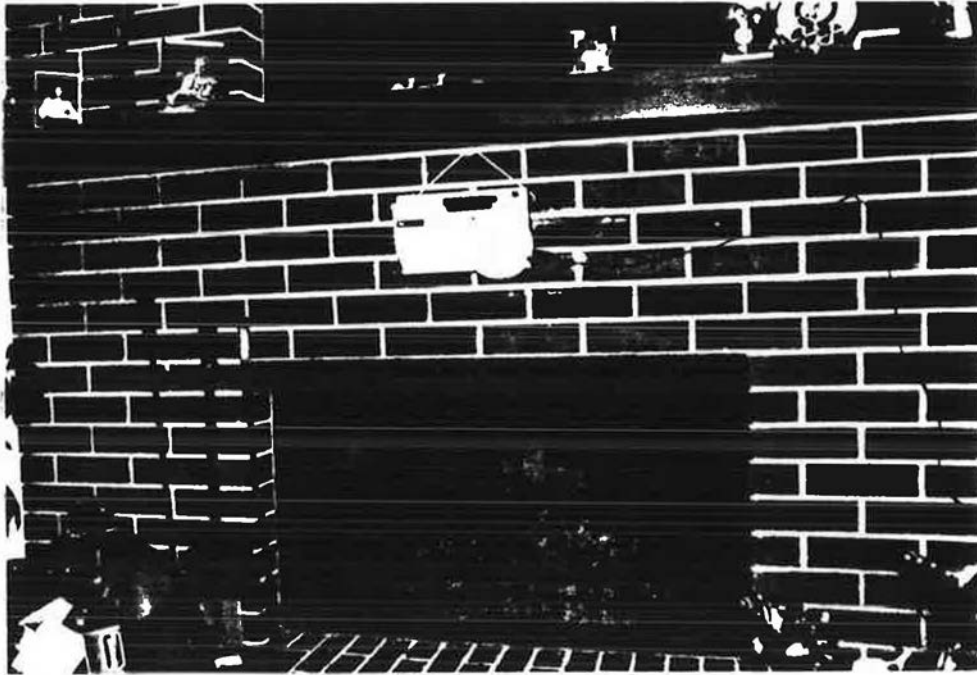
Counter Number: 11

fans. In House No. 11, both the fireplace and water heater spilled excessively, despite only 1.5 to 2 Pascals of depressurization under worst case conditions.

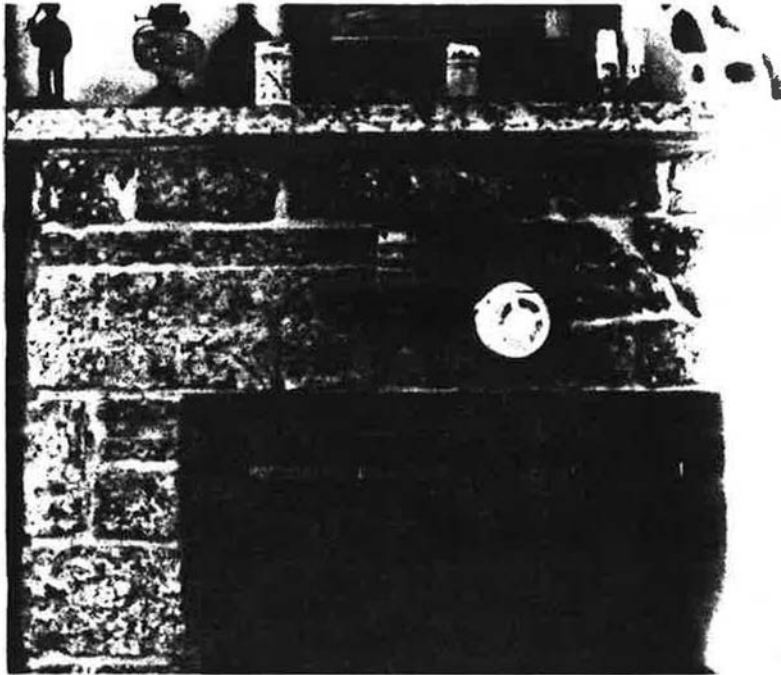
Counter Number: 12

- Basement: Full
- Stories: 1
- Construction date: Post 1975
- Furnace: N/A
- DHW: N/A
- Furnace Location: Open basement
- Furnace chimney on outside wall: Yes
- DHW & Furnace share chimney: Yes
- Outdoor portion of chimney is: Metal
- Approximate age of furnace: Less than 5 years
- Converted from oil heating to gas: No
- Furnace serviced: 2 to 3 years ago
- Type of fireplace: Metal with doors
- Notice aroma of wood smoke during or after a fire: Common (faintly)
- Exhaust fans: 3 (2 Bathroom exhausts and clothes dryer)
- Comments: Housing of smoke detector partially melted on first fire (still works though).

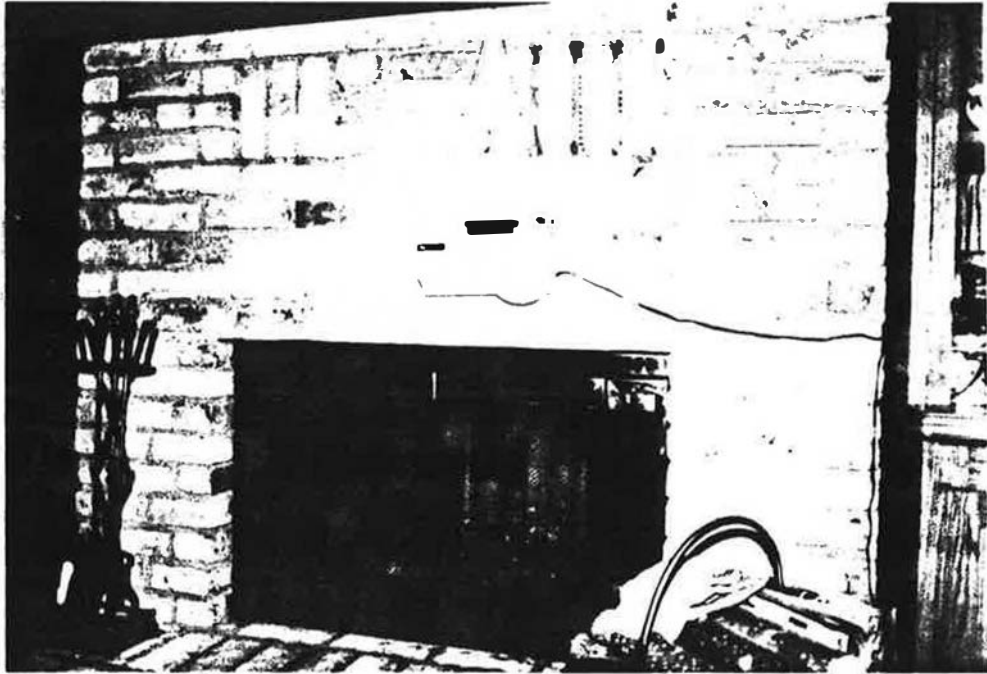
Counter Number: 14

In another case, House No. 14, a householder complained of constant ticking of the CO counter for long periods, for no apparent cause. The detector was removed for several weeks of testing, but was found to be performing properly. Consequently, further investigations were conducted at the house. It was determined that the householder had been regularly idling his car in an enclosed garage, adjacent to the fireplace room. The car exhaust had been drawn into the fireplace room, and, presumably, had triggered the CO detector. Once again, the presence of CO from other sources interfered with the spillage monitoring. In hindsight, it may have been warranted to install a CO alarm in the fireplace room, away from the fireplace, to alert both householders and researchers to the presence of CO from other sources.

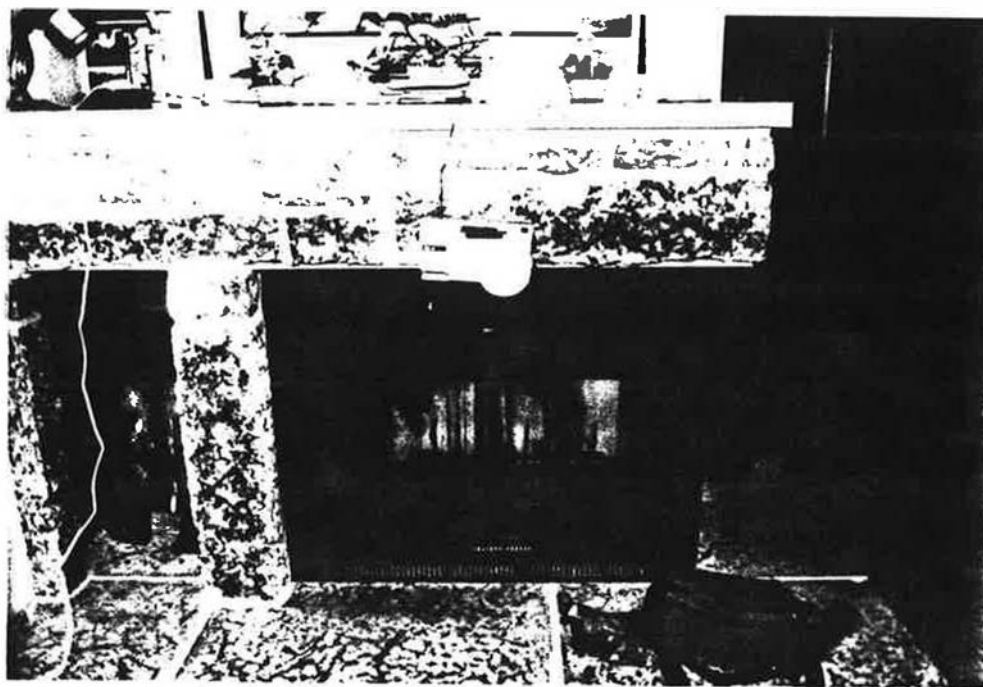
Counter Number: 16

Two of the Winnipeg houses (No. 10 and No. 16) exceeded the HDL, and also experienced excess spillage while under observation. The fireplace in House No. 13 spilled due to 3 Pascals of house depressurization caused by exhaust
