Wet Walls: Apparent Incidence of Excessive Condensation
in House Envelope Construction in Canada

R.E. Platts, P. Eng.
Scanada Consultants Limited
Ottawa, Canada

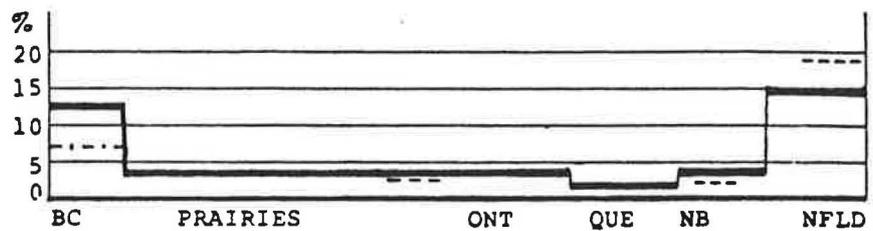
FIGURE 1 MEASURED AND APPARENT INCIDENCE OF WET WALL SPOTS IN OLDER HOUSES (PRE-1960)
 - % OF STOCK -

In the 1981 survey of 1900 houses, randomly selected from the older stock with walls retrofit-insulated, framing moisture content was measured at ten points around the base of the walls of each house. Where at least two of the ten points were found well above normal in moisture content (i.e. where the wood stud, sole plate, inner sheathing face and/or planking may have been approaching, or in some cases were exceeding, the fibre saturation point), that house was counted as a "wet wall" case. The survey itself was done in October, when it would be expected that all but severe accumulations of condensate from the previous winter would have dissipated. (Essentially no comparative investigation of walls was made in houses having no insulation or no retrofitted insulation.)

In March, 1982, a 14,000-house thermography/photography survey was conducted from the street in 13 metropolitan centres across Canada. It also yielded a picture of apparent "wet wall" incidence in older housing stock, much of it probably retro-insulated, and in the newer housing stock as well. The survey was laid out to be representative of the metropolitan housing stock by age group. The apparent incidence was rather similar to that found in the 1900-house moisture probing, but again there has been no attempt made to isolate an energy retrofit effect by itself, i.e. there has been no differentiation between insulated and uninsulated stock.

— Directly probed walls in wall retro-insul. houses —
 --- Thermographically scanned walls, all houses pre-'60 ---
 (BC - 54 houses only - 1951-'60)

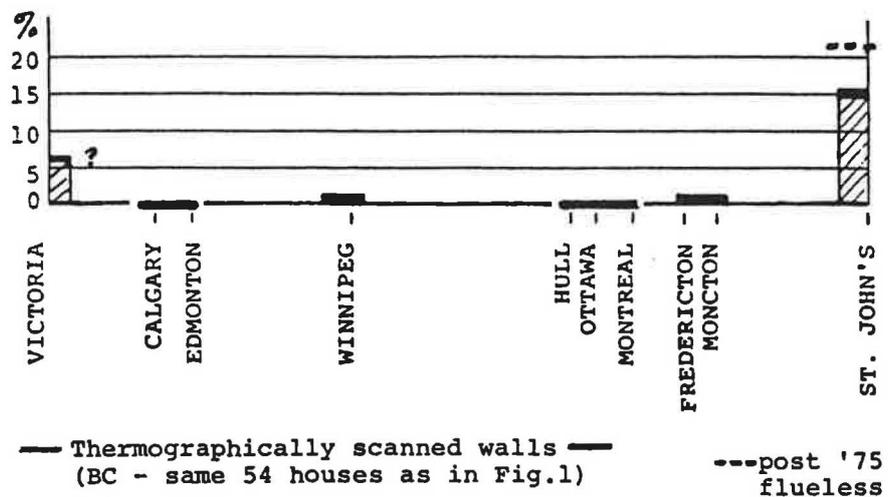
FIGURE 2 APPARENT INCIDENCE OF WET WALL SPOTS IN NEWER HOUSES (1961-'82)
 - % OF STOCK -

This latter survey was done in early spring, when winter accumulations of condensate would be assumed to be at their peak. "Wet walls" in this case were defined as only those walls having many patches or extensive spreads of apparently saturated areas, not just a spot or two. A word of caution: later thermography work has shown that latent heat effects can result in incorrect interpretation of thermography during freezing or thawing periods, so that the findings may understate the incidence of wet areas in the walls but certainly may overstate the apparent quantity of water. Brick veneers in particular can confuse the interpretability of the images. Further, uninsulated walls may also mask the presence of water. Nevertheless it is instructive to chart the findings of both surveys together as shown in Figures 1 and 2, emphasizing however that neither study sheds much light on the extent and seriousness of the apparent wetting within the wall structure.

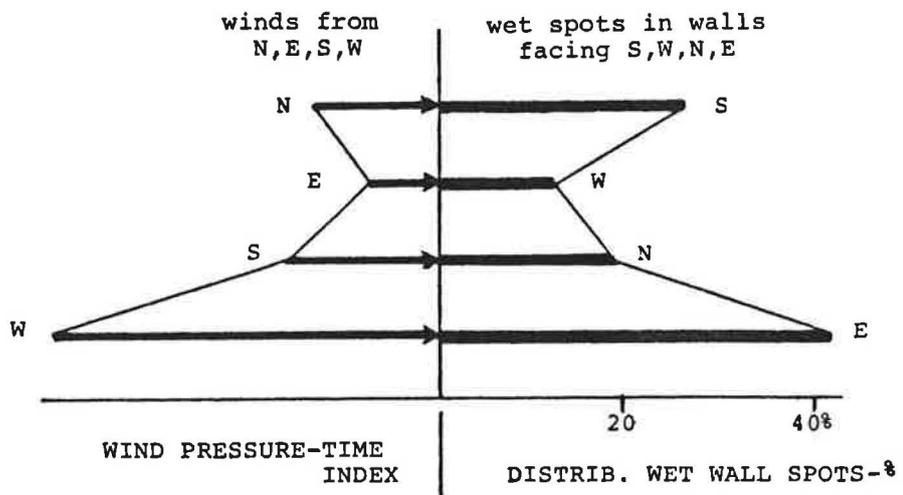
FIGURE 4 : DISTRIBUTION OF WET WALL SPOTS VS. WINTER WIND PRESSURE TIME INDEX, ST. JOHN'S NFLD.

- On the east coast, the spots of excessive moisture (i.e. saturated or supersaturated wood or wood products) tend to be distributed on the lee side of the prevailing winter winds, and tend to be juxtaposed over indoor construction junctions (e.g. floor-into-wall or partition-wall junctions). McKenzie has prepared Figures 3 and 4 from inspections of 80 cases, and Scanada has found essentially the same pattern in analysis of 230 thermographed cases in the same region.
