CONSTRUCTION DETAILS AFFECTING WALL CONDENSATION

Robert J. Kudder, Kenneth M. Lies and Kurt R. Hoigard*

SYNOPSIS

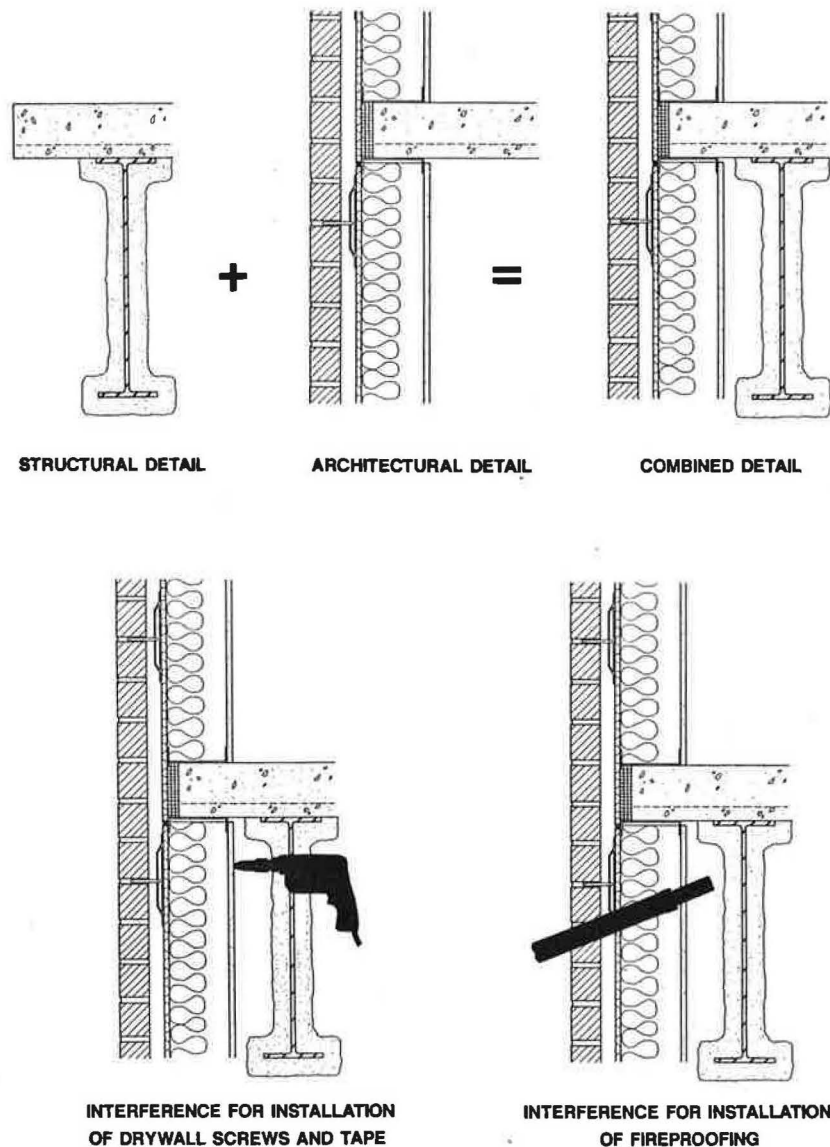
Figure 1

Example of problems resulting from failure to integrate architectural and structural aspects of a detail.

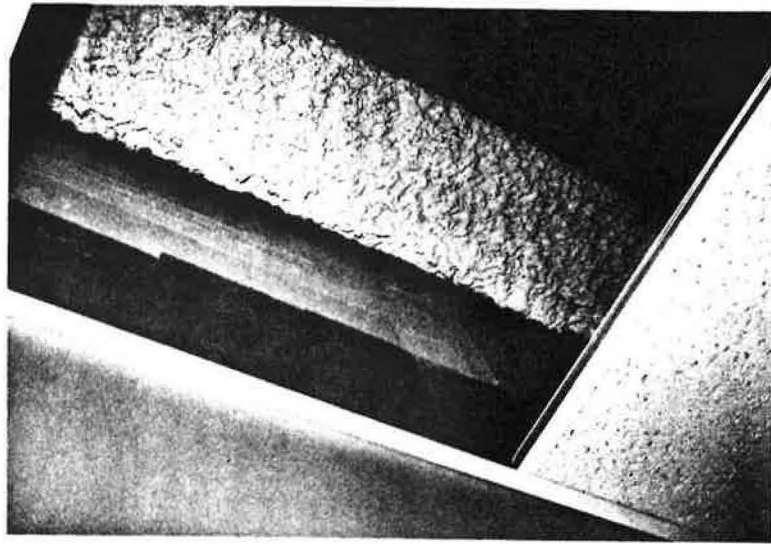
Figure 2

Incomplete installation of interior drywall due to interference from an adjacent structural beam.

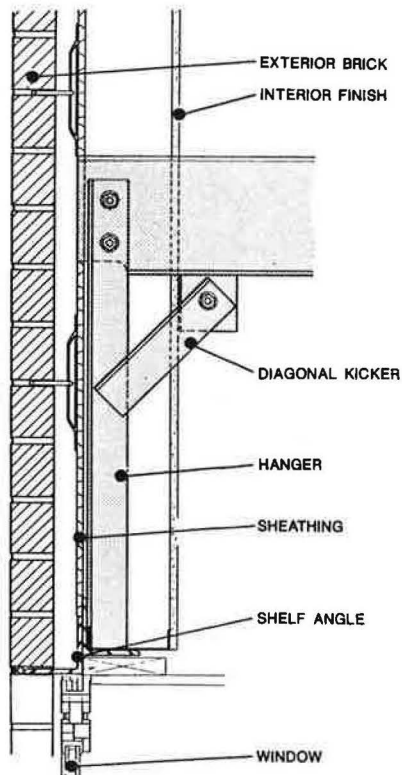
Spandrels above window heads, and diagonal kickers for spandrel hangers, are other locations where an air seal is rarely achieved. Figure 3 shows a representative detail in which miscellaneous steel must be integrated with the interior finishes, the window installation details, and the structural scheme. The diagonal kicker, which is necessary for structural reasons, penetrates the interior drywall and creates a hole in the vapor barrier, as well as an air path to the cavity. In addition, avoiding interference between the hanger and the exterior sheathing on the cavity side of the wall is critical for preventing interior conditioned air from reaching the cavity. Customary construction tolerances make it predictable that at some locations the hanger will be in the same plane as the exterior sheathing, or on the cavity side of the exterior sheathing. Achieving an air seal under those circumstances is virtually impossible. An example of the penetration of a diagonal kicker through the interior drywall, and the difficulty of achieving an air seal, is shown in Figure 4. The infrared thermography image in Figure 5 shows local hot spots where the spandrel hangers and kickers occur above the windows.

Steel hangers and diagonal kickers over window heads make it difficult to achieve an interior air seal.

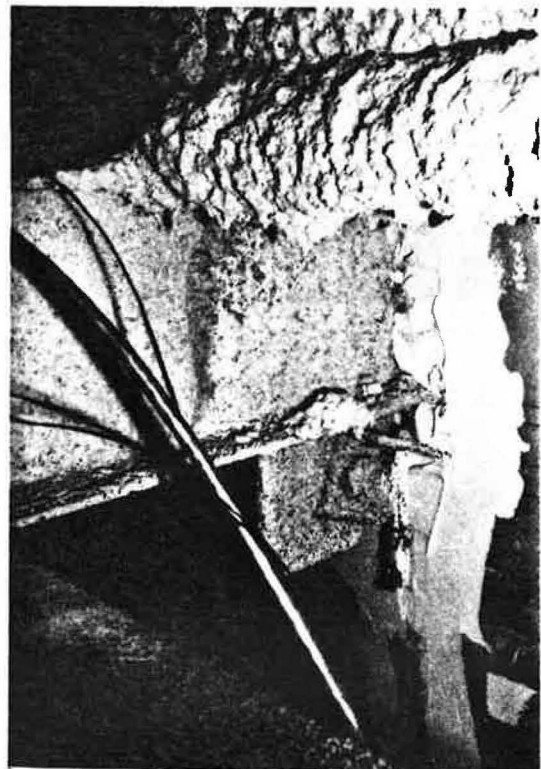
Figure 4

Penetration of a diagonal kicker through the interior drywall. It is difficult to achieve an air seal from the interior at these penetrations.

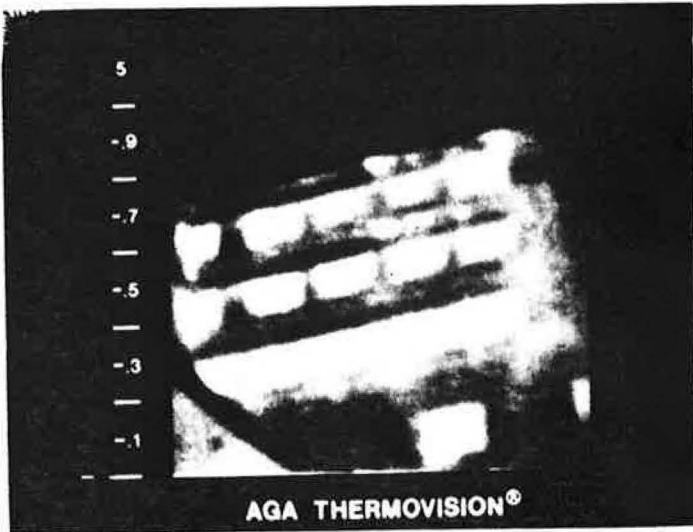
Figure 5

Infrared thermograph illustrating cavity heating and condensation at the location of hangers and diagonal kickers above the windows.

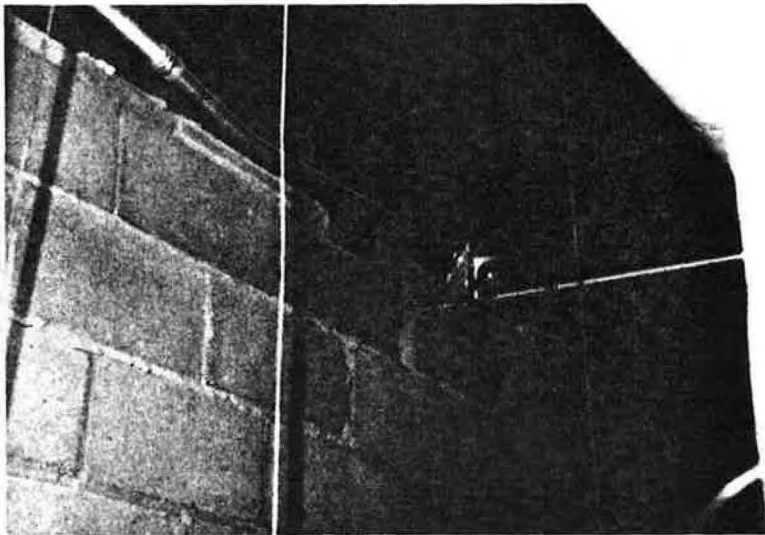
Figure 6

There are several other details repeatedly used in commercial construction which can lead to condensation problems. For example, it is common for an interior back-up wall of concrete block to be installed from the top of the slab to the under side of the spandrel beam above, and between the structural columns. If an air seal sufficient to compensate for construction tolerances and block shrinkage is not detailed between the back-up and the structural steel elements, an air path exists from the interior to the cavity beyond the block. In such a situation, as shown in Figure 6, condensation problems have been observed.

Concrete block back-up wall with no air seal at the underside of the spandrel beam.

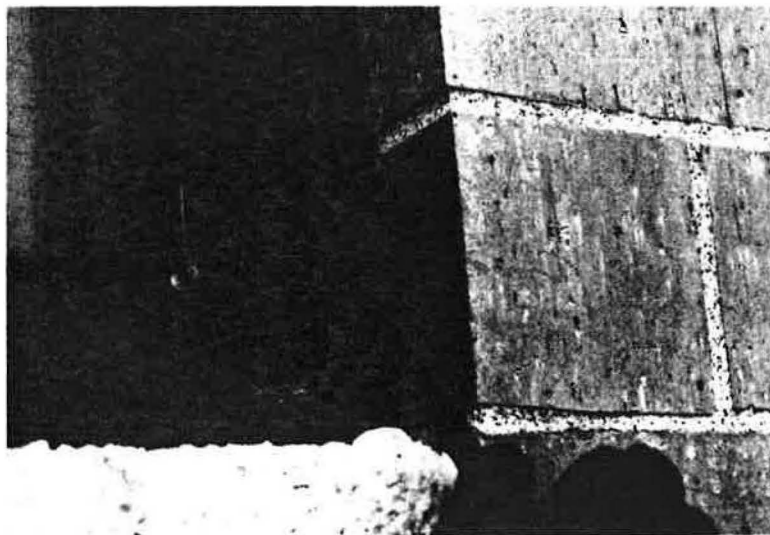
Figure 9

Condensation on the exterior of moisture transported by air exfiltrating from the cavity.

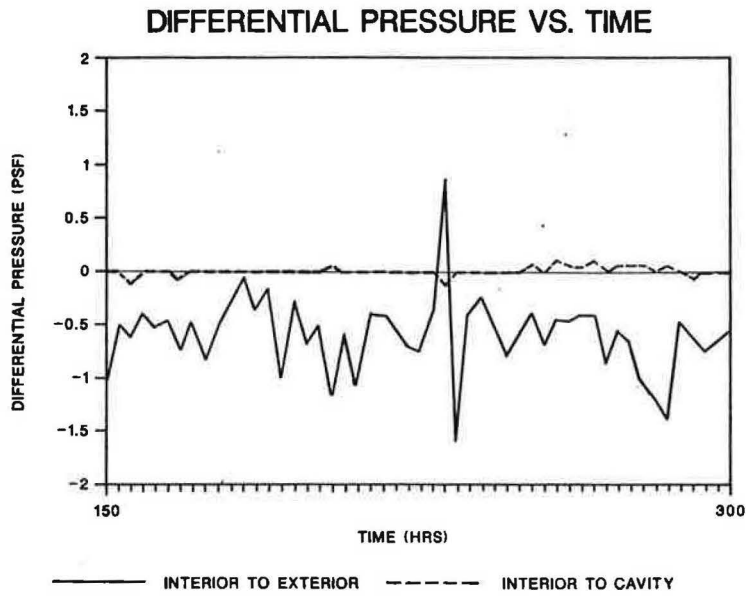
The temperature and relative humidity measurements indicate that interior conditioned air is circulating in the cavity, and that condensation is occurring. The lack of isolation between the interior and the cavity is also demonstrated by the differential pressure data shown in Figure 12. There is very little difference in pressure between the cavity and the interior, indicating an essentially unobstructed exchange of air. Additional differential pressure measurements were made during manual operation of the ventilating fans of the building HVAC system. Fans were turned off and the pressures were monitored for 20 minutes; fans were then turned on and the monitoring continued. The operation of the fans created no noticeable differential pressure between the interior and the cavity, confirming the existence of large air flow paths.

Figure 12
Measured differential pressure data.
