**CASE STUDY: INSULATED FLAT ROOF TOWNHOUSES
FAILED ROOFING & STRUCTURE DUE TO AIR EXFILTRATION/CONDENSATION**

K.A. Coulter, Manager, Building Science Department
Tillyard & Partners Inc.
Brampton Ontario, Canada

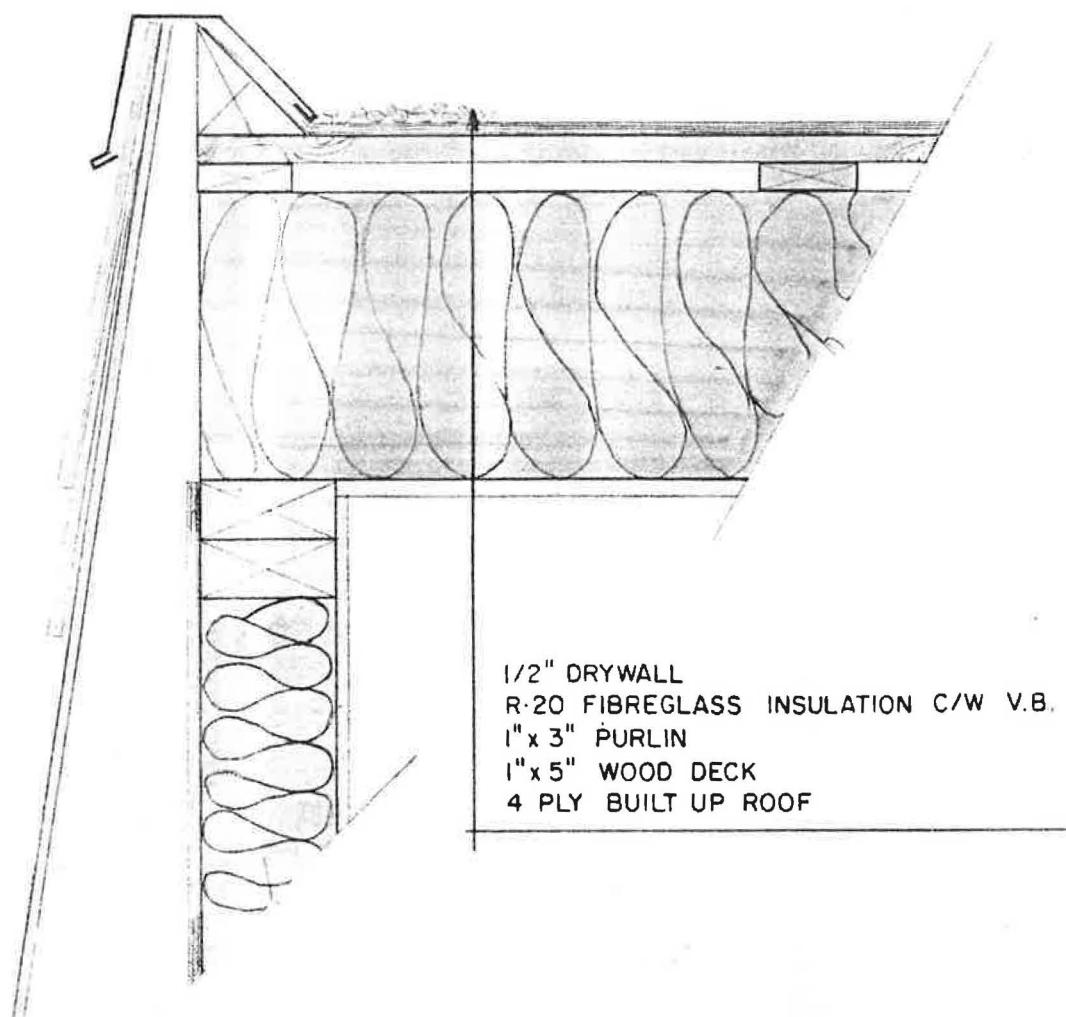
FIGURE 1

Built in 1972, the roof construction consisted of the following components (in to out) as shown in Figure 1:

- 1/2" drywall ceiling
- 2"x8" wood joists @ 24" c/c
- R-20 kraft-faced glass fibre batt insulation
- 1"x3" @ 24" c/c
- 1"x5" wood decking
- 4 ply built-up asphalt roof membrane

Venting of the joist cavity was attempted by leaving out the joist headers at the front and rear of the units. Air movement originated from the vents, located at the mansard roof soffit, approximately 11 feet down from the joist cavity.

To gain additional information about the condition of the roof system, ceilings were taken down in some units that were experiencing severe problems. Extensive deterioration of the roof deck, saturated glass fibre insulation and other deck areas which were literally dripping wet, with moisture contents measured at over 30% were observed. The wood rot and fungus not only created a structural problem but also was a source of contamination of the indoor air via air-borne spores when the air flow is reversed due to wind etc. Other ceilings were observed to have had the batt insulation installed upside down with the vapour barrier on the cold side, thus creating a vapour trap.

Even with the original design, the ability for these roofs to ventilate was in serious doubt. The designer had expected the air flow to run via one soffit vent, travel 11 feet up to the roof cavity (joist headers not installed), pickup any moisture and exit out the other side of the roof down 11 feet to the soffit vent and out. Even if the roof cavity had not been restricted with the R-20 batt, the fact that at some parts of the roof structure, the joists spanned from side to side (not front to back) meant that any air flow was seriously impeded.
