MOISTURE DAMAGE TO HOMES IN CHAMPAIGN CO., IL

William B. Rose is an architect and Research Assistant Professor at the Small Homes Council/Building Research Council at the University of Illinois in Urbana-Champaign

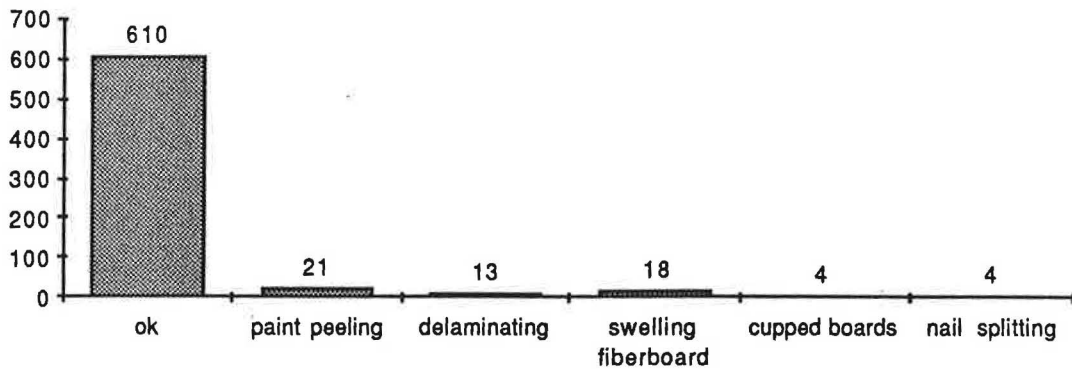
CHART 1.1 NUMBER OF HOMES SHOWING SIDING DAMAGE CONDITION

- 9.1% of the homes inspected have siding problems.
- Siding problems are usually associated with the effect of wind driven rain. The correlation of paint peeling with wet foundation conditions and other interior-generated moisture is typical.

- Only 21 homes have reports of paint peeling. Many of the homes inspected were prepared for sale and inspection by recent painting of the exterior.
- Swelling fiberboard is a phenomenon due primarily to the effect of wind driven rain on the exposed down-facing edges of fiberboard siding.

- An association is found between siding problems and crawl space construction. In the inspection reports, siding problems are defined as those which occur on large sections of the siding surface, not in local sites (such as near downspout discharges). Crawl space houses in Champaign County are typically sided very close to the ground (within 4") and local damage to the lower boards is more common than this study indicates.

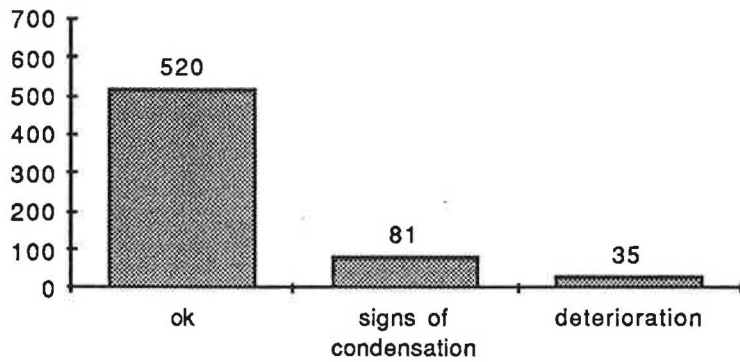
CHART 2.1 NUMBER OF HOMES SHOWING WINDOW DAMAGE CONDITION

- "Signs of condensation" among descriptive conditions refers to peeling paint and varnish finishes on the interior of windows.
- The sum of the cases does not in this case equal 670, the number of homes inspected. In the analysis a category was established for aluminum frame windows. Such windows are quite common in Champaign Co. (they were a typical detail of National Homes), and the condensation which usually occurred on the frames tended to moisten and soften the sheetrock surrounds. Because the condition is peculiar to one detail they were excluded from this analysis.
- A significant number of windows (5.2%) showed deterioration. There is a slight correlation between deteriorating frames and evaporative sources.

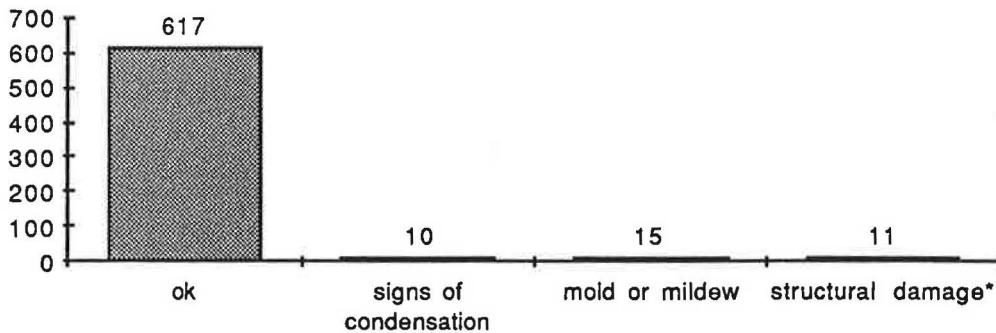
CHART 3.1 NUMBER OF HOMES SHOWING FLOOR FRAMING DAMAGE CONDITION

- 5.4% of the home inspected show damage to the floor framing.
- The most destructive damage conditions noted during the inspections were to floor framing elements. The inspectors have noted extreme cases where floor framing members have collapsed into the crawl space after the joist ends had been weakened by fungal growth.

- The asterisk on "structural damage" indicates that this is a major condition requiring replacement or reinforcement of major framing members--floor joists.

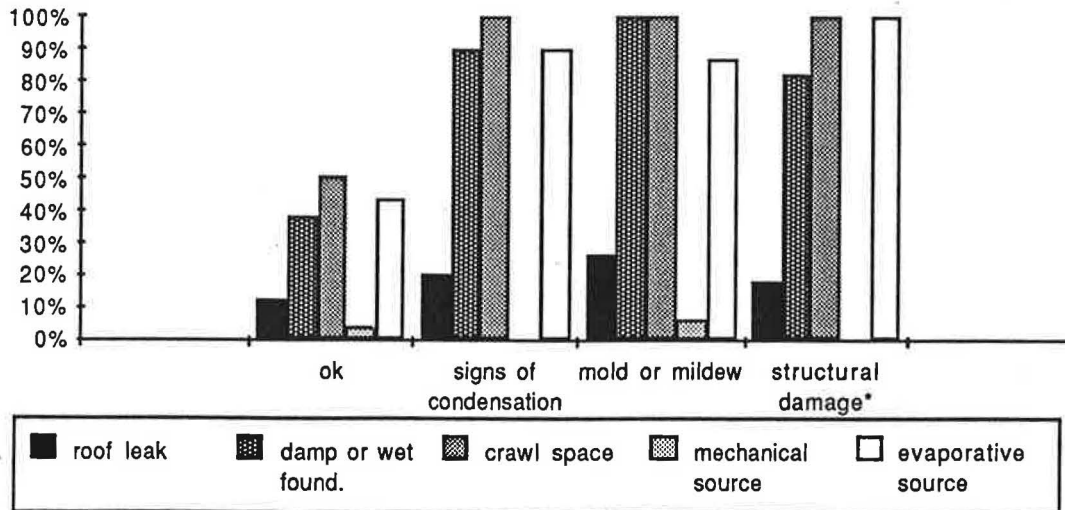
CHART 3.2 CORRELATION OF FLOOR FRAMING DAMAGE CONDITION WITH EXPLANATORY CONDITIONS

- Damage to floor framing is strongly associated with an evaporative source of moisture in crawl spaces.
- Damage to floor framing occurs first in the band joist and end joist (protected from outside temperatures only by wall sheathing). Damage to this member is included in the damage conditions, although it is structurally less critical than the floor joists--band joists and end joists carry facade loads along their entire length. The damage condition "structural damage" indicates damage to joists such that their load bearing strength is noticeably reduced.

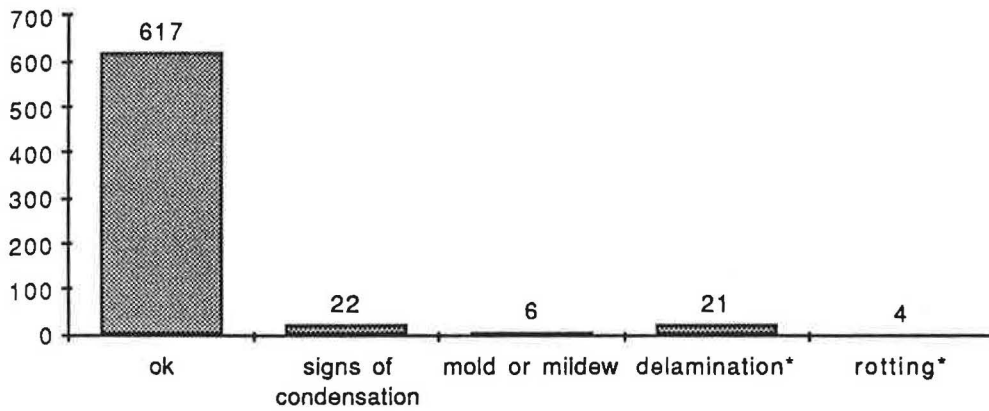
CHART 4.1 NUMBER OF HOMES SHOWING ATTIC SHEATHING DAMAGE CONDITION

- 8% of the homes inspected suffer damage to the attic sheathing.
- Condensation and mold on attic sheathing is strongly associated with the presence of an evaporative source of moisture and wet foundations.
- Moisture damage can progress from condensation to mold formation to delamination. But a great amount of rotting and delamination of attic sheathing is associated with roof leaks.
- The asterisk on conditions "delamination" and "rotting" indicate that this is a major defect requiring replacement of the sheathing, a structural member.

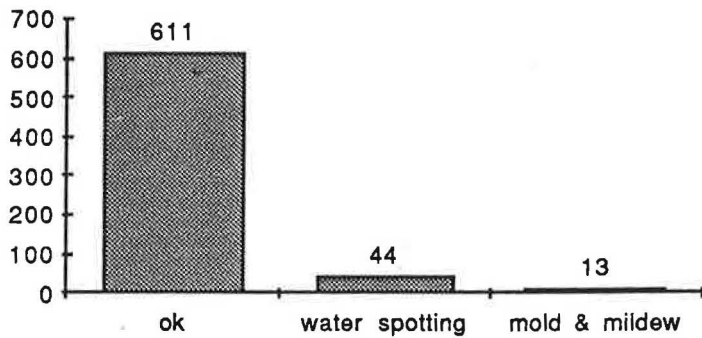
CHART 5.1 NUMBER OF HOMES SHOWING INTERIOR WALL DAMAGE CONDITION

- 8.5% of the homes inspected showed water damage to interior walls and ceilings.
- Water spotting on walls (and ceilings) is more often associated with roof leaks than with vapor transfer.
- The formation of mold and mildew on walls is strongly associated with humidity from mechanical sources (dryer vents, humidifiers and unvented combustion appliances).

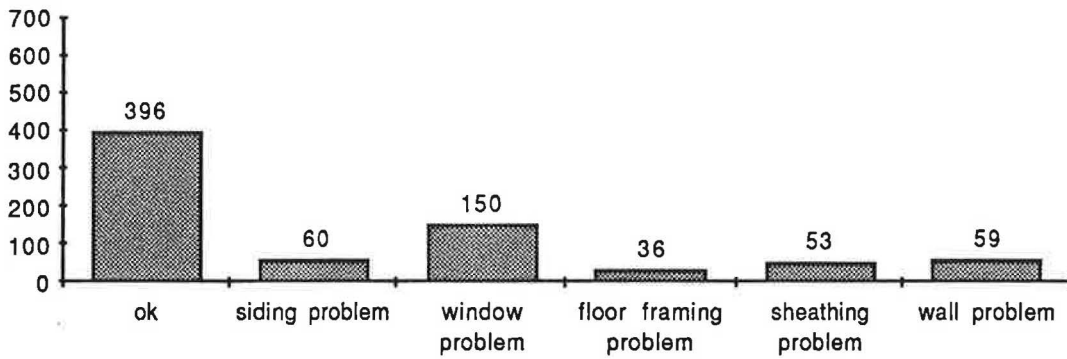
CHART 6.1 NUMBER OF HOMES SHOWING GENERAL DAMAGE CONDITION

- 41% of the houses show water-induced damage; 59% of the homes show no damage at all. The damage note may be very mild (as in the case of peeling of window finishes) to severe, requiring replacement of structural members. Many homes have more than one damage condition.
- 5.4% of the homes inspected have severe moisture damage.
- Three areas most at risk from evaporative-source moisture damage are attic sheathing, floor framing and siding. Of these three, damage to floor framing is most clearly associated with evaporative sources of moisture.
- Crawl space homes have a greater incidence of damage than homes with basements or slabs.
