A CASE STUDY OF THE CAUSE OF ROOF MOISTURE DAMAGE

George A. Tsongas, Ph.D., P.E.
Mechanical Engineering Department
Portland State University
Portland, OR 97207

Bruce Bolme, P.E.
U.S. Army Corps of Engineers
Trail, OR 97541

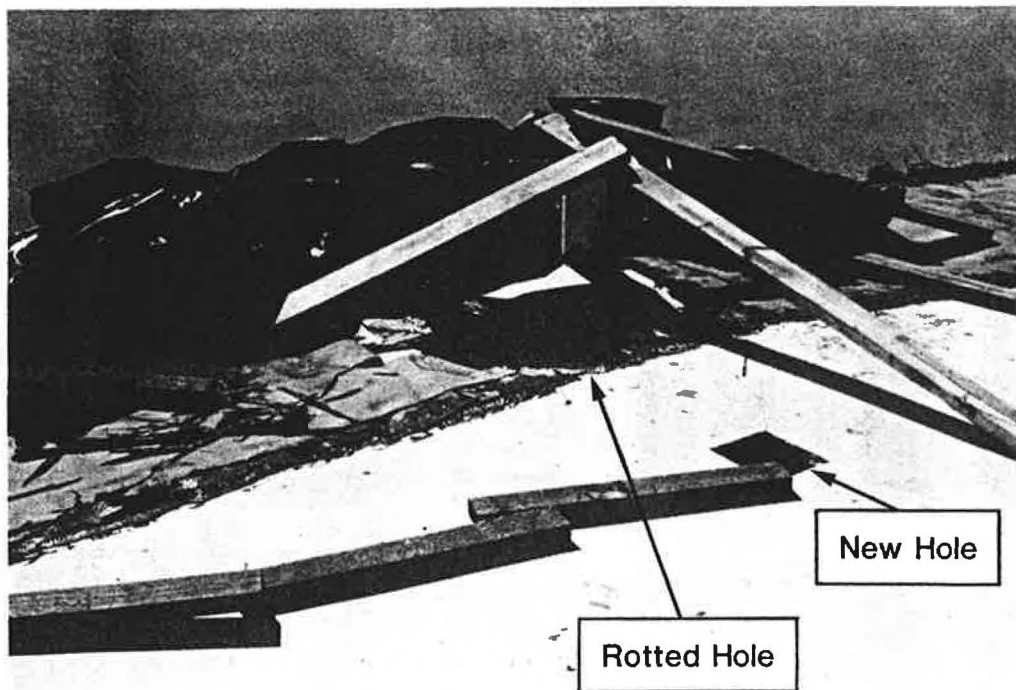
In one slightly low spot in the flat roof there was a large hole a few square feet in size (see Figure 3). A leak had been observed below inside the building. The hole apparently was caused by decay of the plywood. The top surface plywood that had been removed from the vicinity of the hole was clearly rotten (wood decay). The upper joists were in good condition except for a slight amount of decay on the top surface of the joist that was directly beneath the hole. That decay would not significantly reduce its structural integrity. The moisture content of the joist was very low. However, the moisture content of the lower plywood sheet was as high as 23%, which is relatively high. The upper plywood sheet moisture content was as low as 12% and generally was drier than the lower plywood. Presumably the decay was caused by moisture accumulation and subsequent wood decay.

It was decided to open a new hole about one square foot in area in the top plywood to inspect inside the roof cavity in an area about six feet away that felt solid and looked like it might be dry inside (see Figure 3). It was very humid inside. The bottom plywood had moisture contents up to 26% and looked dark and damp. The upper plywood was marked Group 1 exterior and along with the joists looked dry and had much lower moisture contents. No wood decay was noted. The insulation was in good condition, including the aluminum vapor retarder. There was no accumulation of moisture either on the lower plywood sheet above the vapor retarder or inside the insulation just above its aluminum foil vapor retarder facing.

Fig. 3. Hole in the outer roof surface of the hatchery building.

It was thus recommended that the outer roof surface consisting of the hypalon membrane and the upper plywood surface be removed; that was subsequently done in all three buildings. The exterior of the roof cavity was inspected and minor repairs made. Then the roof level was raised to provide additional roof ventilation and a new similar flat roof was installed. Since flat roofs are always prone to leaks, a policy of regular inspection and recoating of the hypalon surface has been instigated to prevent future damage. Of additional importance is the need in the future for more careful design and inspection of such flat roofs to avoid blocking the ventilation. That is especially important with increased levels of insulation where blockage is more likely.

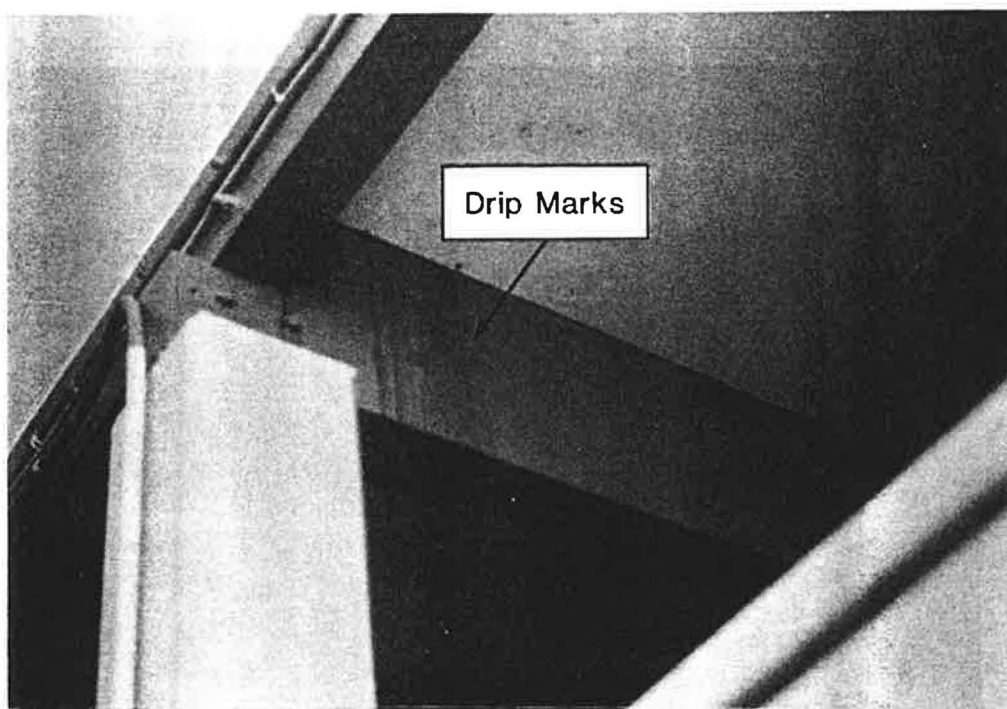
It should be mentioned that lack of time prevented making further openings from the outside of the roof. However, an additional opening was made from the inside. In an area just below the roof area where the leak and hole occurred, a loft area existed in the hatchery building. Thus it was easy to gain access to the underside of the roof. Close inspection in the loft area indicated numerous drip lines from previous leakage on the laminated beams; the water had leaked out from the joint between the lower plywood panel edges and the laminated beam (see Figure 4). In addition, rust was apparent on the drain pipes coming out of the roof cavity (see Figure 5).

Measurement was made of the moisture content of the beam and plywood about 7 1/2-8%, which is quite dry. However, near the leak signs there were a few locations where the ceiling plywood had moisture contents of greater than 30%, which is soaking wet. In the wettest location, a roughly one square foot hole was opened next to a beam by cutting the plywood with a circular saw (see Figure 5). As the cut was made, water trickled out of the roof cavity. After the hole was completely opened, the insulation was found to be soaking wet as was the bottom plywood. There was definite dry rot and some structural damage in places on both the plywood and the adjoining beam. However, the whole beam did not appear to be in jeopardy from the dry rot in that location. Lack of time prevented further openings from being made.

Fig. 4. Water leak drip marks on indoor ceiling laminated beam.

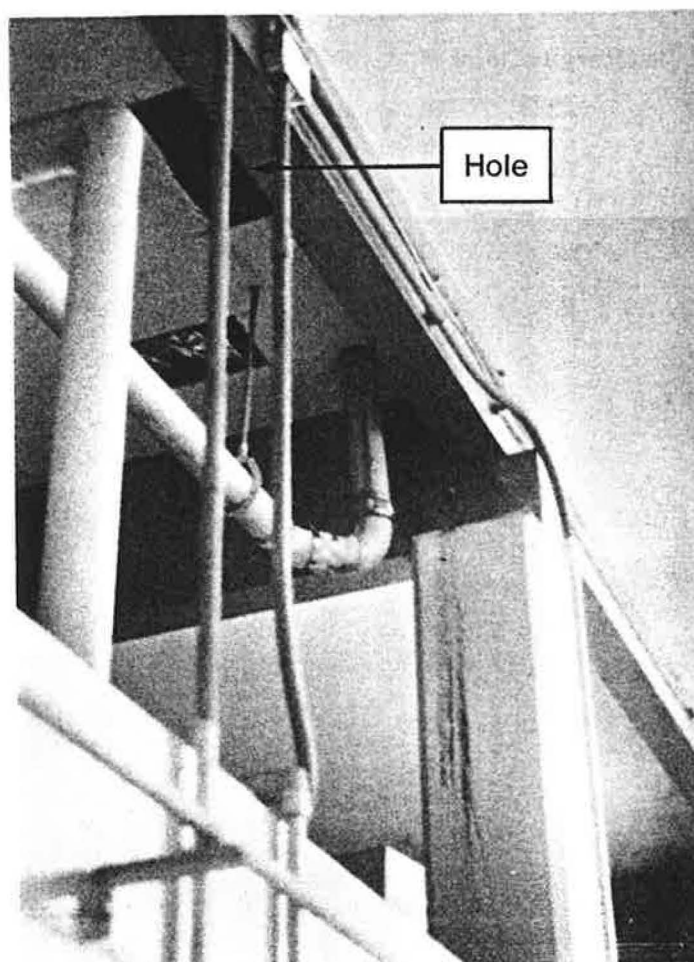
Fig. 5. Water leak rust stains on drain pipe and vertical post.

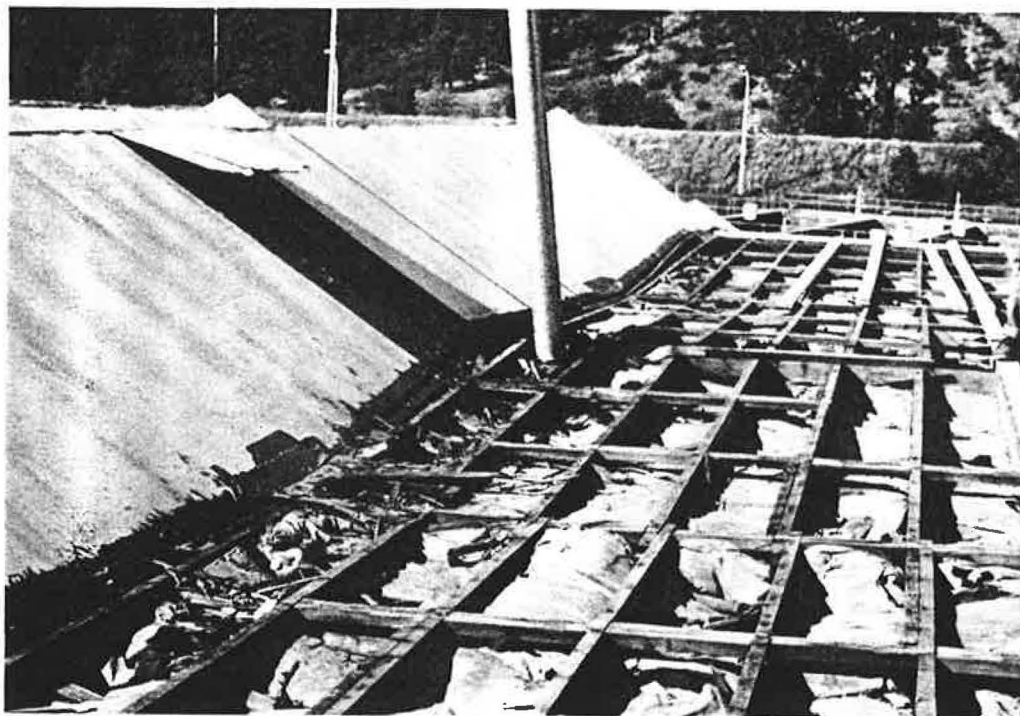
Fig. 6. Hatchery building flat roof with outer plywood surface removed.
