Overview of Moisture-Related Damage in One Group of Wisconsin Manufactured Homes

J.L. Merrill, D.Arch.

A. TenWolde
ASHRAE Member

ABSTRACT

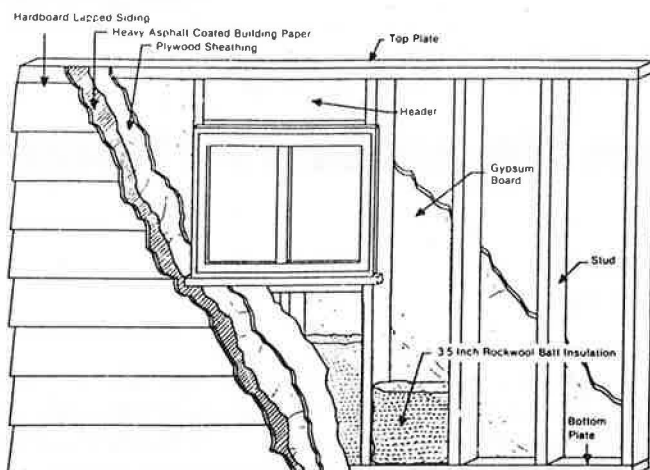
Figure 1 Wall construction of tri-state homes (ML87 5395)

A sketch of typical wall construction is shown in Figure 1. The interior surface material was 1/2 in (13 mm) sheet rock nailed to nominal 2- by 4-in (50 by 100 mm) studs. Mineral fiber insulation was installed between the studs. The insulation had an exterior kraft paper facing. The interior facing material was polyethylene, kraft paper, or aluminum, depending on the year of construction. The interior facing on the insulation was secured to the studs on the exterior side. The 1/2 in (13 mm) plywood sheathing was installed on the outside of the studs. For many homes, a layer of asphalt-coated building paper was installed over the sheathing. This was covered with hardboard lapped siding.

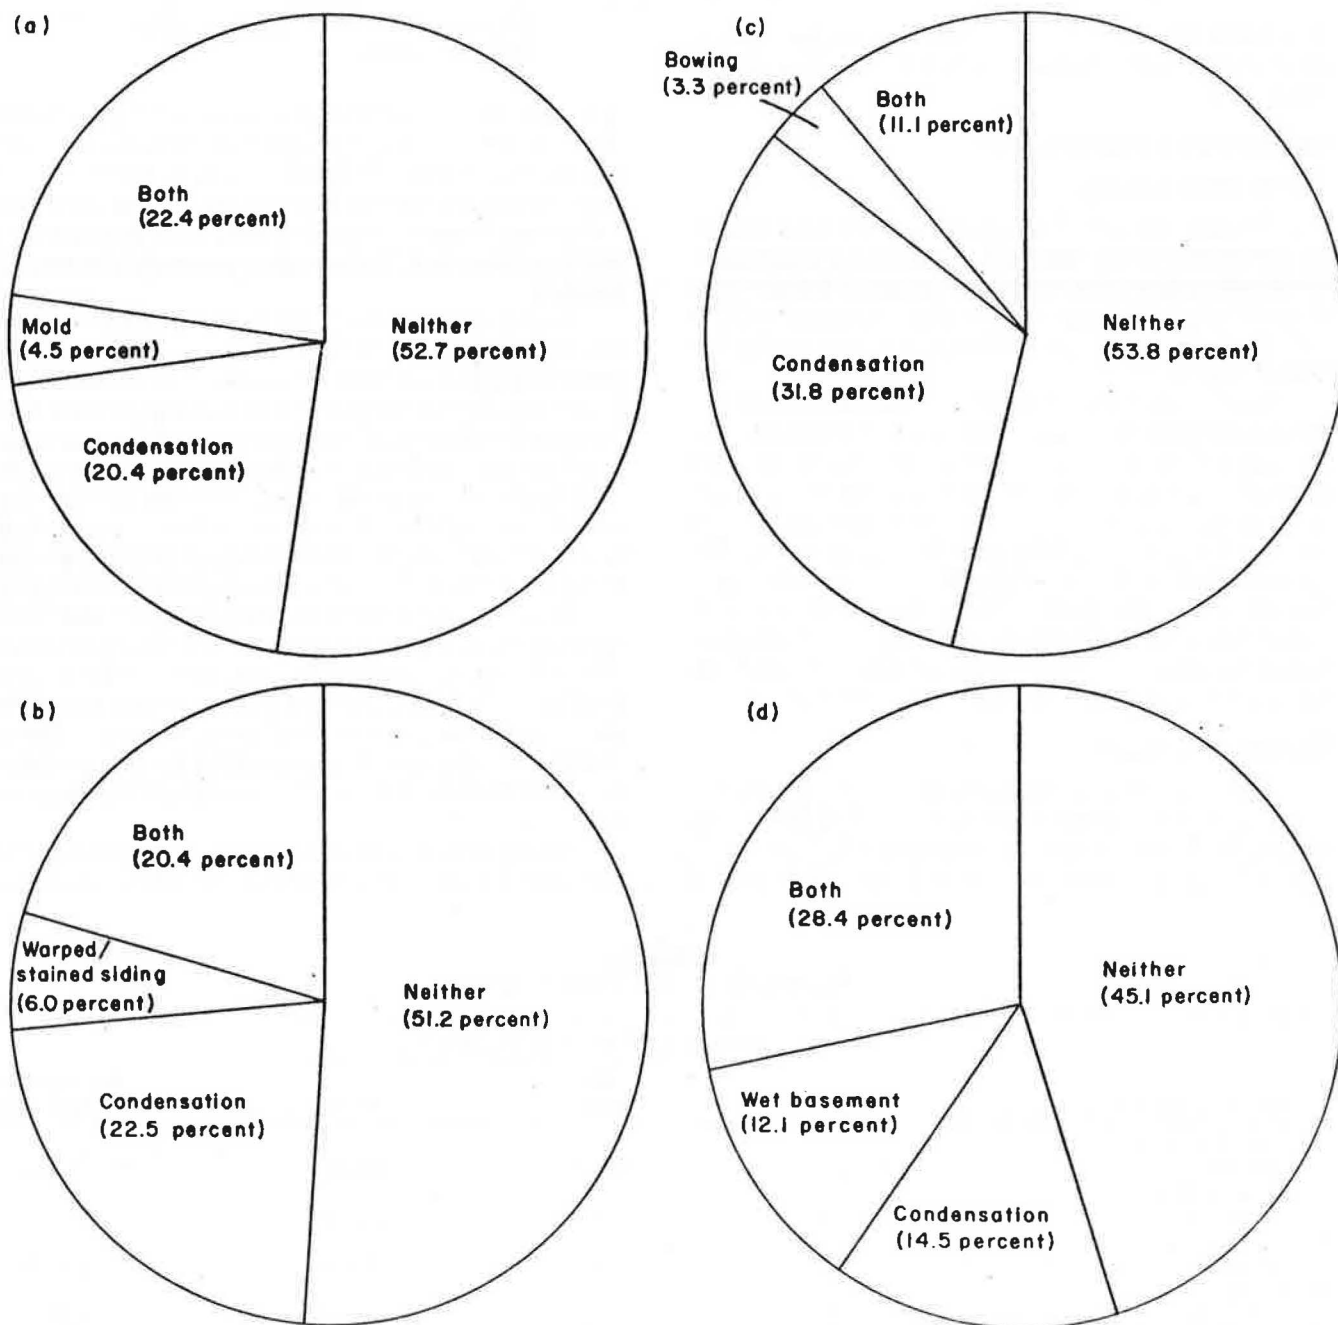
Figure 2 Reported concurrent moisture problems: (a) current condensation on windows and mold or mildew on walls or ceilings, (b) warped or stained siding, (c) bowing or crumbling of walls or ceiling, and (d) damp or wet basement (ML88 5610)

Figure 2a shows that 42.8% of the respondents reported condensation and 26.9% reported mold. Only 4.5% reported mold without reporting condensation as well. This means that 83% of those who reported mold also had problems with heavy condensation. Conversely, of those with a condensation problem, 52% also reported mold. Condensation without mold was reported by 20.4%. These results suggest that mold indicates a more severe humidity problem than heavy condensation and that heavy condensation on windows may serve as an early warning of excessive indoor humidity.

Figure 2b relates the incidence of heavy condensation with reports of warped or stained siding. Of those reporting condensation, almost half (47%) mentioned siding problems. Only 6% reported siding problems without condensation (23% of respondents with siding problems). This suggests that the majority of siding problems were related to indoor humidity problems and that heavy condensation apparently is associated with an increased risk of damage to the siding.

The incidence of current condensation and bowing of walls or ceiling is shown in Figure 2c. A relatively small number of respondents (14%) reported bowing of walls or ceiling. Of these, 77% also reported heavy condensation on the windows. A stronger correlation was expected because a causal relationship was anticipated between condensation (indoor relative humidity) and bowing of the gypsum board. This suggests that other reasons for wetting of the gypsum board, such as voids in the insulation, roof leaks, or leaking from ice dams, may play a significant role. However, as with the siding, heavy condensation does raise the probability of bowing of the gypsum board on the walls or ceiling.

Figure 2d presents the concurrent incidence of condensation and damp or wet basements. Wet basements are reportedly often the cause of high indoor humidity and condensation. Forty percent of all respondents reported damp or wet basements. However, a substantial number of respondents (14.5%) reported condensation without a wet basement. This suggests that wet basements may help create indoor humidity problems but are by no means the only contributing factor. It may also be argued that a damp basement during winter is the result of a low ventilation rate and high indoor humidity; the basement is not allowed to dry out from high moisture conditions in the summer.

In summary, the responses indicate that heavy condensation on windows is a reasonably good indicator of the potential for other moisture problems, including staining and warping of the siding. Because heavy condensation is primarily related to high indoor humidity, this finding also supports the initial conclusion that the decay of the plywood sheathing in many of these homes was most likely caused by excessive indoor humidity during the winter, resulting in condensation in the walls. Conversely, the responses also suggest that when no heavy condensation occurred, other moisture problems were much less likely to exist. This implies that lowering indoor humidity is likely to be effective in eliminating most moisture problems. Usually, the most convenient and economic way to lower indoor humidity is through increased ventilation.

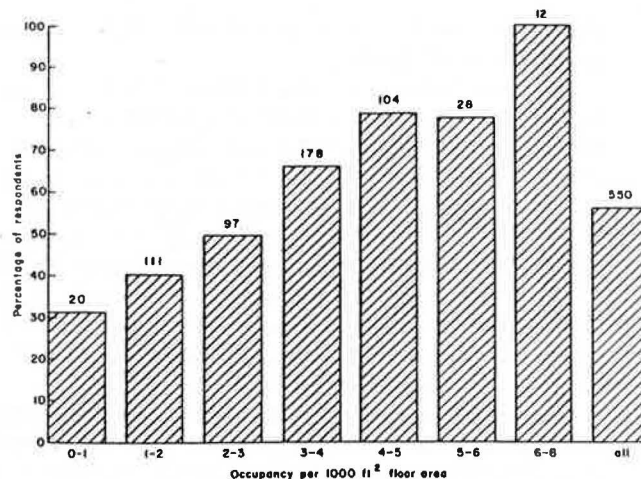
Figure 3 Incidence of moisture problems as a function of occupancy load, expressed as percentage of total respondents in each occupancy load class. Numbers above bar are numbers of respondents reporting problems (ML99 5609)

tivities, with moderate occupancy load and without unusual sources of moisture. Nevertheless, Figure 3 also shows a significant number of moisture problems in homes with a relatively low occupancy load, indicating other causes for condensation.
