**Flair Homes Project
REPORT NO. 5
Airtightness Performance of
Twenty Detached Houses
Over a Two-Year Period**

Report of the Flair Homes
Enerdemo Canada/CHBA Mark XIV Project

AIRTIGHTNESS PERFORMANCE OF
TWENTY DETACHED HOUSES OVER
A TWO YEAR PERIOD

PART OF THE
FLAIR HOMES ENERGY DEMO/CHBA FLAIR MARK XIV PROJECT
BY
G. PROSKIW, P.Eng.
UNIES Ltd.

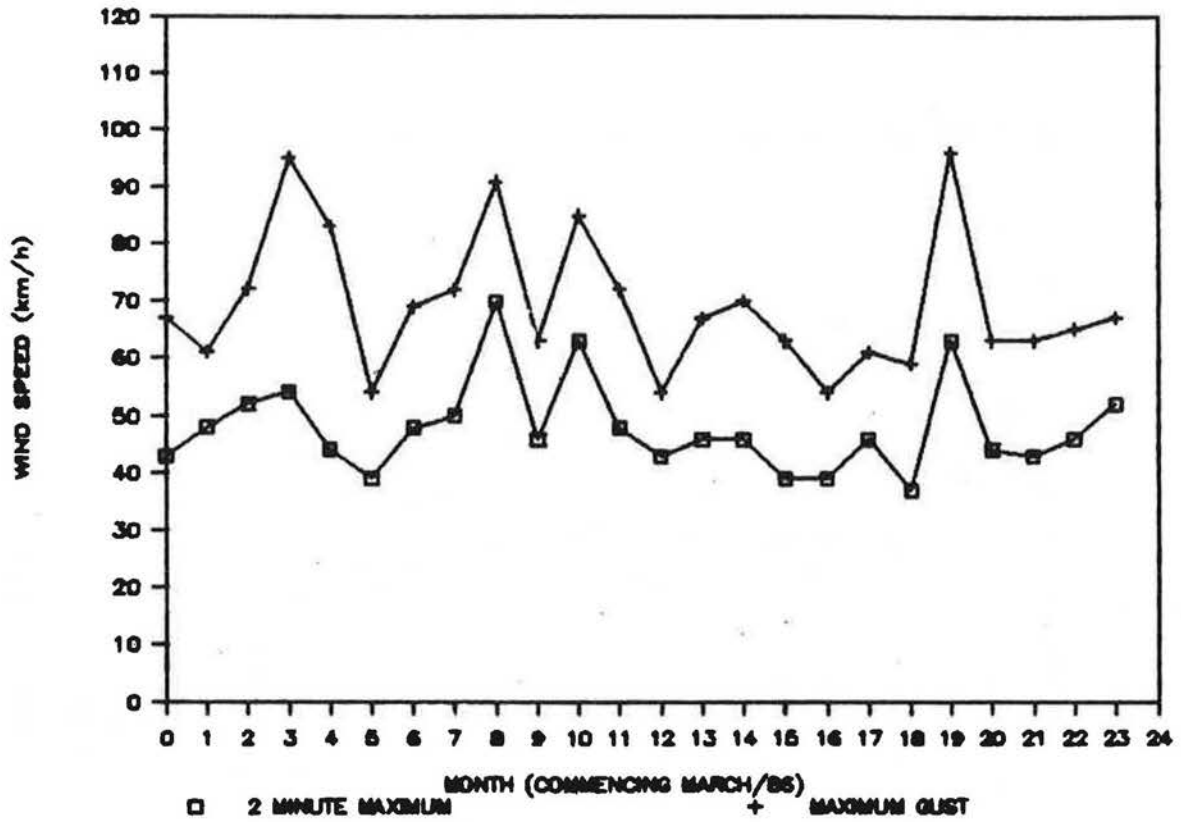
FIGURE 2

Maximum monthly wind speeds and the corresponding velocity pressures recorded during the monitoring period are shown in Figs. 2 and 3. These were measured at 10 m above ground level at Winnipeg International Airport, located approximately 15 km from the project site. It should be noted that 19 of the 20 project houses were located on the extreme northern edge of urban development with little protection against winds from that direction.

MAXIMUM MONTHLY WIND SPEEDS (AIRPORT DATA)

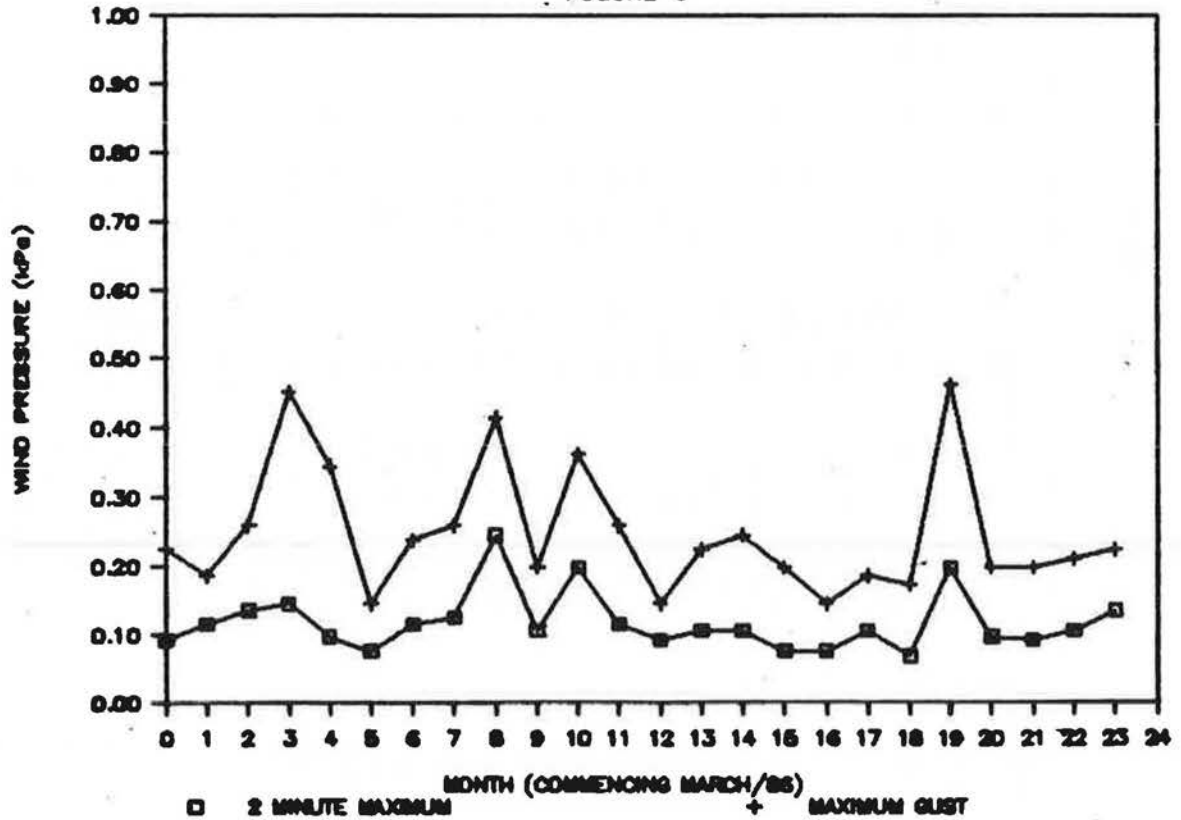
FIGURE 3

MAXIMUM MONTHLY WIND PRESSURES (AIRPORT DATA)

The current debate on the structural requirements of air barriers has focused on the need to withstand the pressure loading created by gusting wind conditions such as those in Figs. 2 and 3. During the monitoring period, the maximum gust recorded at the airport weather station was 96 km/h from the north, equivalent to a pressure loading of 460 Pascals compared to

the Winnipeg design value of 880 Pascals. The loading actually experienced by the houses is unknown but would have likely been less than that at the airport. However it should be noted that 19 of the 20 project houses were located on the extreme north edge of urban development with very little protection against winds from that direction.

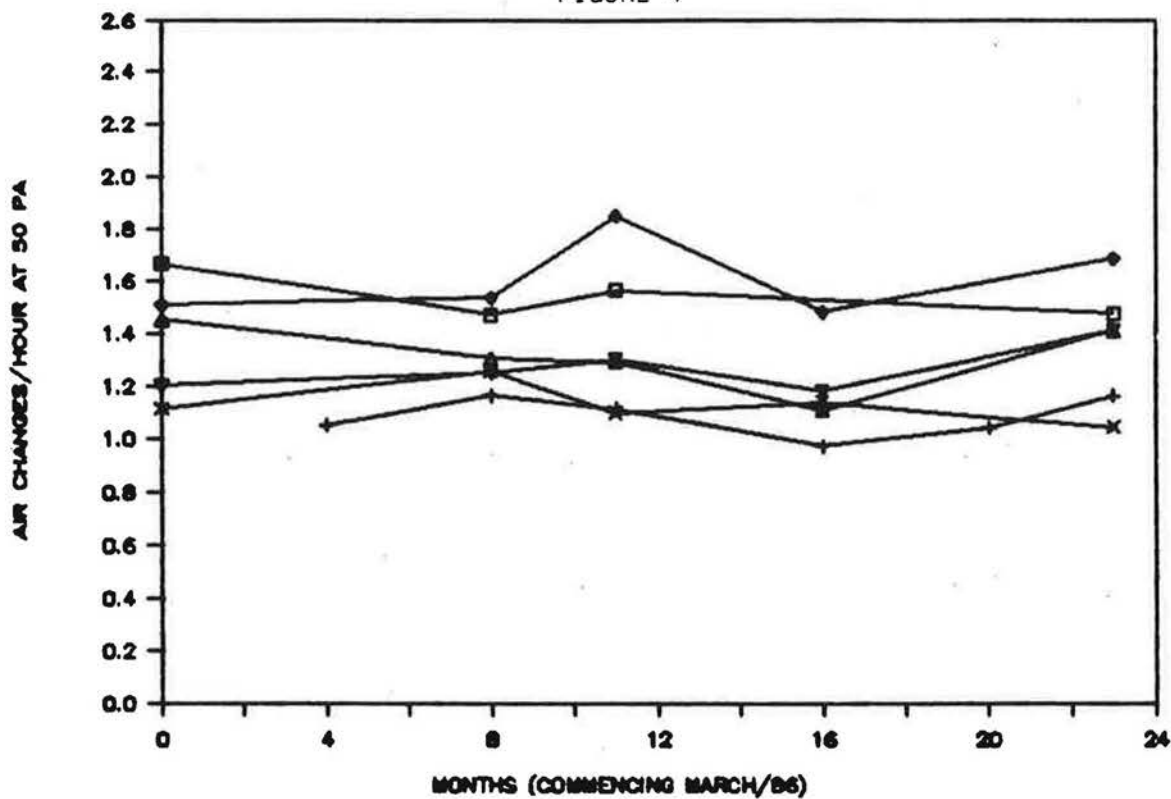
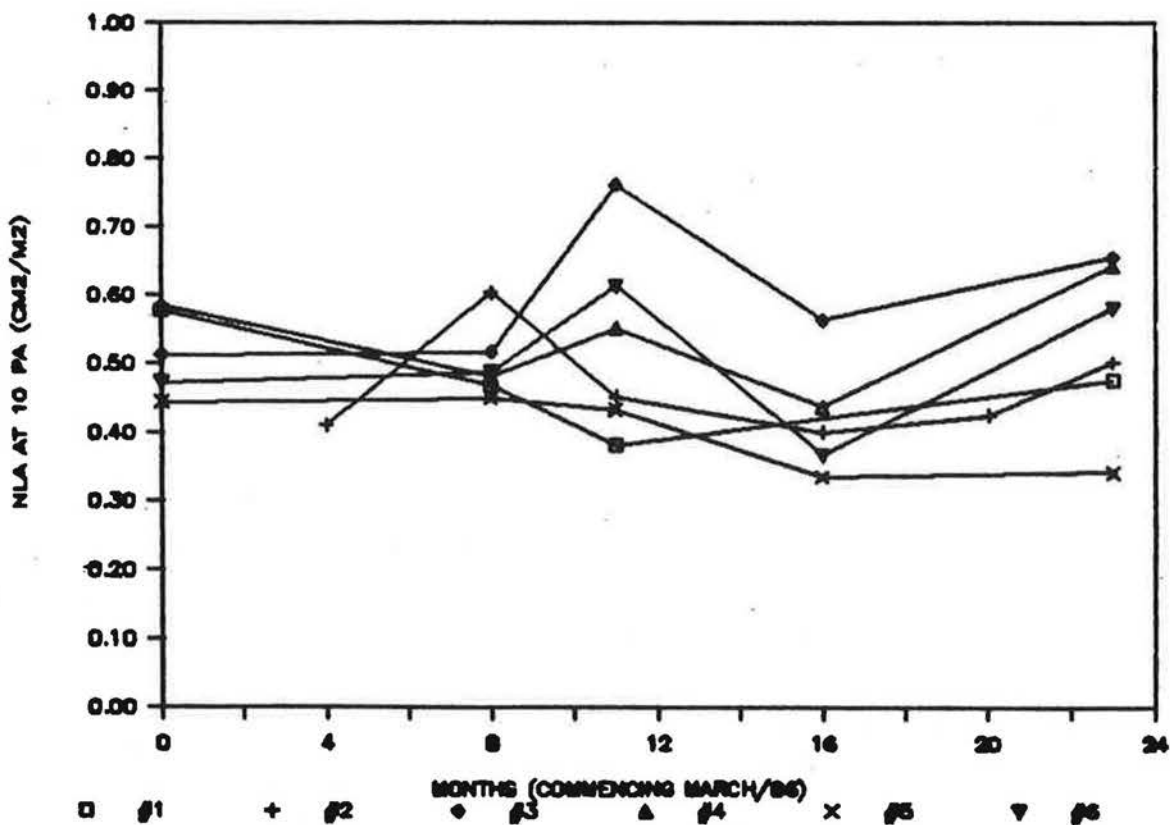
FIGURE 4

The airtightness results are plotted in Fig. 4. As shown, the initial airtightness performance of the houses was at or slightly below the R-2000 requirement. Airtightness levels then fluctuated over the monitoring period and while some noticeable variations did occur, particularly in the NLA_{10} , no permanent, systematic change was observed.

a) AIR CHANGES PER HOUR AT 50 PASCALS

b) NORMALIZED LEAKAGE AREA AT 10 PASCALS
HOUSES #1 TO #6 (MARCH/86 TO FEBRUARY/88)

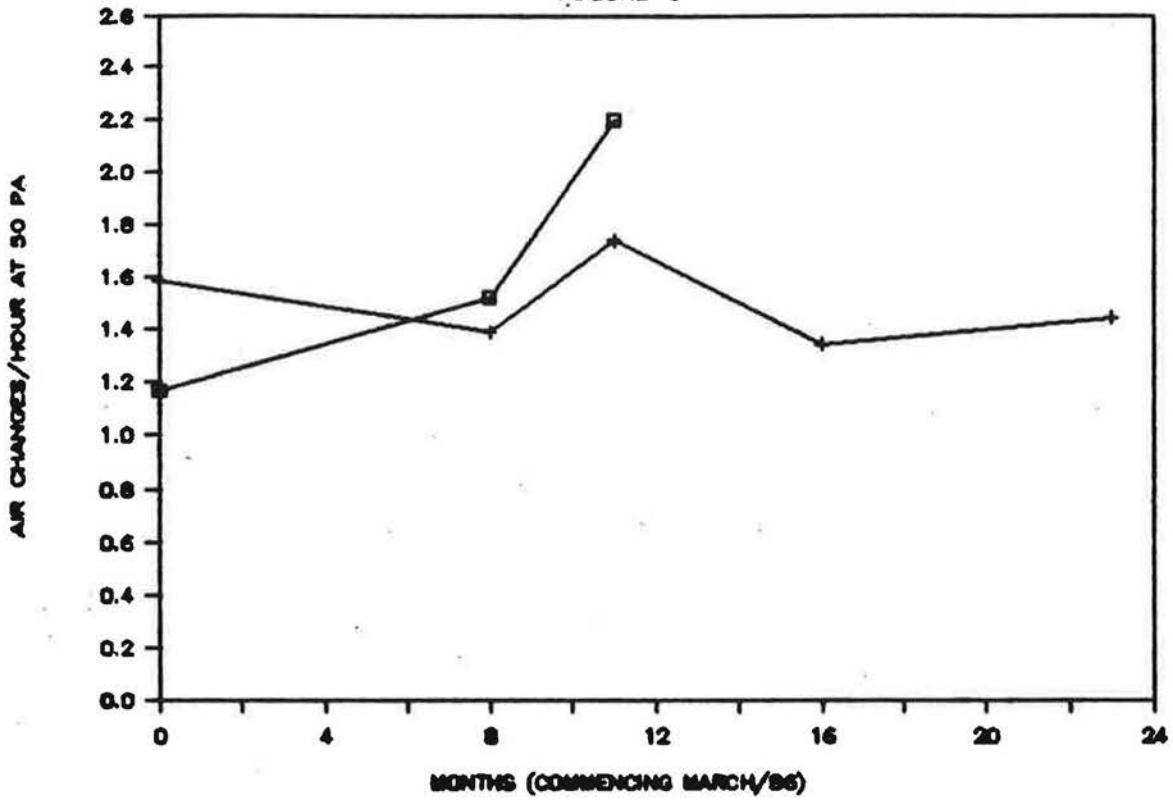
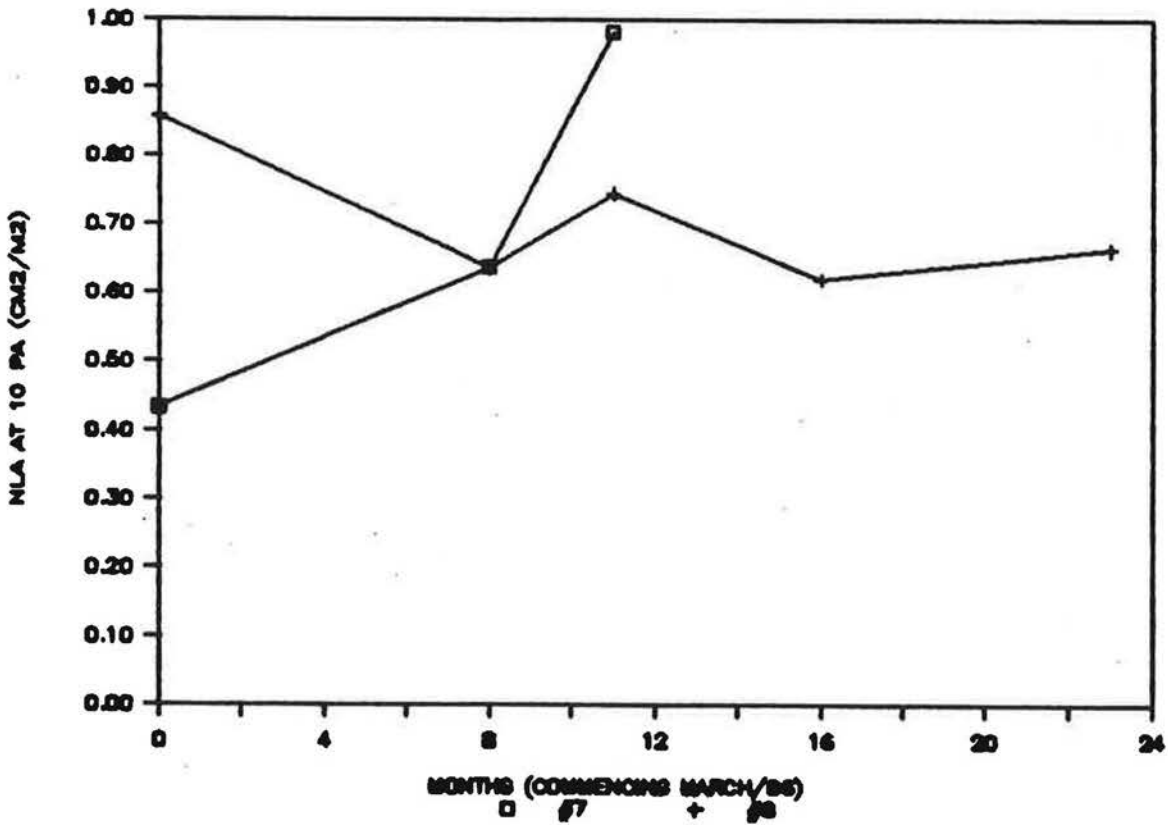
FIGURE 5

a) AIR CHANGES PER HOUR AT 50 PASCALS

b) NORMALIZED LEAKAGE AREA AT 10 PASCALS
HOUSES #7 AND #8 (MARCH/86 TO FEBRUARY/88)

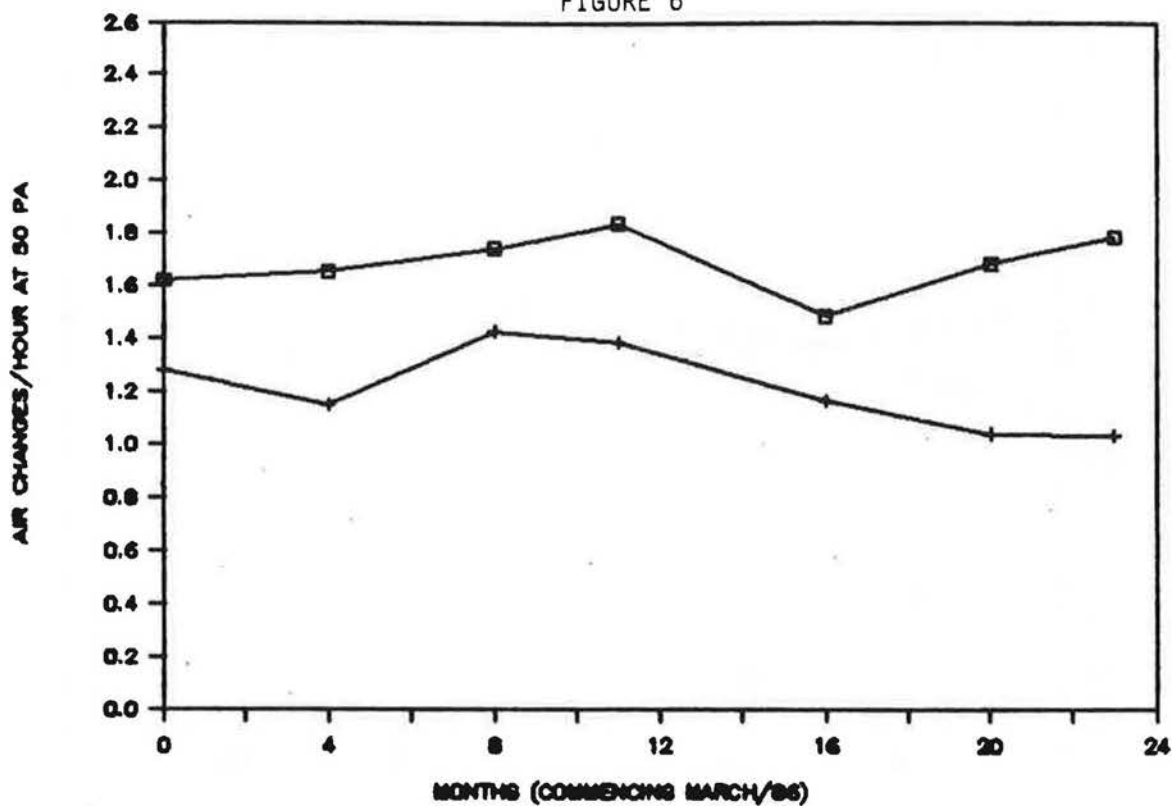
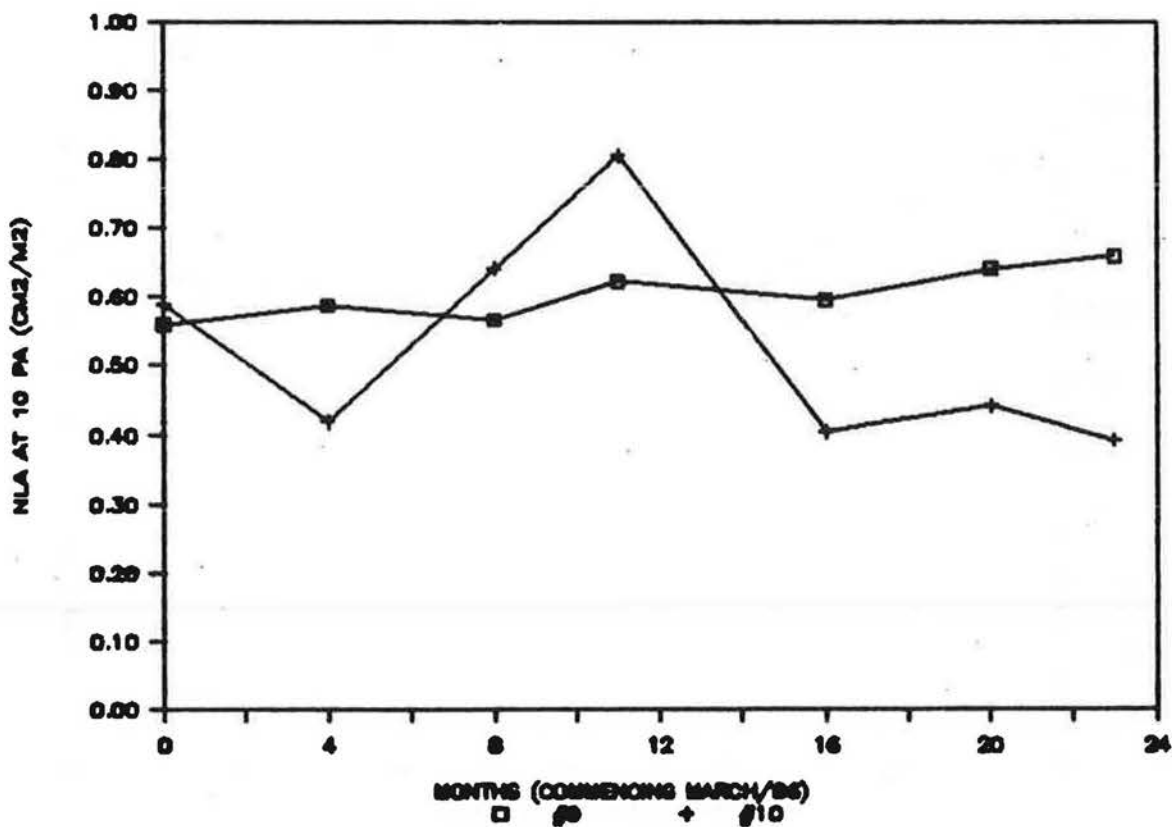
FIGURE 6

As expected, these were the leakiest structures in the project, as Fig. 6 indicates. Although not designed to the R-2000 Standard, both initially met the airtightness requirement using the NLA_{10} parameter. This can likely be attributed to the builder's previous experience with energy-efficient construction and the use of stucco and the cast-in-place floor system which minimizes leakage at the critical wall/floor/foundation intersection.

a) AIR CHANGES PER HOUR AT 50 PASCALS

b) NORMALIZED LEAKAGE AREA AT 10 PASCALS
 HOUSES #9 AND #10 (MARCH/86 TO FEBRUARY/88)

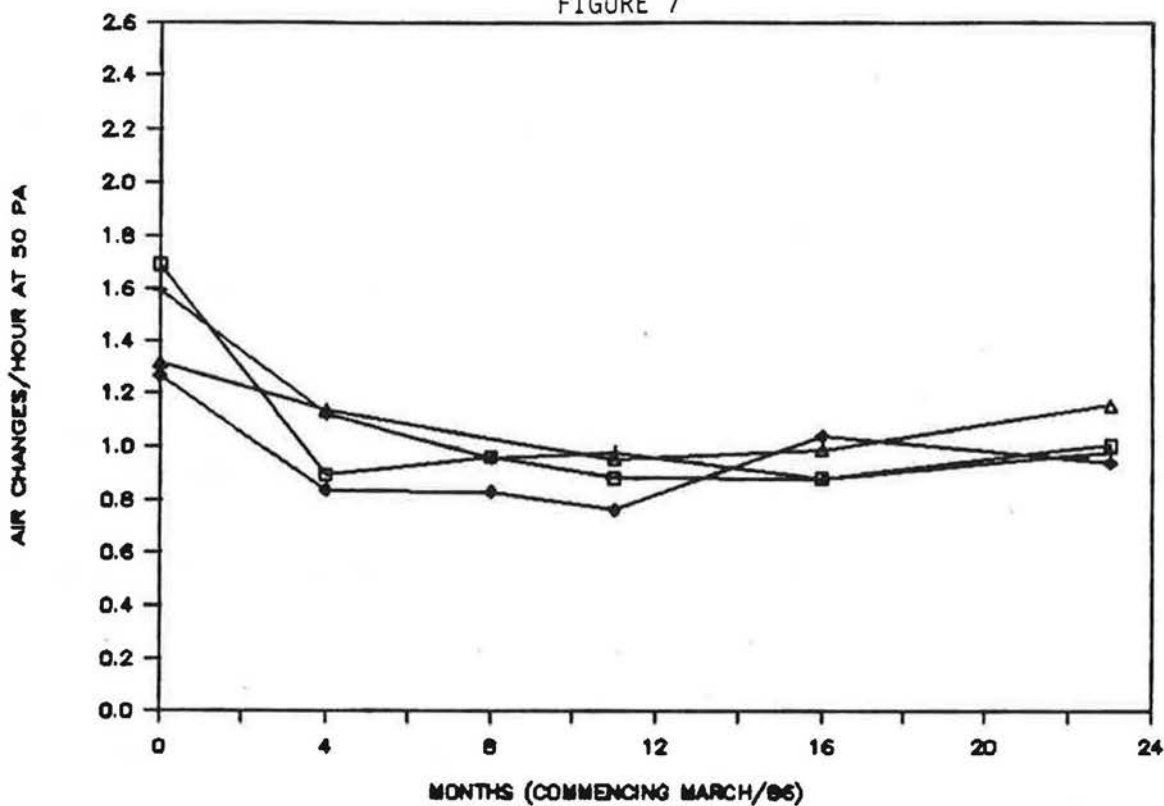
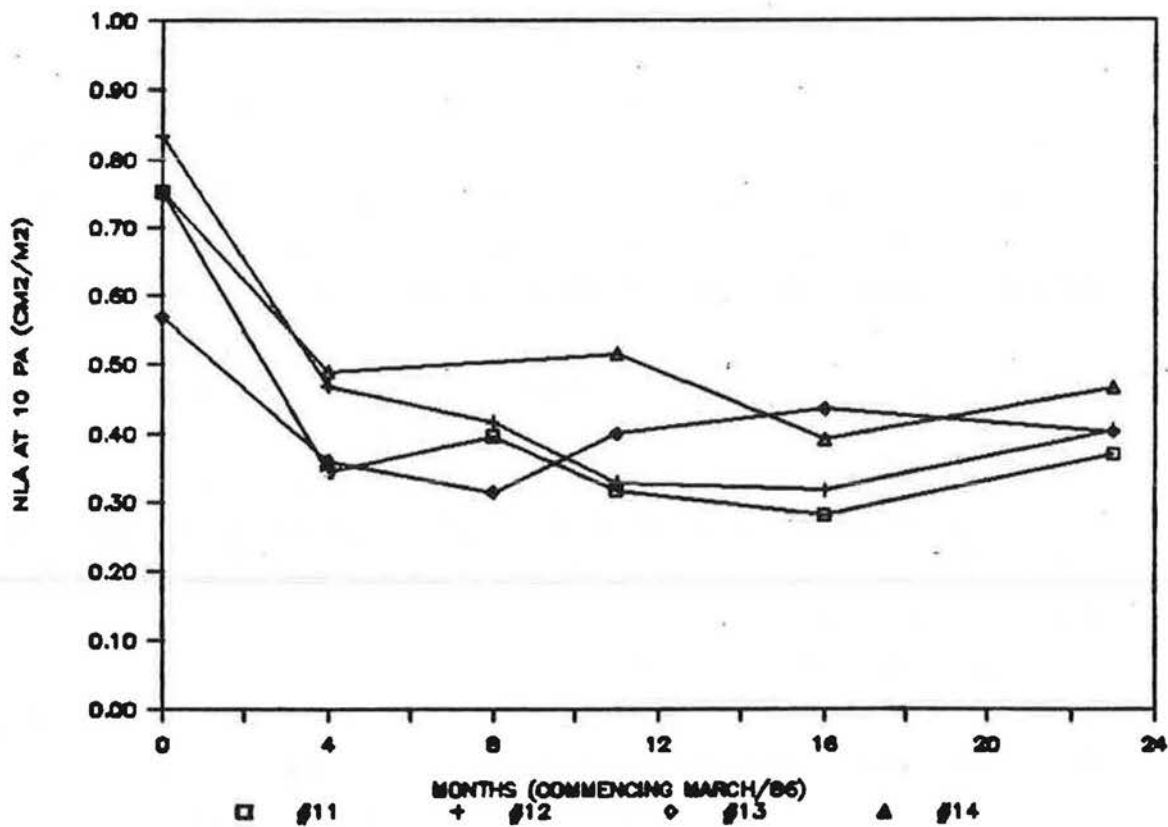
FIGURE 7

interior framing and insulation for the walls and no sub-slab insulation. The stucco was applied between the first and second tests on all four houses. The airtightness results are plotted in Fig. 7.

Stucco was observed to have a significant impact on airtightness, producing an average reduction of 31% in ac/hr_{50} and 43% in NLA_{10} . Following application of the stucco, the airtightness remained constant with no indication of significant degradation or improvement. The two different methods of insulating the basement do not appear to have had a major impact on performance.

a) AIR CHANGES PER HOUR AT 50 PASCALS

b) NORMALIZED LEAKAGE AREA AT 10 PASCALS
 HOUSES #11 TO #14 (MARCH/86 TO FEBRUARY/88)

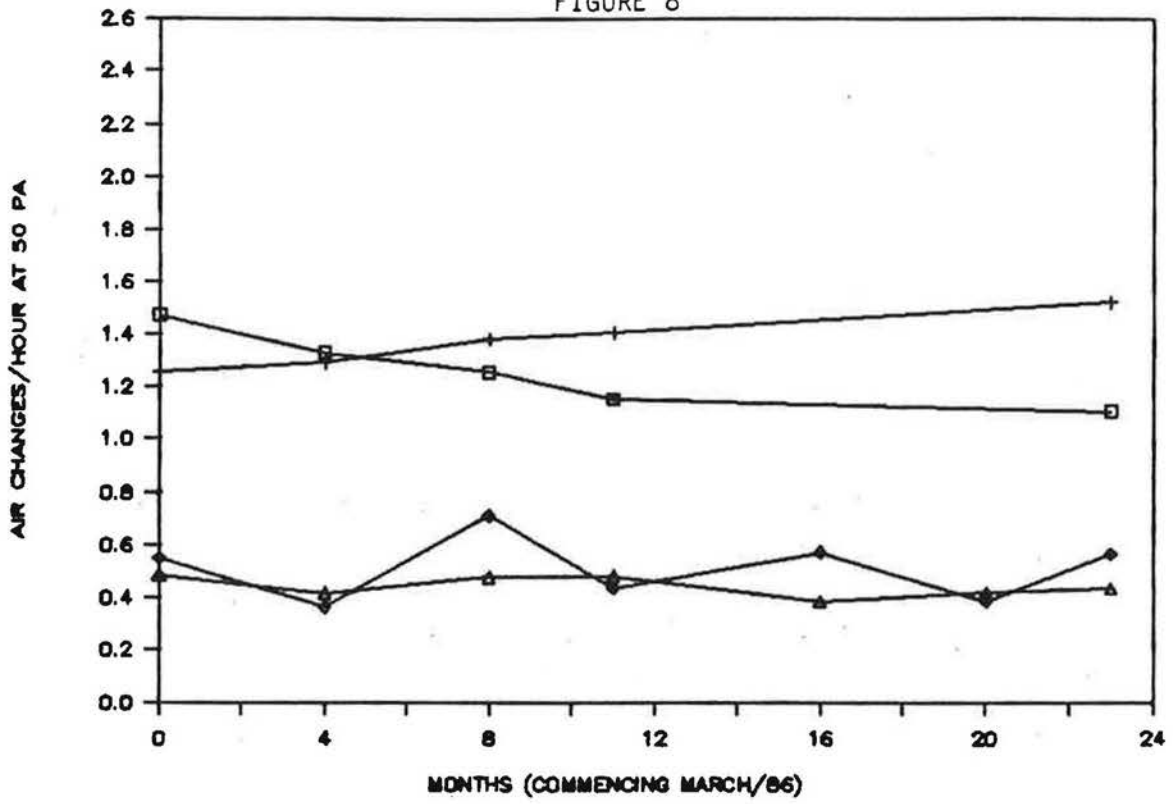
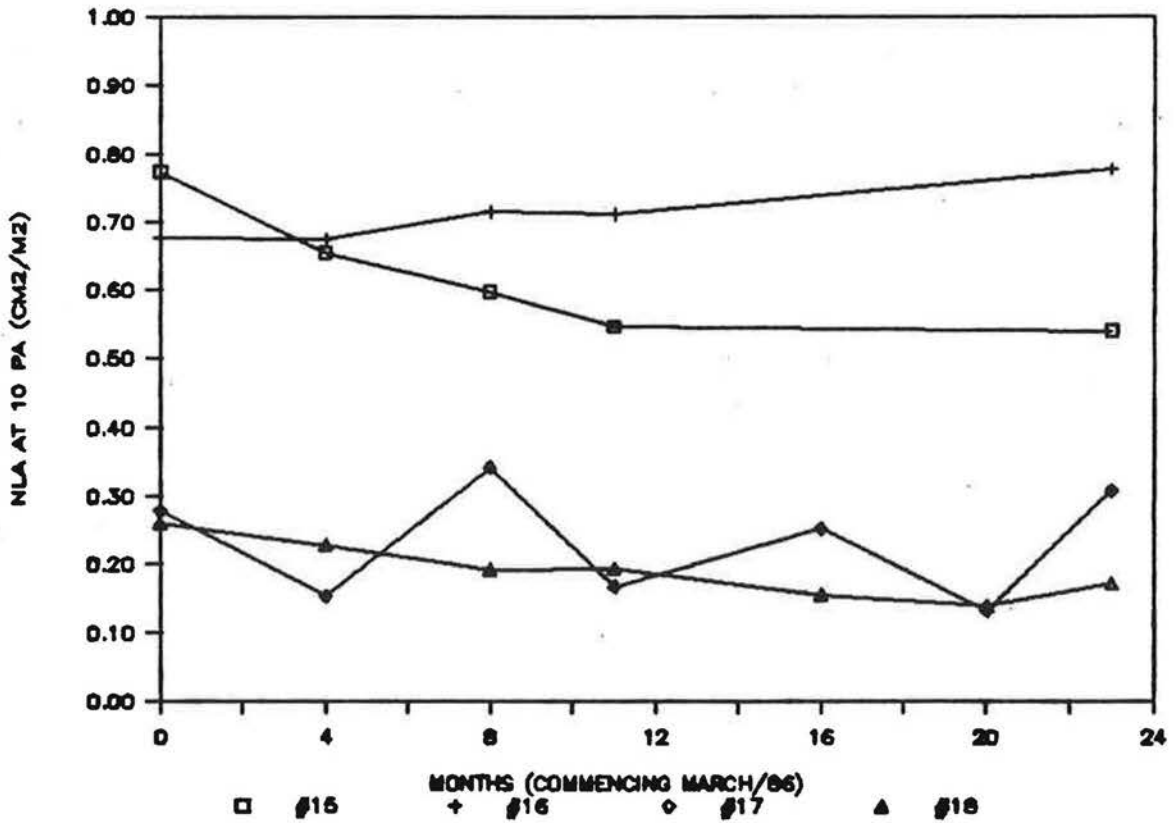
FIGURE 8

The airtightness results, plotted in Fig. 8 are quite interesting. Despite identical construction of the envelopes, Houses #15 and #16 were consistently leakier during all tests. Examination revealed significant air leakage through the (outdoor air) ductwork of the mechanical system as well as the unit itself. In particular, leakage was noted at the filter housings and vibration isolators.

Houses #17 and #18 were the tightest in the project, with measured airtightness values approximately one third of the maximum permitted by the R-2000 Standard. There was no evidence of significant change in airtightness during the monitoring period. The application of stucco had no apparent effect on the airtightness.

a) AIR CHANGES PER HOUR AT 50 PASCALS

b) NORMALIZED LEAKAGE AREA AT 10 PASCALS
 HOUSES #15 TO #18 (MARCH/86 TO FEBRUARY/88)

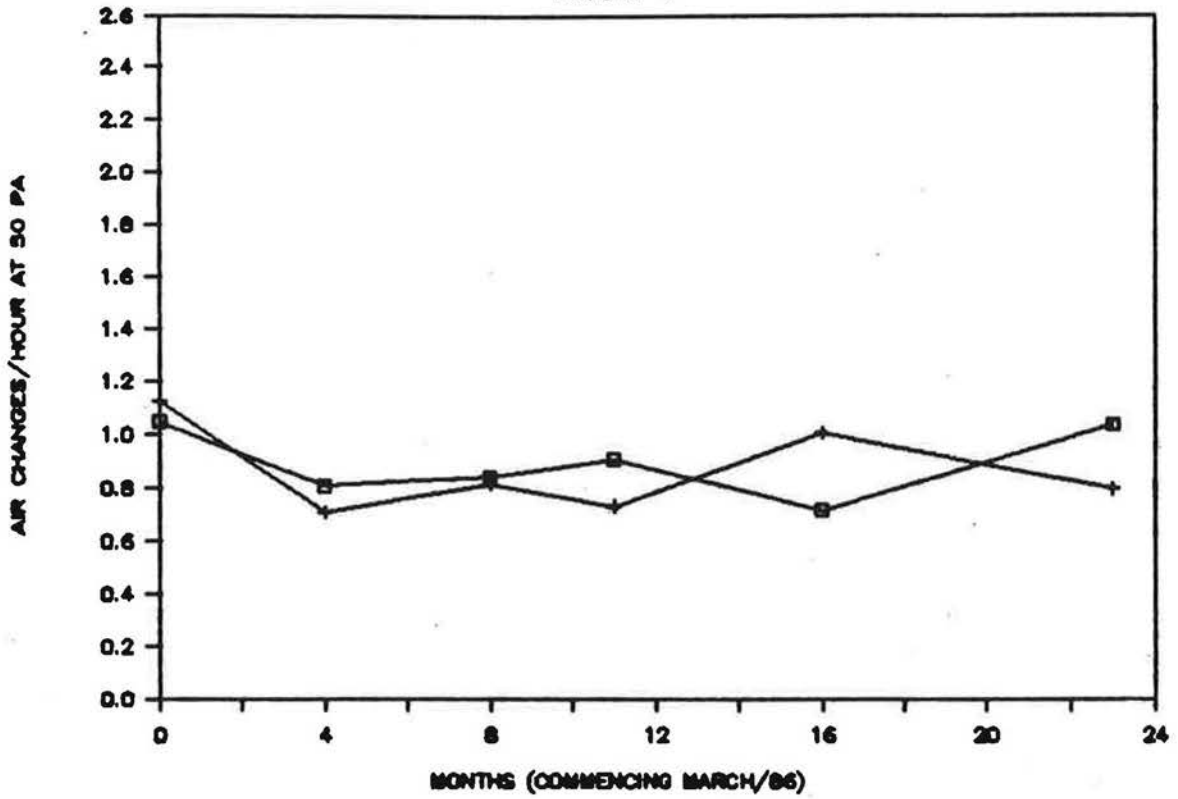
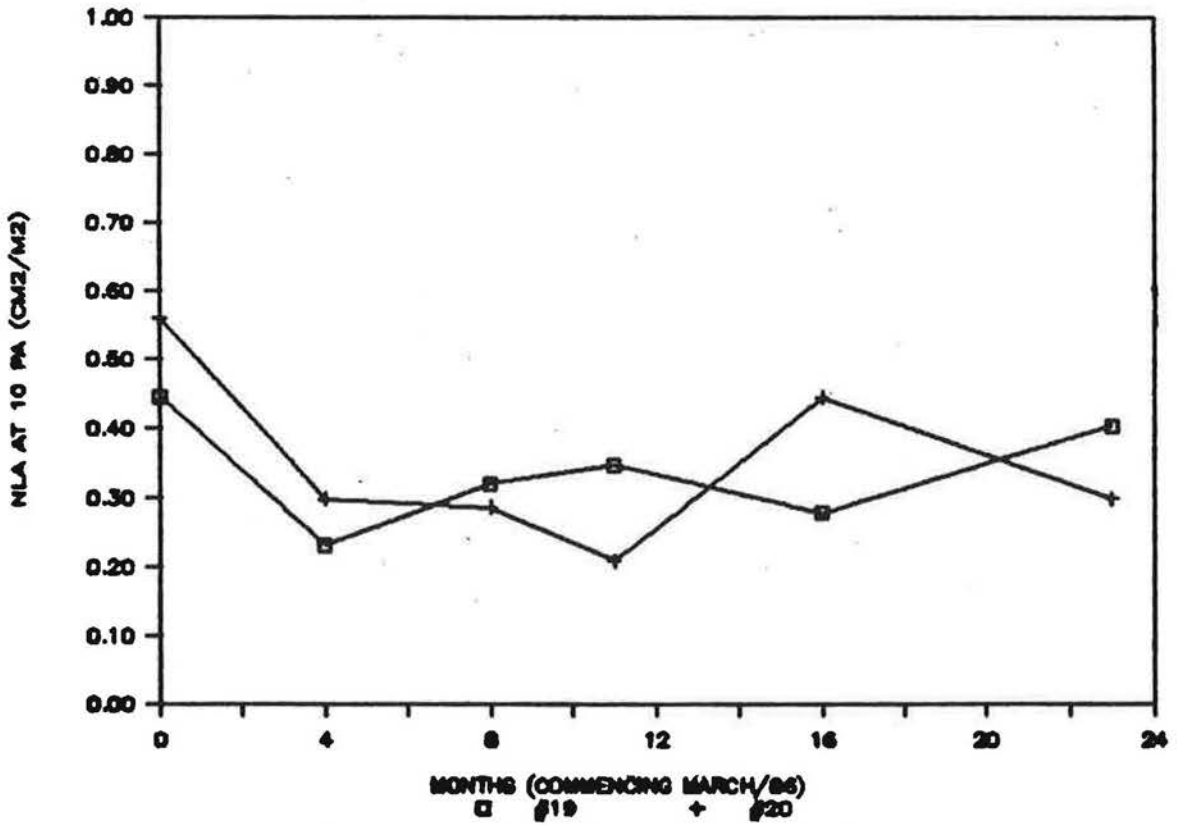
FIGURE 9

As shown in Fig. 9, these houses performed in a manner similar to Houses #11 and #14 with initial (pre-stucco) airtightness levels below the R-2000 Standard and with a significant improvement attributable to the application of the stucco. Measured levels were relatively stable after this point. The fibreboard sheathing used on House #20 does not appear to have had an impact on the airtightness.

a) AIR CHANGES PER HOUR AT 50 PASCALS

b) NORMALIZED LEAKAGE AREA AT 10 PASCALS
 HOUSES #19 AND #20 (MARCH/86 TO FEBRUARY/88)

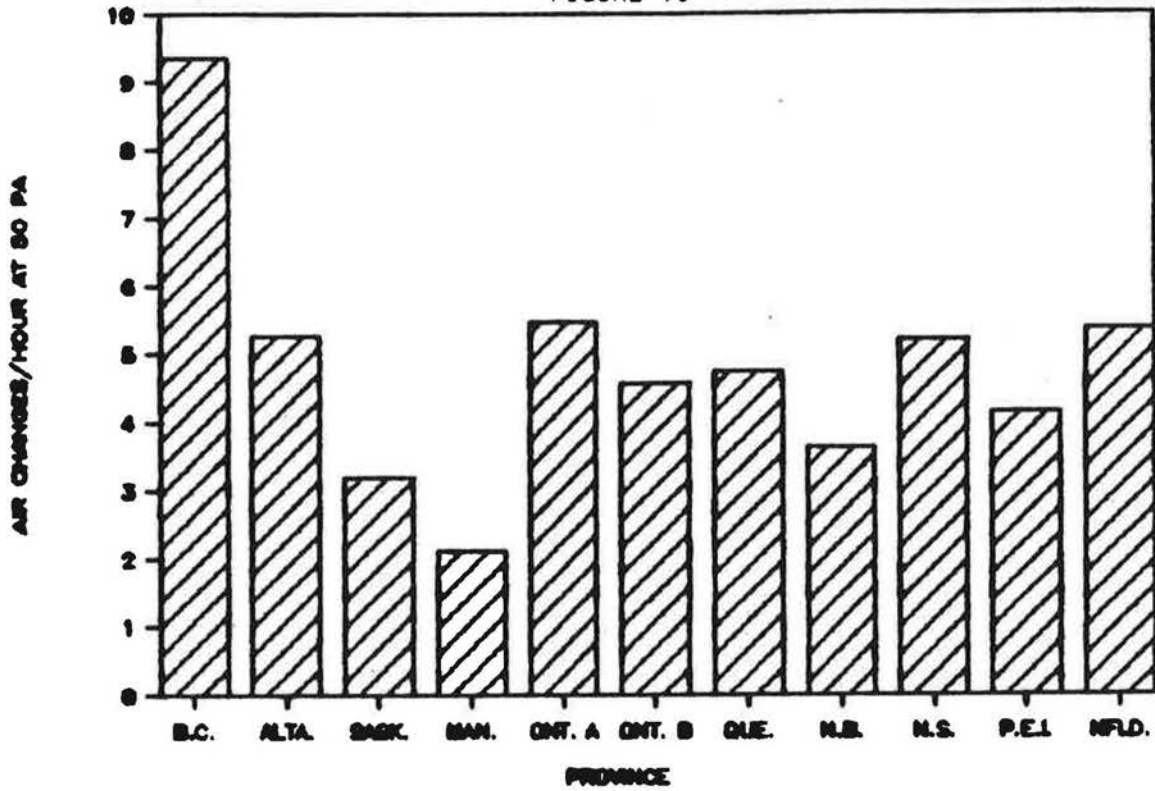
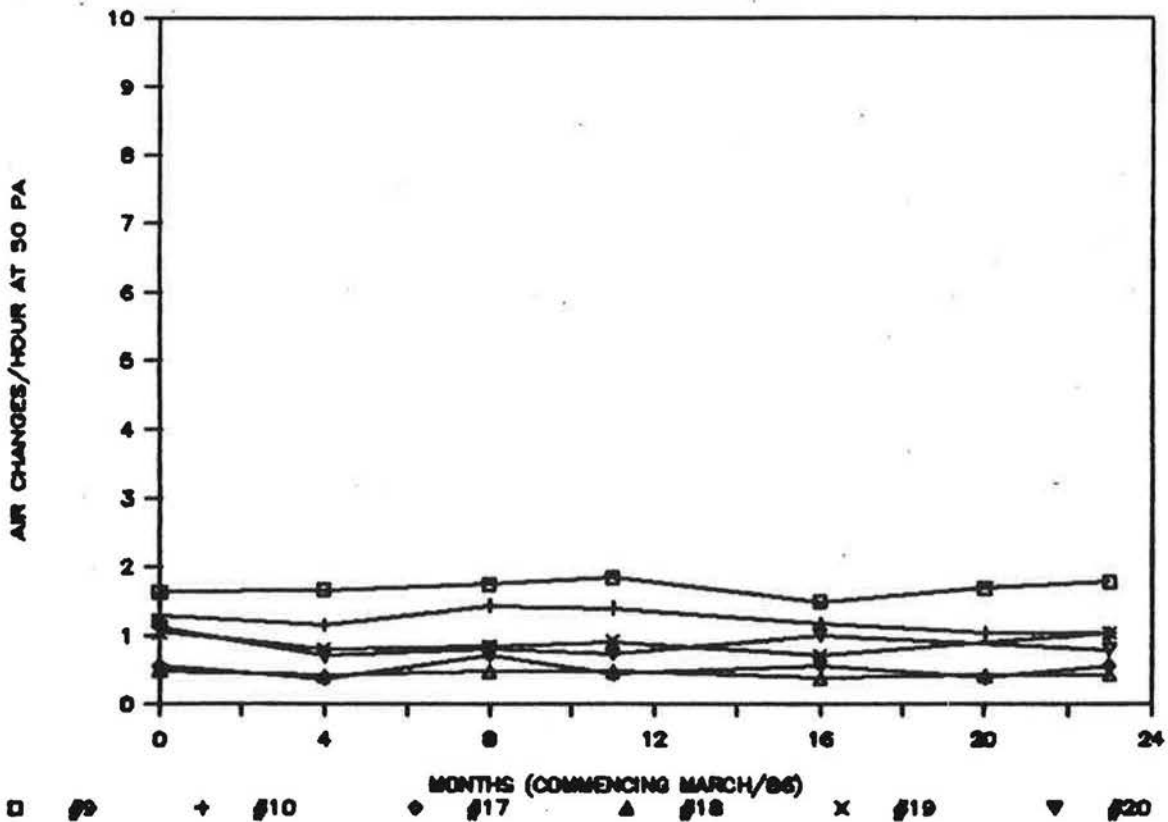
FIGURE 10

a) CONVENTIONAL NEW HOUSES, BUILT 1980 TO 1982
(FROM REF. 12)

b) SAMPLE OF PROJECT HOUSES
AIRTIGHTNESS VARIATIONS AMONG CONVENTIONAL NEW HOUSES
AND SAMPLE OF PROJECT HOUSES

and #20 are also shown using the same scale instead of the 0 to 2.6 ac/hr₅₀ scale used in Figs. 4 to 9. When viewed in this manner, the variation in airtightness of the project houses appears very slight.
