Cellulose Insulation (3)

Blown-in batt approach (2)

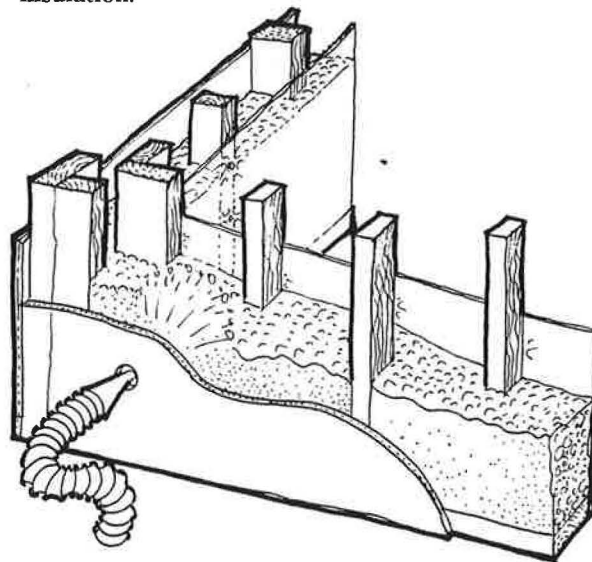
The walls are a staggered stud arrangement. The 2"x4" outer studs and 2"x3" inner studs, each on 2 foot centres are attached to common top and bottom 2"x6". This staggered stud arrangement reduces thermal bridging through the wall and allows the insulation to flow around the studs during the filling operation. The corner detail also provides a free path for insulation flow and limits thermal bridges.

The outer surface of the wall is sheathed primarily with fibreboard. The inner surface of the cavity is a 6 mil polyethylene air vapour barrier attached to the studs by 2"x2" horizontal strapping on 16" centres. The joints in the polyethylene are overlapped, sealed with acoustical caulking and clamped with blocking. The inner surface is unsheathed for the insulating operation to allow the inspection of the insulation through the transparent vapour barrier.
