# WALL INSULATION

## Measured R-values in arctic conditions

Summary of: "In situ testing of the thermal performance of wall sections in NWT" by G.K. Yuill & Assoc. for CMHC.

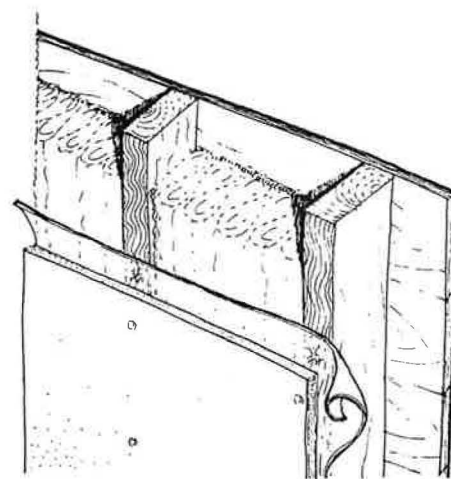
Fig. 1  
1/2" gypsum board; poly u.b.; R20 batt insulation; 2x6 studs @24"; cedar siding

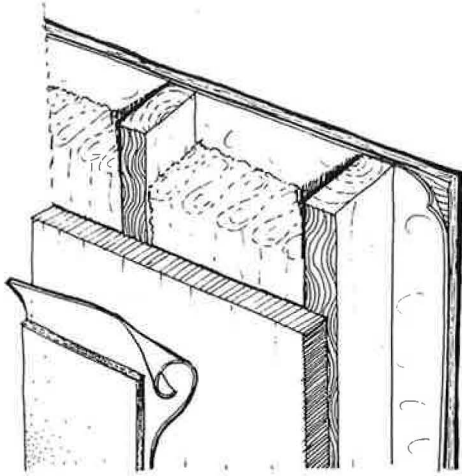
Fig. 2  
1/2" gypsum board; poly v.b.; 1" rigid insulation; R20 batt insulation; 2x6@24"; air barrier; 5/8" plywood siding

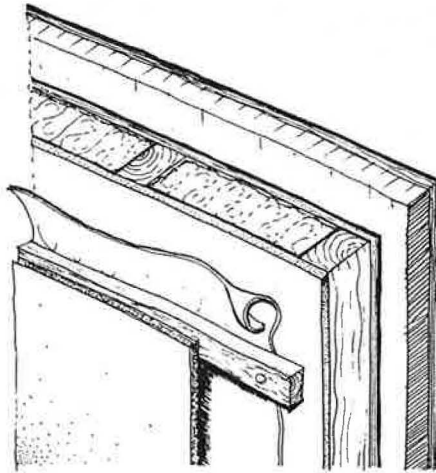
The measured effective R-value of the wall section in House No. 3 was found to be 42% lower than the calculated theoretical value. The infrared thermography scan did not indicate signs of moisture damage. However, there was an air space behind the gypsum board wall to which the test equipment was attached. Cold spots that were close but not immediately behind the metered area may have provided a route for heat to escape from the adjoining air space by convection currents in the void.

Fig. 3  
gypsum board on 1x3@ 16"; 6 mil poly v.b. on existing wall plus 2x2 vertical @4'0" with 1 1/2" glassclad and plywood siding

The oldest house tested was built in 1976 and retrofitted in 1986. It was the only house where the insulating value tested was lower than the theoretical value. What the cause for this reduction of R-value were not

identified in this project. However, as there was an air space in the well, it may be the convection currents were established in the cavity and worked to speed heat transmission through the wall.

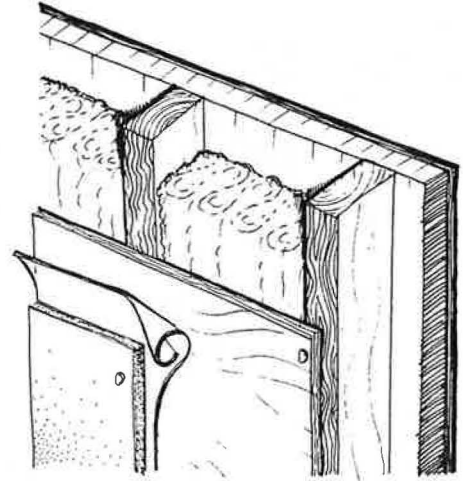
Fig 4  
1/2" gypsum board; 6 mil poly v.b.; 3/8" plywood; R20 batt insulation; 2x6@24"; 1 1/2" glassclad; plywood siding
