Radon mitigation in schools

Case studies of radon mitigation systems installed by EPA in four Maryland schools are presented

By David Saum, A.B. Craig and Kelly Leovic

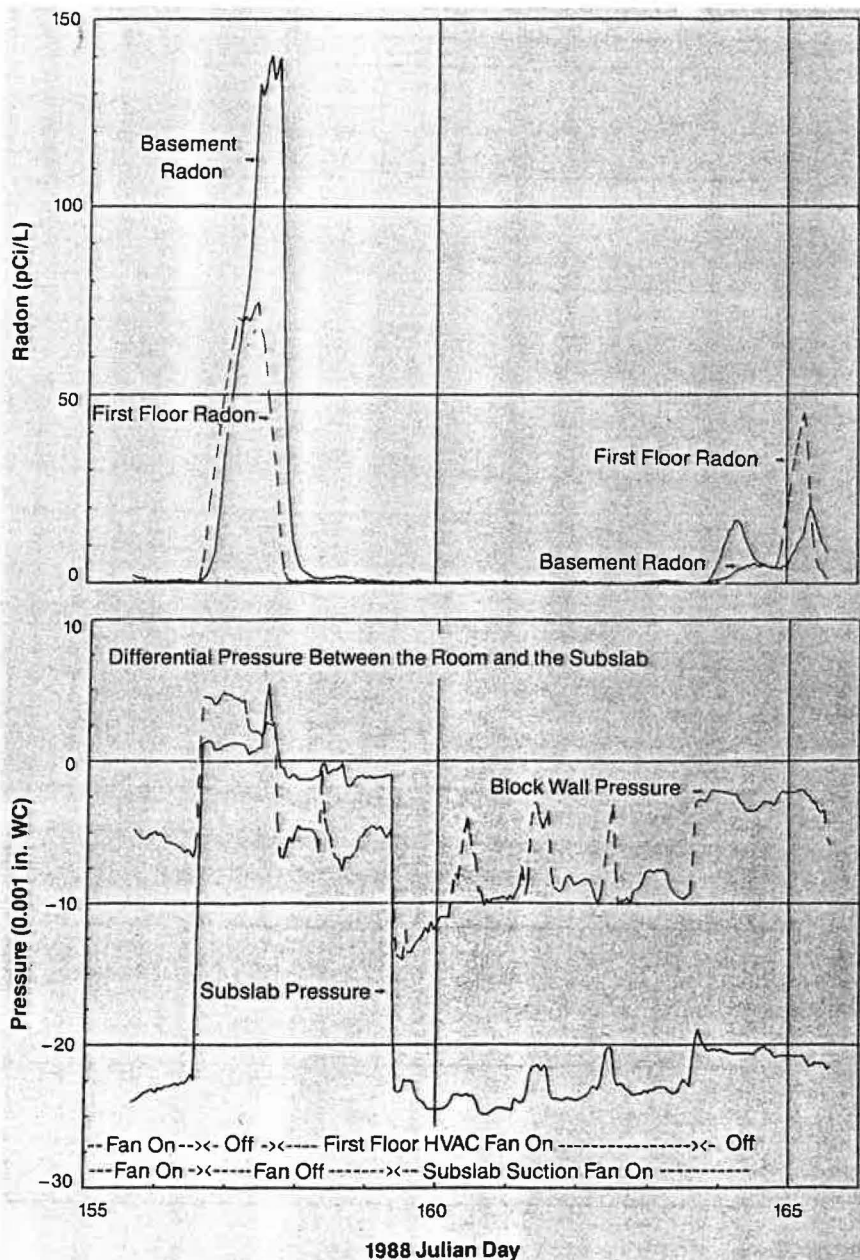
Figure 2. Radon and pressure measurements over a 10-day period in Case Study B.

Over the weekend (day 156), the HVAC system and the single-point sub-slab suction system on the first floor were turned off, and the radon levels rose quickly to more than 70 pCi/L on the first floor and 140 pCi/L in the basement.

On day 157, the subslab suction system remained off, but the first-floor HVAC system was turned on. Radon levels on both floors dropped and the differential pressure under the slab and within the block wall became slightly negative relative to the room. On days 158-163, both the HVAC system and sub-slab suction system were operating and radon levels remained low.

On days 164 and 165, the subslab suction system was operated and the first-floor HVAC system was off. This increased first-floor radon levels to 40 pCi/L, indicating that one suction point was not adequate if the HVAC system was not operating.

To ensure acceptable radon levels on the first floor while the HVAC system was not in operation, another suction point with a 3-ft-diameter suction pit was installed on the first floor. Addition of this suction point reduced levels on the first floor, although radon levels on both floors still rose above 10 pCi/L at night with the HVAC system off.
