EFFECT OF BUILDING AIRFLOW ON REENTRY AND IAQ

D.R. Bahnfleth, P.E. F.A. Govan, P.E.

ABSTRACT

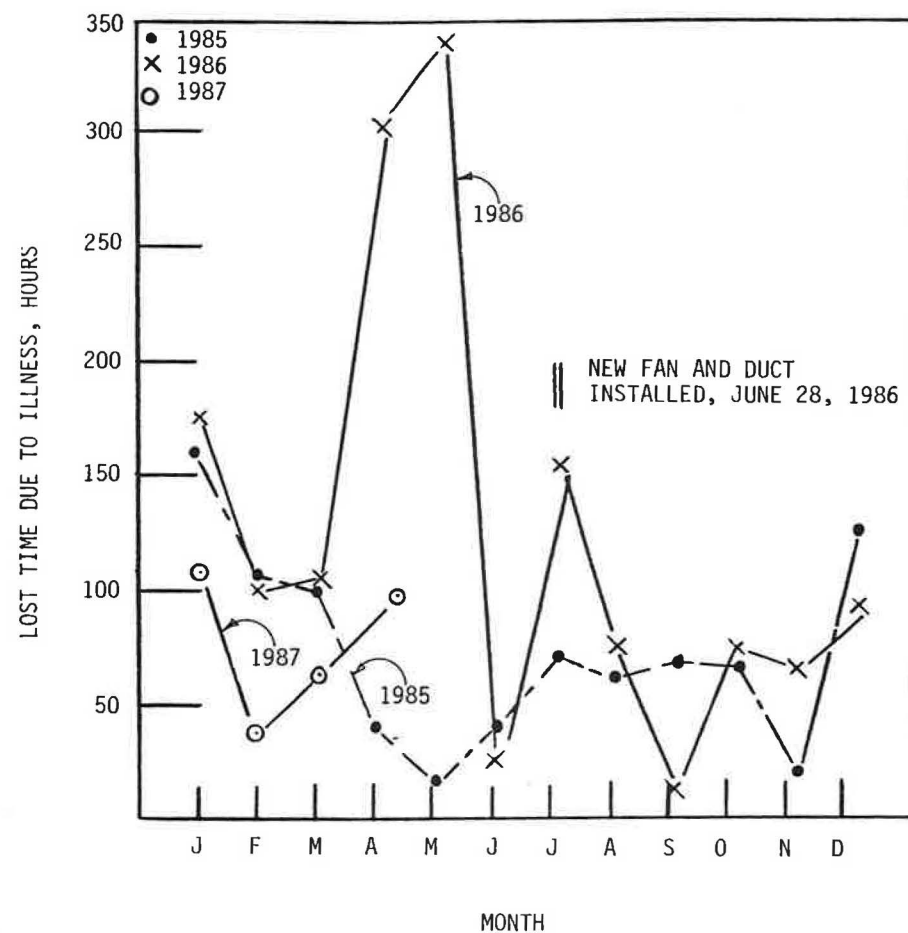
Comparison of lost time for the first eight months of the year during the year before and the year after installation of the grill exhaust showed lost time of 543 manhours before and 1271 manhours after, respectively. Value of the lost time was estimated to be approximately \$32,000. Losses of productivity among those who remained on the job could not be measured but lost time was evident.

The manhours lost each month for reasons of illness during 1985, 1986 and to date in 1987 are plotted in Figure 2. Annual trends are similar for the three years with the exception of the spring and early summer of 1986. During this time, the wall-mounted mushroom fan discharged grill exhaust into the secondary street. Lost time during the period between installation of the mushroom fan and its replacement with a centrifugal blower and vertical discharge duct was about 730 hours with a market value of about \$32,000.

Figure 2. Sick time reported monthly 1985, 1986, and 1987 to date

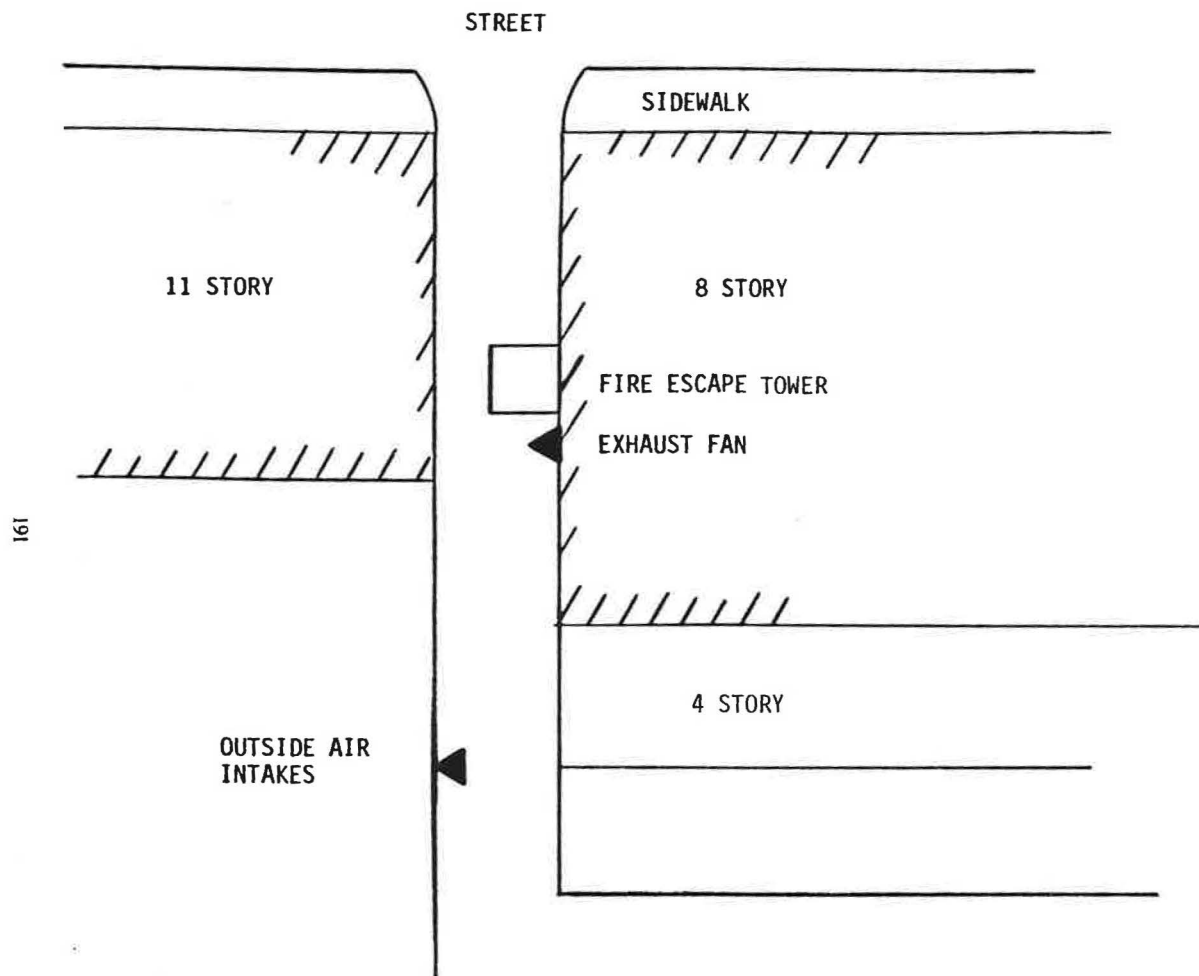
The locations of the exhaust fan discharge and the outside air intake are shown in Figure 3 and a photo of the fan is shown in Figure 4. Both are at the same elevation and the horizontal separation is approximately 45 feet. The hoped for dilution which is expected to occur between exhaust discharge and outdoor air intake did not occur. Designs based upon such assumptions frequently fail because the mixing and dilution do not occur.

Figure 3. Part plan showing location of exhaust fan and outdoor air intake

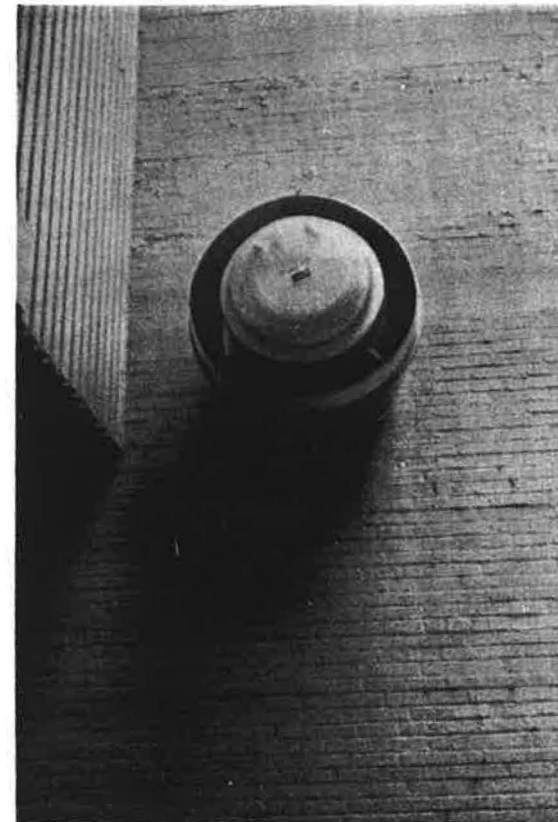
Figure 4. Wall mounted mushroom fan exhausting short order restaurant frying grille

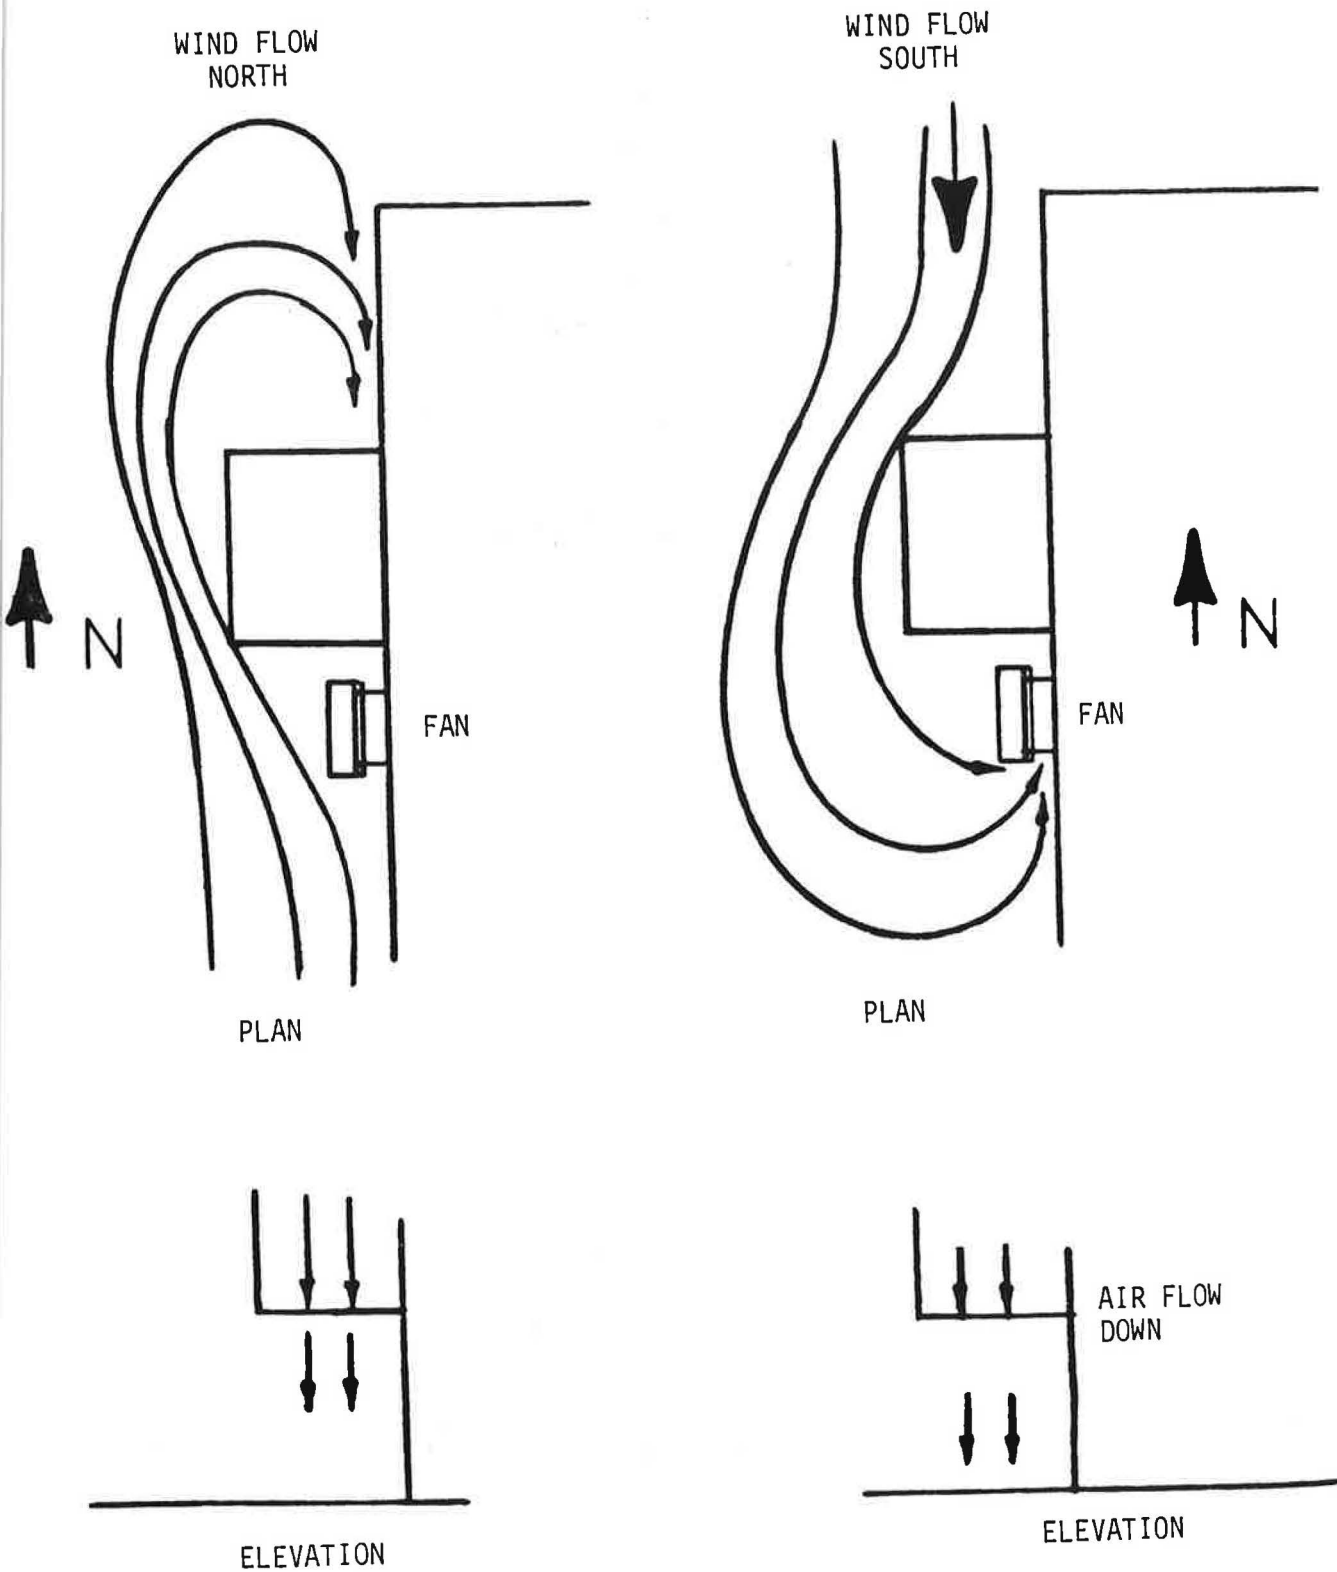
In this particular case, airflow down the building housing the grill drove the fumes down into the secondary street under many wind conditions. The downflow was enhanced by the fire escape enclosure adjacent to and north along the west wall from the fan. Wind could not flow freely in either the northerly or southerly direction because of the obstruction shown in Figure 5. In either case, the exhaust would be contained in the flow cavity and tend to be driven down to the street. For those unfamiliar with how air flows over buildings, Chapter 14 of the ASHRAE Handbook -- 1985 Fundamentals, will provide many useful insights and understanding of this too often ignored source of building reentry and contamination problems.

Figure 5. Effect of fire escape enclosure on wind flow and movement of exhaust fan discharge air

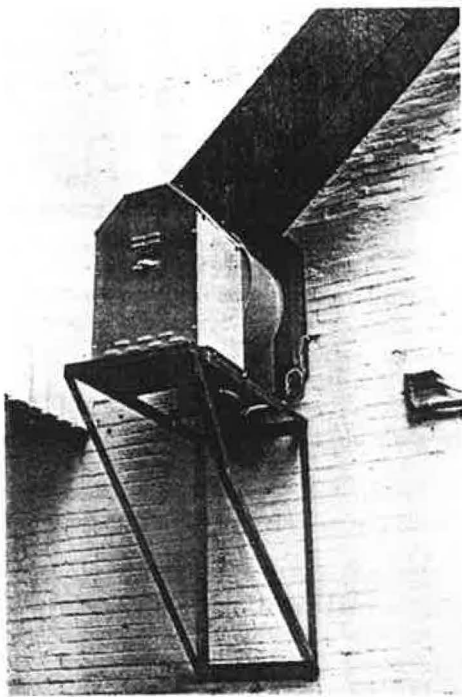
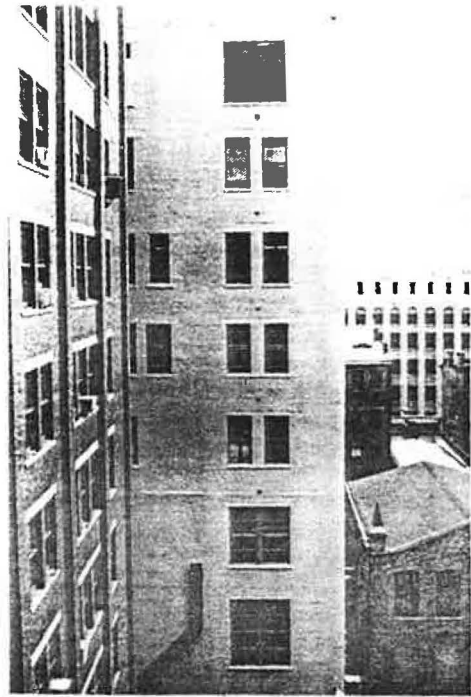
Subsequently, some reentry was experienced even though the duct discharge was vertical. It is of interest to note that on one day in which grease fumes were very heavy, the jet followed classical expansion theory and extended to the top of the building. A window on the top floor was open, however, and the jet turned and entered the building.

Figure 6. Centrifugal fan (left) and ductwork installed to minimize contamination of outdoor air intake

When action finally was taken in June 1986 to correct the exhaust discharge, a centrifugal fan and a short length of ductwork was installed. The fan and duct installation are shown in Figure 6. This first attempt to get the exhaust fumes up and away from street level was moderately successful. Note in Figure 2 that absenteeism dropped subsequently to "normal" levels. It was unclear, initially, whether the reduction occurred because less outdoor air was being taken into the office, because dilution was occurring before the fumes got down to street level, if indeed they did, or because absenteeism under any condition is lower during summer.

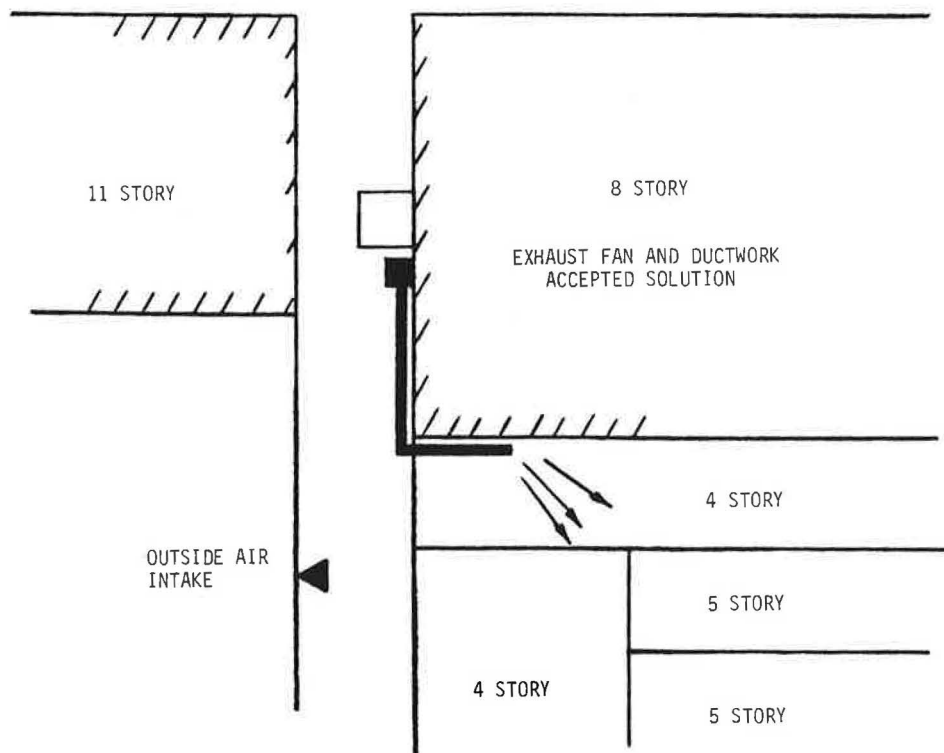
Figure 7. Part plan showing final duct arrangement for exhaust system

Because of concern for outdoor air intake volumes during economy cycle operation and the now and then entry of odors, the complete solution was requested. As noted in August 14, 1986 through February 26, 1987, this caused further action and solution discussions. The next step in the evolutionary solution was to extend the ductwork to the south side of the building with a discharge directing the exhaust plume to the southeast as shown in Figure 7. Horizontal discharge was accepted after the city officials expressed concern for reentry into the building in which the restaurant is located if the fumes were discharged vertically.

To date the installation is not complete, but it is expected that the final additions will solve the IAQ problem.
