Corrosion of heat recovery exchangers in swimming pool hall ventilation systems

T L BIRD BA

Electricity Council Research Centre, Capenhurst, Chester CH1 6ES, UK

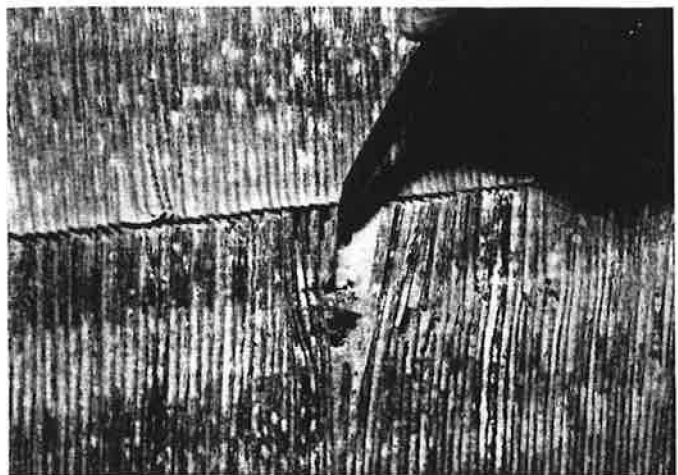
At the three ozone-sterilised pools investigated, the pool hall air is recirculated, and the heat recovery exchangers thus act as dehumidifier coils. They had suffered differing amounts of dissimilar metal corrosion: serious at O₃-1, moderate at O₃-2, slight at O₃-3. At pool O₃-1 after 2 years of operation, the aluminium fins were severely corroded in the regions close to the copper tubes on the air-impact side. This corrosion had become pronounced at an early stage. After just one year, the collars were covered by a layer of corrosion product, while a year later some of the fins had become separated from the tubes (Figure 1). In contrast, the fin material remote from the tubes was in good condition. The corrosion product on the collars was predominantly hydrated Al_2O_3 , with only small quantities of other materials; in particular it contained only a trace of chloride. On the other face of the exchanger, the air-exit side, there were merely the initial signs of attack even after 2 years, with a milky-coloured liquid exuding from the collars. At pool O₃-2 the fins had also suffered from dissimilar metal corrosion, but less than at pool O₃-1. For instance, the collars on the air-impact side took 4 years to become encrusted with corrosion product, while the air-exit side remained free from attack. At pool O₃-3, the dissimilar metal corrosion was very slight; on the air-impact side, the aluminium fins showed only the initial signs of dissimilar metal corrosion in the collar region some 4 years after commissioning.

Figure 1 Bimetallic corrosion on the two-year-old dehumidifier coil at pool O₃-1

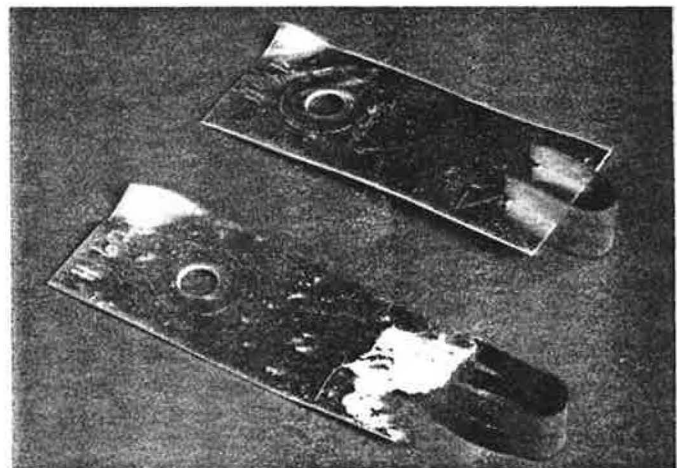
Serious corrosion of aluminium components in bimetallic aluminium-to-copper test assemblies occurred at both ozone and chlorine pools. In the worst instances, corrosion perforated the 0.25 mm thick aluminium coupon in the region of contact with the copper fixture within six months. The intensity of attack reflected the aggressiveness of the environment as indicated by the copper coupon corrosion rates. However, even the mildest conditions gave serious attack. For instance, at pool C1-4 there was considerable dissimilar metal corrosion after one year's exposure. The test coupons also indicated that the contamination of the air-impact face at pool O₃-1 had hastened bimetallic corrosion. Figure 2 shows that the coupons which became contaminated were more heavily corroded than those which remained clear: the latter were placed on test after the air filter had been fitted in front of the exchanger to eliminate contamination.

Figure 2 Dissimilar metal corrosion suffered by test sample which had become contaminated during 5 months' exposure at pool O₃-1. The other sample was tested for the same length of time after an anti-fouling filter had been fitted.

At some sites the exchanger can become deleteriously contaminated if the air from the pool hall is not filtered. A disposable glass-fibre filter in front of the exchanger is effective in preventing fouling.
