REDUCING THE MOISTURE CONTENT IN A CONCRETE PREFAE CONSTRUCTION HELPS TO IMPROVE REPORTED SENSORY-IRRITATION SYMPTOMS

Edvard Liden
Göran Stridh
Department of Occupational Medicine
Örebro Medical Center Hospital
S-701 85 ÖREBRO
SWEDEN

In a health care center erected in 1981 several sensory-irritation symptoms were reported. A combined medical and technical step-by-step investigation indicated technical shortcomings in the building. With the use of self-administrated questionnaires before during and after release technical alternative and after release technical actions are released to the released technical actions ar questionnaires before, during and after relevant technical alterations, an obvious reduction of the building related symptoms were documented. The results from chemical and moisture measurements will be presented and discussed.

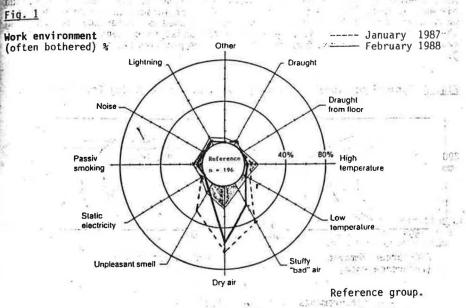
In <u>figure 1</u> there is a clear reduction of complaints concerning the work environment between January 1987 and February 1988. As illustrated by <u>figure 2</u> an obvious reduction of the symptoms related to the indoor climate was achieved. This is true in particular for sensory-irriation

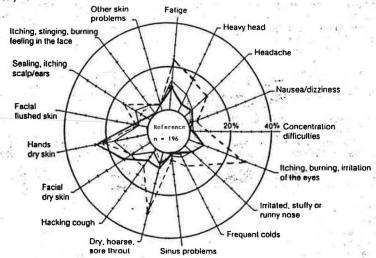
Fig. 2

symptoms and general symptoms. In fact the symptoms are reduced to a level close to or better than the reference group. The small increase in skin symptoms is probably due to an unusual cold winter 1988 (-25°C).

The shaded area represents complaints . as reported from n=196 persons in healthy buildings.

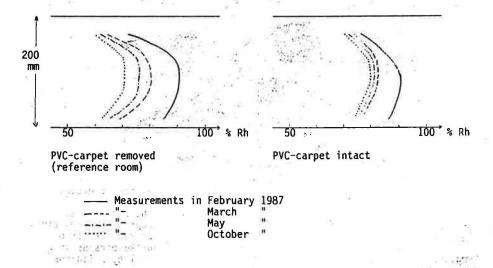
As a premier attempt to reduce the moisture content of the slab, dried heated air was flushed under the slab. The floor was kept intact. In one room, however, we removed parts of the PVC-carpet. This room was used as a reference when studying the moisture reduction rate. We studied the moisture content by intermittent measurements over approx. 9 months. The moisture profiles are presented in <a href="figure3">figure3</a>.

Fig. 3 Typical moisture profiles in the slab. Active drying from below.

The left-hand drawings represents the moisture conditions when the carpet is removed and the right-hand when the floor covering (PVC-carpet) is kept on. It is obvious from the figure that it is impossible, in reasonable time, to dry the slab with heated dry air from below. It can also be seen that the drying from both upper and under sides gives a good result.

Thus the PVC-carpet was removed and the slab was dried from the upper side by using active dehumidifiers in each room. The self-levelling screed is sensitive to high moisture contents and higher values than 75 % Rh leads to ammonia emission.

The time needed to reach 70 % from the initial 90 % varies due to the thickness of the slab and to a minor extent to the weather conditions. In the case presented here we reached 70 % within 2-4 weeks. After the successful reduction of moisture and change of PVC-carpets no complaints about bad odour have been reported.
