**REPORT ON ATLANTIC CANADA
WOOD FRAMING MOISTURE SURVEY**

MAY 1989

**PROJECT IMPLEMENTATION DIVISION
CANADA MORTGAGE AND HOUSING CORPORATION**

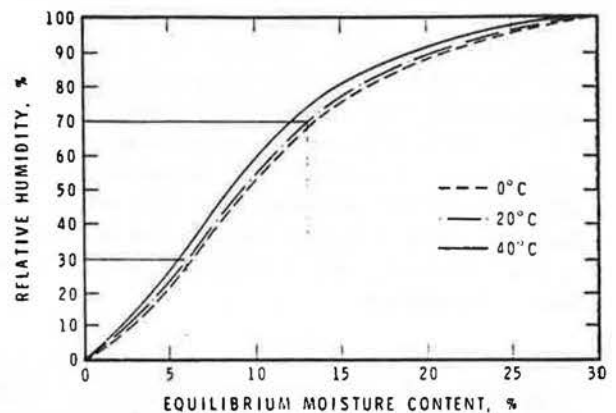
Fig. 1 Moisture content of wood at various relative humidities

The moisture level of the wood will eventually reach equilibrium with that of the surrounding air. This equilibrium moisture level depends principally on the relative humidity of the air. Air temperature has little effect on the equilibrium moisture level over its normal indoor range. Figure 1 shows the equilibrium moisture content of wood at various humidity levels and temperatures.

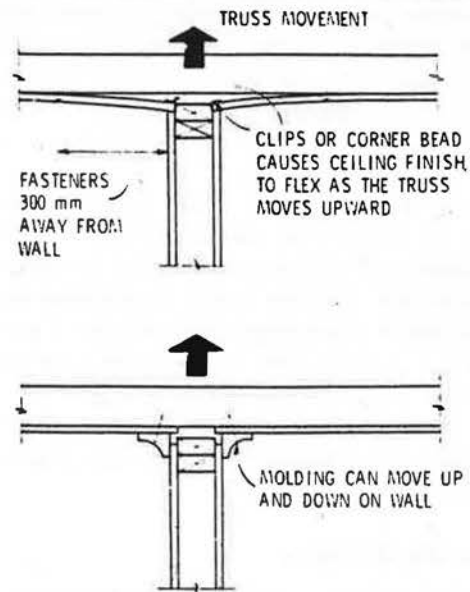
Fig. 2 Masking the effects of upward bowing

Using unseasoned lumber may be a significant factor in truss uplift problems, particularly when the ceiling is installed before the moisture level of the trusses has been reduced to a reasonable level. Tests on roof trusses containing unseasoned juvenile wood have demonstrated that either upward or downward movement can occur as the wood dries, depending on whether the juvenile wood is located in the upper or lower chords.

greater the amount of arching for the same difference in moisture content between the upper and lower chords. The amount of insulation is another factor; the more insulation, the greater the difference in moisture content between the upper and lower chords. Differential shrinkage resulting from the lower moisture content of the partition framing in winter, compared with the exterior wall framing, can also contribute to the separation of the ceiling membrane from the partition.
