HVAC SYSTEM COMPLICATIONS AND CONTROLS FOR
RADON REDUCTION IN SCHOOL BUILDINGS

by: Kelly W. Leovic, D. Bruce Harris, and Timothy M. Dyess
U.S. Environmental Protection Agency
Air and Energy Engineering Research Laboratory
Research Triangle Park, NC 27711

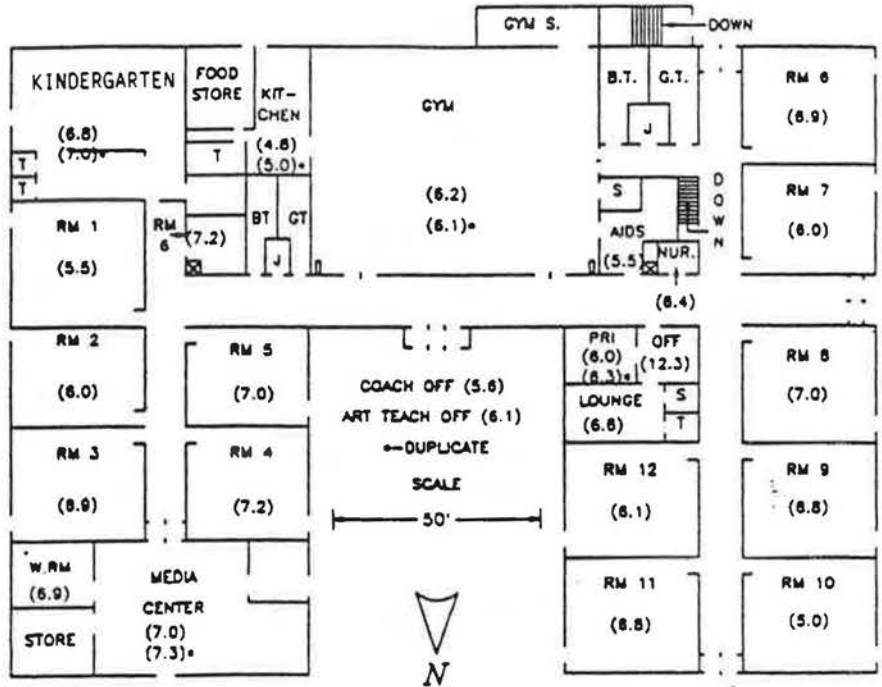
E-Perm measurements made in all classrooms from January 15 to 17, 1990, averaged 6.6 pCi/L with a minimum of 4.8 pCi/L and a maximum of 12.3 pCi/L. Most of the rooms were remeasured during followup tests from February 14 to 16, 1990. These later measurements averaged 7.6 pCi/L with a minimum value of 5.8 pCi/L and a maximum value of 10.2 pCi/L. The results of both sets of measurements are shown on the floorplans in Figures 1 and 2, respectively.

Figure 1. Results of January 1990 radon measurements in Colorado school, pCi/L.

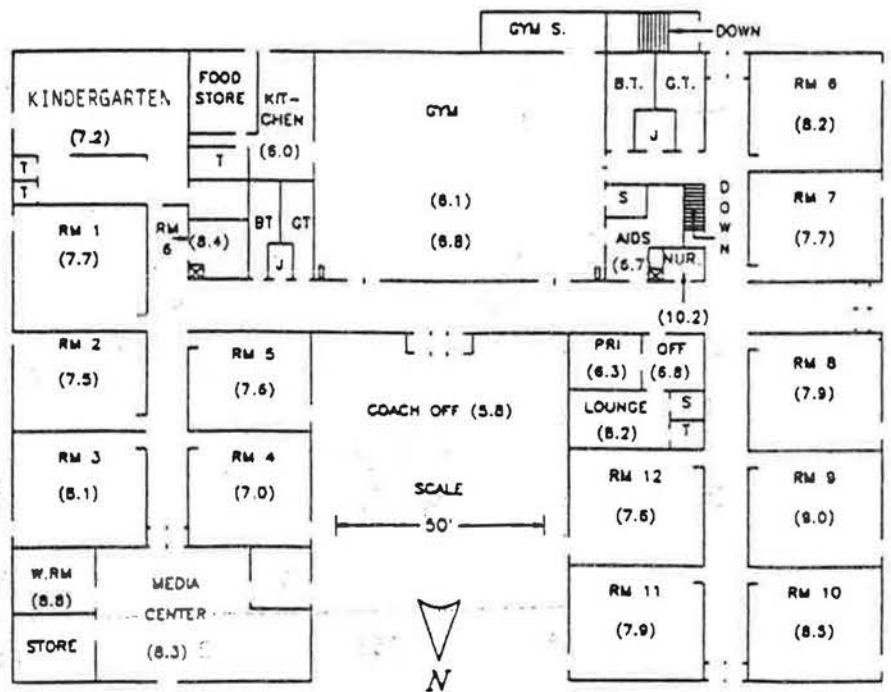
Figure 2. Results of February 1990 radon measurements in Colorado school, pCi/L

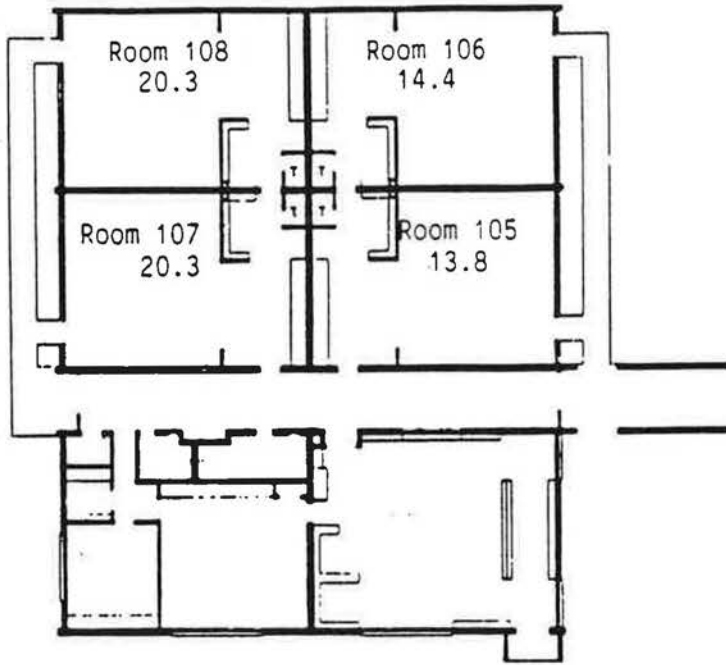
The area being studied is a four classroom addition, as shown in Figure 3. Each of the classrooms has a wall-mounted unit ventilator that has the ability to provide outdoor air when the damper is open. Although there is a large exhaust fan in the school (3600 cfm), according to school officials it is never used.

Figure 3. Results of initial radon measurements in wing of Maryland school, pCi/L.

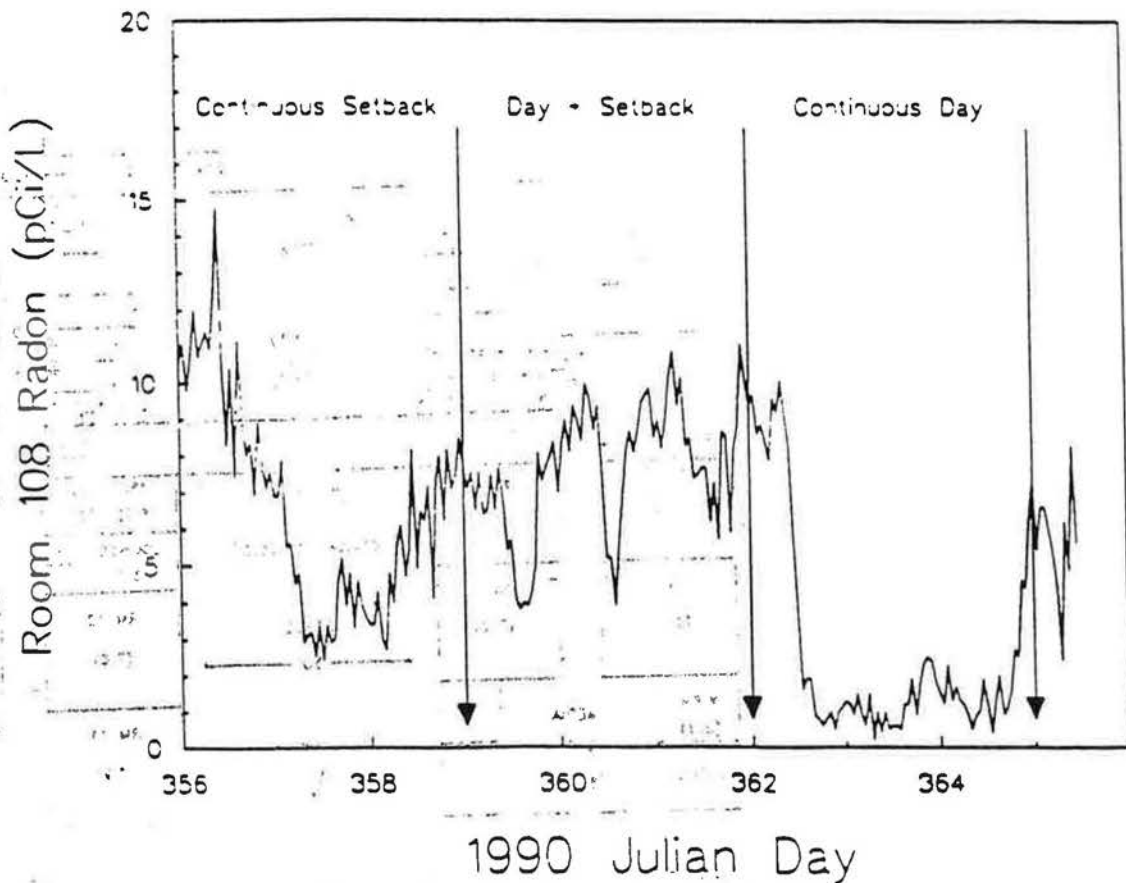
1) setback (no outdoor air), 2) normal operation (with evening setback), and 3) continuous operation with no setback (outdoor air provided for entire period). The fans for these units operate during setback unless room temperatures drop below 60°F. The radon levels measured in Rooms 107 and 108 during these three conditions are shown in Figure 4. As seen by these data, radon levels remain below 4 pCi/L while the unit ventilator is operated continuously but rise above 4 pCi/L during setback modes. Note that during the day-plus-setback operation, radon levels rise at night to about 4 pCi/L during the day.

Figure 4. Continuous radon measurements in Maryland school.

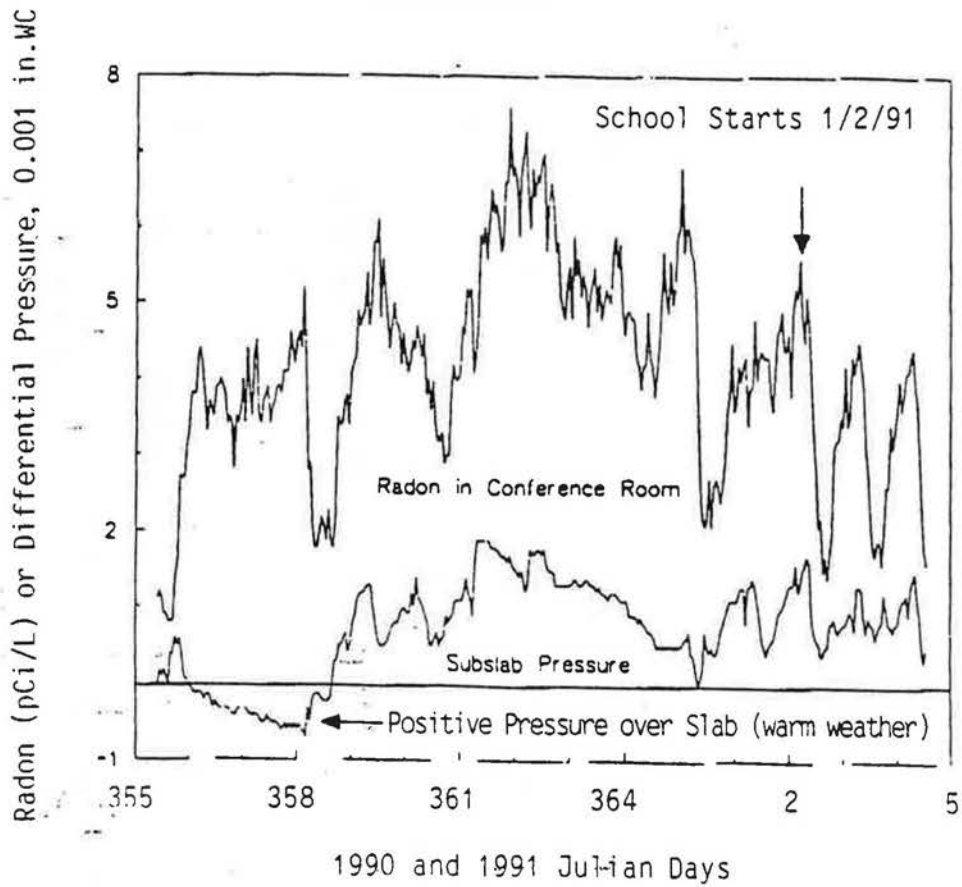
Differential pressure data showed the room to be at a negative pressure relative to the subslab, thus the air-handling units were not adequately pressurizing the building as intended. A datalogger was placed in a conference room December 21, 1990, to collect continuous radon, differential pressure, and temperature data. These results, displayed in Figure 7, show that radon levels are about 4 pCi/L when the room is at a negative pressure relative to the subslab. Radon levels tend to drop slightly as the room-to-subslab differential pressure approaches zero.

Figure 7. Continuous radon and differential pressure in Virginia school.

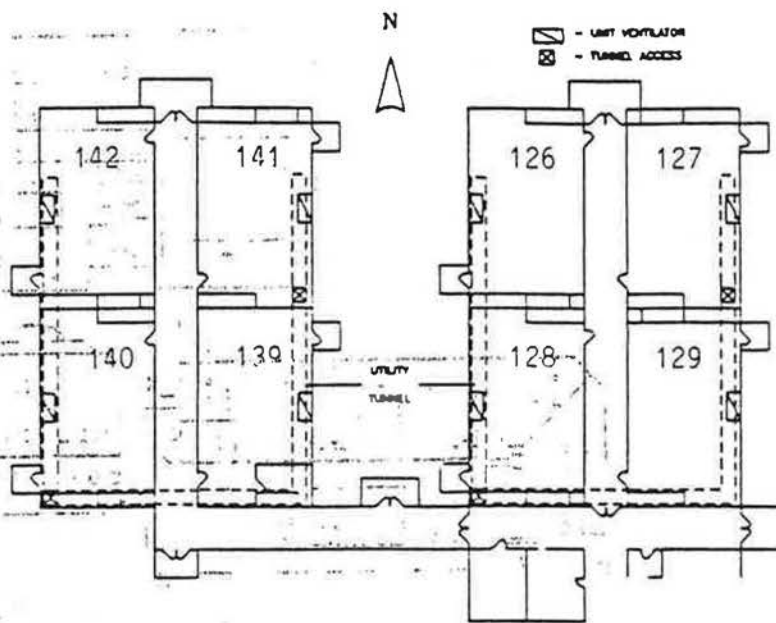
The piping was routed to each unit ventilator through tunnels under the slab, as seen in Figure 8. The return air for the unit ventilator was not isolated from the slab over the tunnel, thus any opening in the slab (e.g., a pipe sleeve, crack) would allow air from the tunnel to enter the unit ventilator and mix with the room air return and outdoor air. A high radon level in the tunnel could be the source of elevated radon levels in the room. Some openings were found around pipe penetrations, and radon levels in the tunnel averaged about 55 to 60 pCi/L.

Figure 8. Partial floorplan showing utility tunnel and room locations in Washington school.

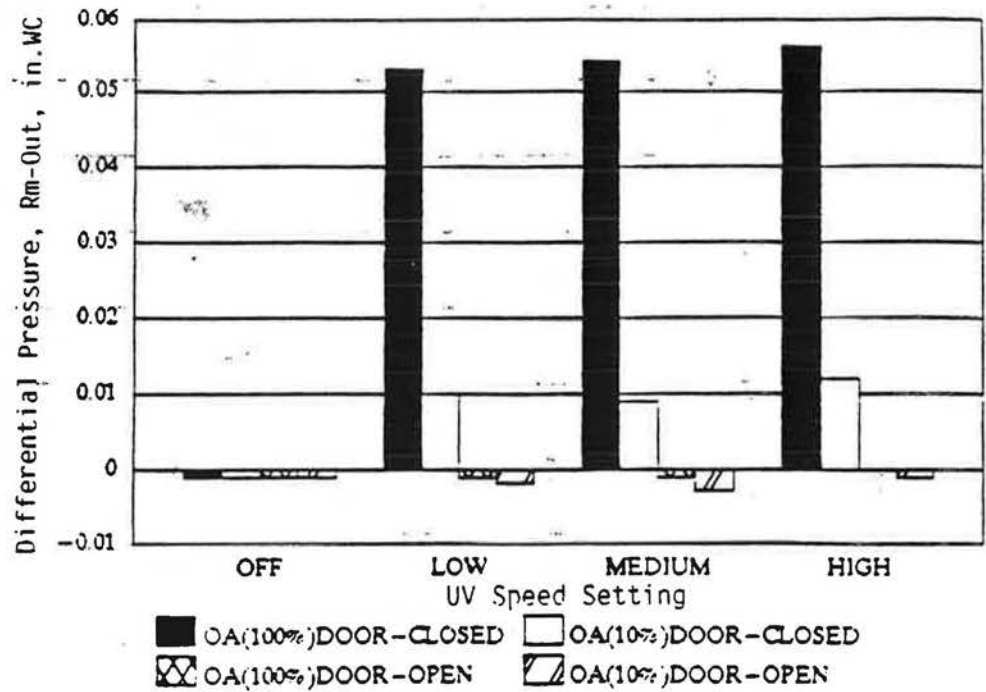
OBSERVATIONS: Room 139 (Library) could be pressurized with the unit ventilator, regardless of the outdoor air damper position, but only when the room-to-hall door was closed. It does not have an exhaust vent like the other rooms, thus it is easier to pressurize.

Figure 9. Differential pressure measurements in Room 139, August 1990.

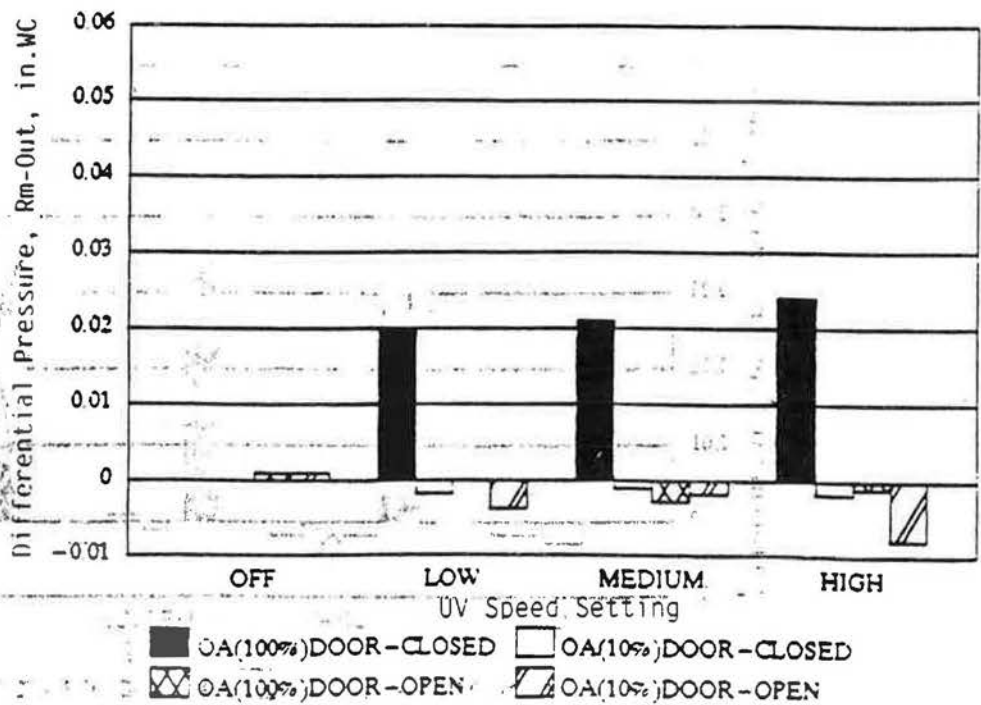
Room 140 could be pressurized with the unit ventilator, only with the outdoor air damper in the fully open position, and the room-to-hall door closed. This room has a passive vent and is more difficult to pressurize.

Figure 10. Differential pressure measurements in Room 140, August 1990.

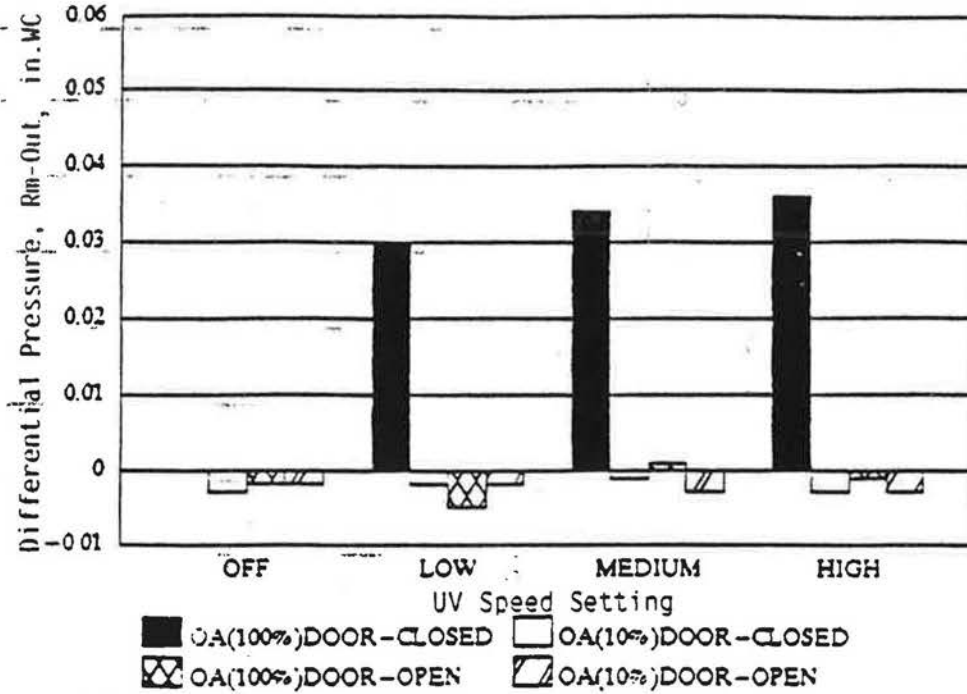
OBSERVATIONS: Room 141 could be pressurized with the unit ventilator, only with the outdoor air damper in the fully open position, and the room-to-hall door closed. This room has a wind turbine exhaust and is more difficult to pressurize.

Figure 11. Differential pressure measurements in Room 141, August 1990.

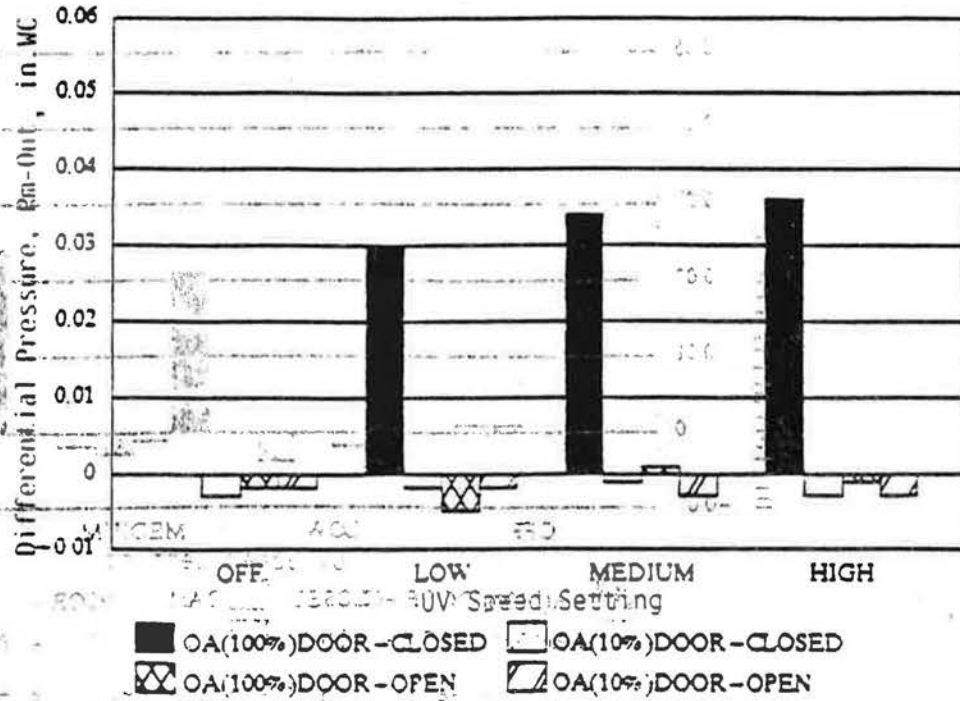
Room 142 could be pressurized with the unit ventilator, only with the outdoor air damper in the fully open position, and the room-to-hall door closed. The room has a wind turbine exhaust vent and is more difficult to pressurize, although the turbine was inoperable during these measurements. The outdoor air damper appears not to open fully.

Figure 12. Differential pressure measurements in Room 142, August 1990.
