RADON DIAGNOSIS IN A LARGE COMMERCIAL OFFICE BUILDING

by: David Saum and Marc Messing  
Infiltec  
Falls Church, VA 22041

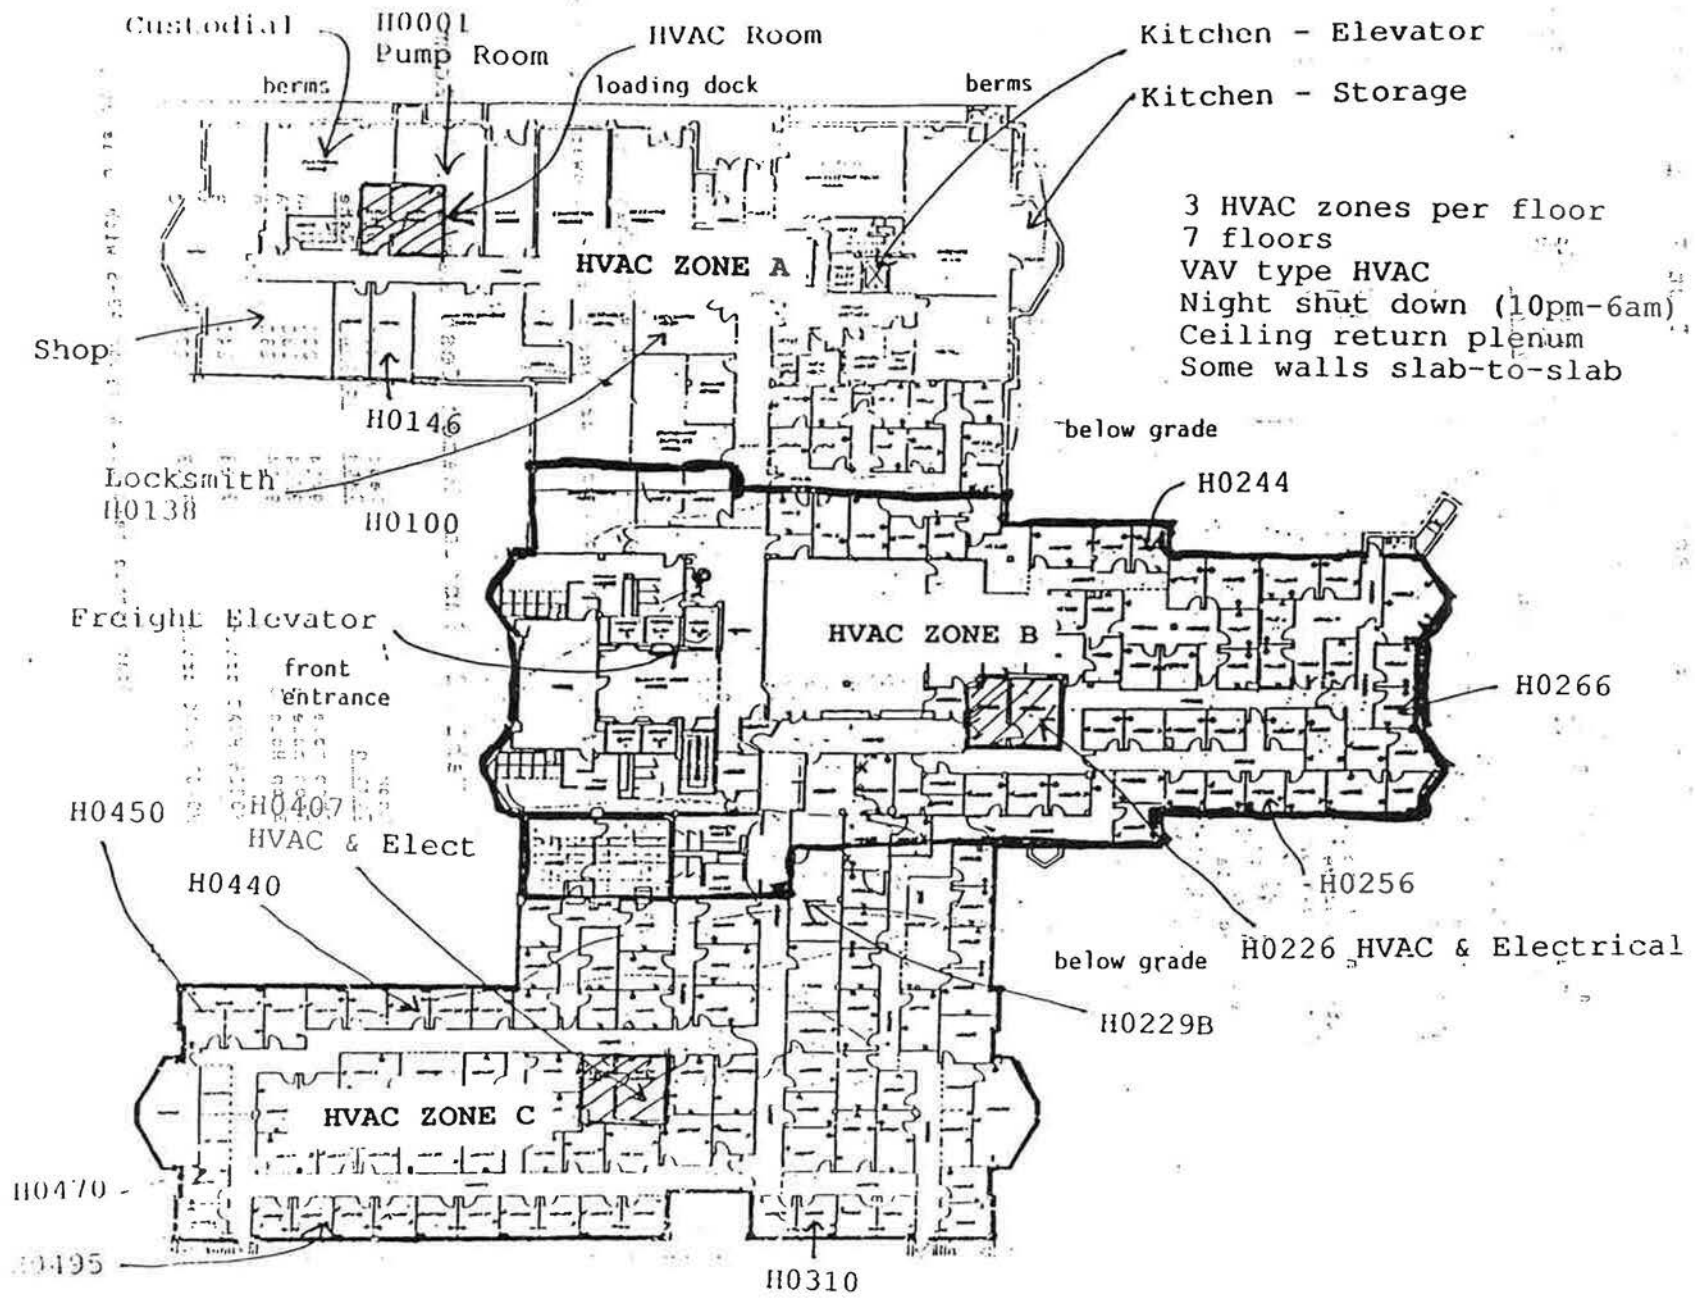
Figure 1 Basement Plan of Building

The ground floor of this Washington, DC Metro area 7 story, 5 year old building is underground except for a loading dock area. The HVAC system is a VAV type with 3 air handlers on each floor, supplies in most rooms, and a return plenum overhead. Figure 1 shows the floor plan of the basement and each of the three HVAC zones is outlined. There are a number of areas in the basement with slab-to-slab walls that may cross the boundaries of the HVAC zones.

Previous radon tests were made with alpha-track monitors deployed for three months during the summer and winter of 1989. Rooms indicated on Figure 1 are locations of radon tests. Table 1 lists all of the radon test results. When some radon levels above 4 pCi/L were found, all the building VAV units were adjusted to supply a minimum airflow of 30%, and booster fans were installed in the fresh air supply ducts. All of this work was assumed to guarantee that the building would be under a positive pressure while the HVAC system was on. No further radon tests were performed after these modifications, and one of the goals of the Infiltec work was to determine if the HVAC modifications have made a change in the radon levels. Additional goals include a determination of the pressure balances inside the building and suggestions for mitigation if elevated radon levels are found.

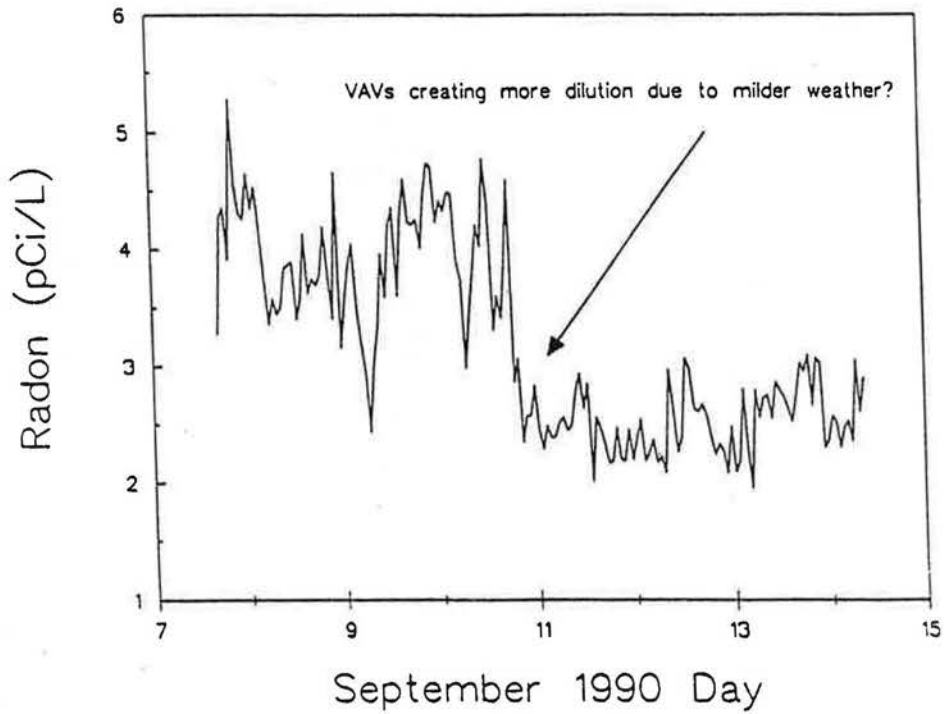
Figure 2 Continuous Radon in Zone B, Room H0226

Figure 2 shows what happened to the radon levels in one room in zone B which is expected to be representative of most of the rooms in this zone. On the evening of September 10 the radon levels fall from about 4 pCi/L to about 2.5 pCi/L and remain there. The electret data suggest that this is what happened in all the rooms in zones B and C. One possible explanation is that the onset of cooler weather on 9/10 may have changed the VAV settings to bring in more fresh air. At present the reason for this sudden change in radon levels is unknown but it seems to have only affected the radon levels in zones B and C. Since Figure 2 shows that the radon levels in zone B do not show a day/night fluctuation, it seems that radon is being constantly pulled into these zones during the day and that when the HVAC system shuts down at night there is no significant increased or decreased entry.

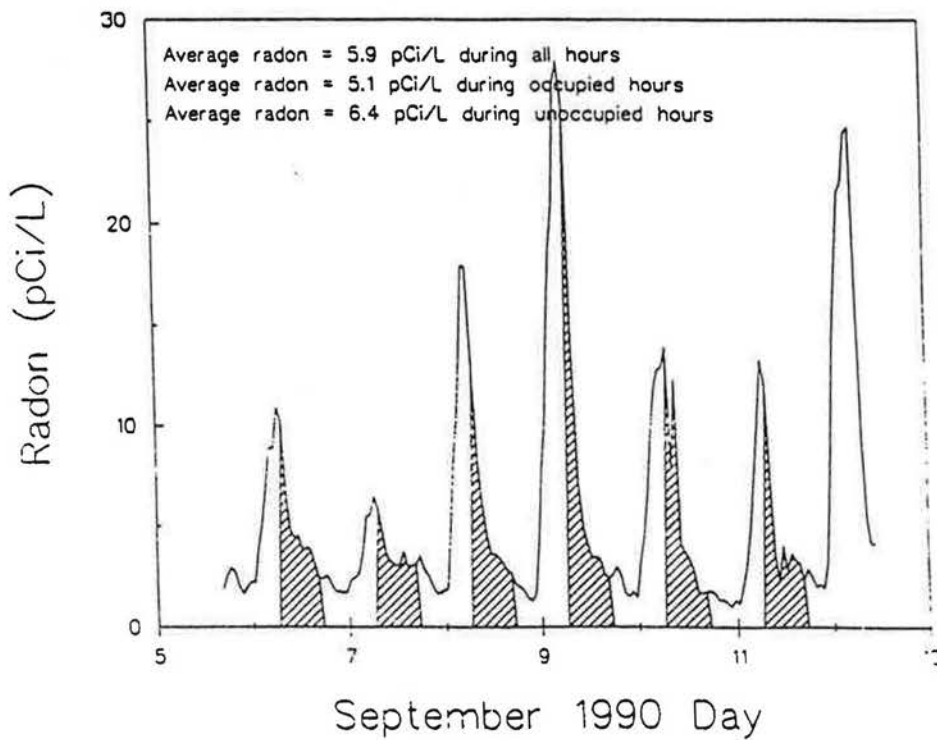
Figure 3 Continuous Radon in Zone A, Shop Room

Figure 3 shows that the radon levels in the shop area exhibit extreme day/night fluctuations with peaks up to 30 pCi/L at night and decreasing to 1 or 2 pCi/L during the day. The shaded area on this graph shows the radon levels during occupied hours (7 am to 5 pm), and the average radon during occupied hours is not very much different from the average levels during occupied hours because the HVAC system comes on at 7 am and it takes several hours to sweep the radon from this room. Some of this effect may be due to time lag in the CRM response. Note that Table 1 shows that radon levels in the rest of zone A rooms are quite low. There seems to be a strong radon source in the

shop that is suppressed during the day by either positive pressure or ventilation, but when the HVAC system shuts down this source raises the levels in the shop very quickly.

4. The radon source in the shop was not found and it might be easier to locate when the HVAC system was shut down. It is difficult to locate it during the day because the positive pressure in the shop appears to suppress the radon entry.

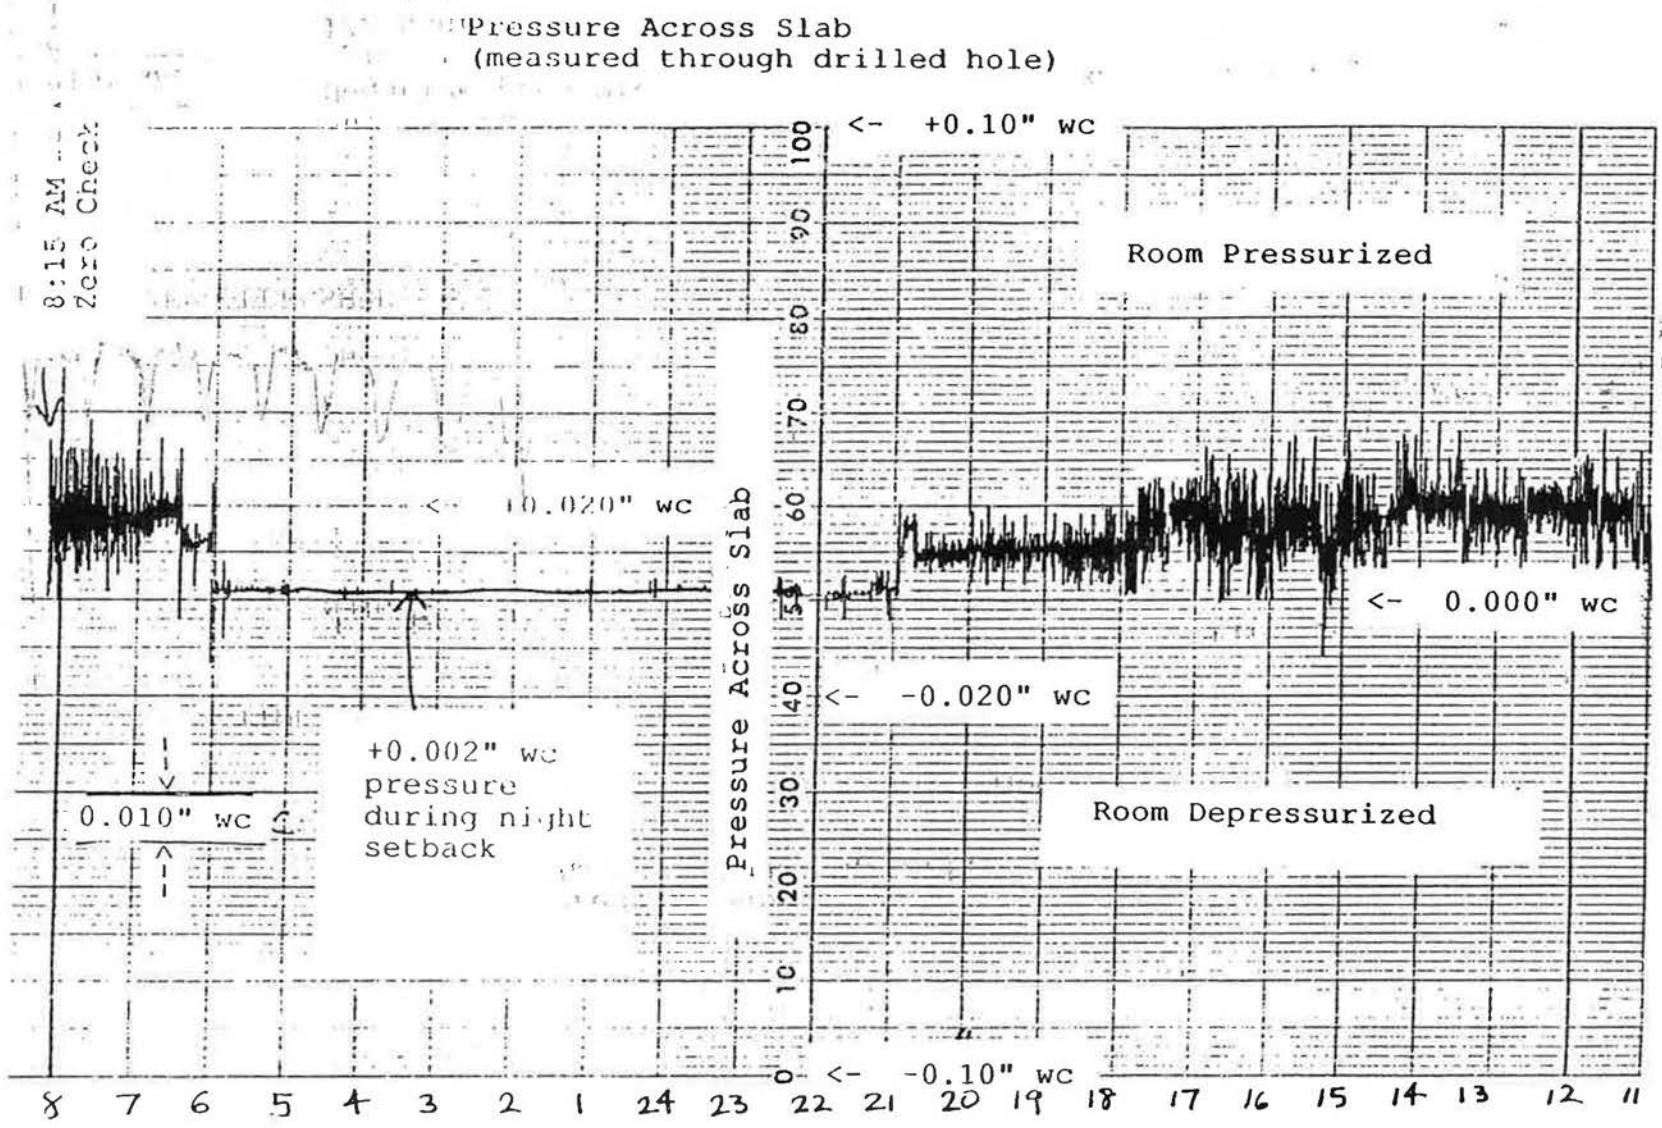
Figure 4 Continuous Pressure in Zone A, Shop Room

Figure 4 shows a recording of the pressure difference between the shop and the subslab gravel layer. This data was measured through a small hole drilled through the slab in the shop. The graph shows that there is a positive pressure in the shop (relative to the subslab) during the day of 0.01 to 0.02 inches of water column ("wc) and when the HVAC system is shut down at night there is still a positive pressure of about 0.002 "wc. The pressure in the shop relative to the hall was measured at about 0.007 "wc lower than the hall during the day (Table 1) and Figure 4 suggests that zone A is generally well pressurized by the HVAC system. It is generally assumed that if there is any positive pressure in a room relative to the subslab that all radon entry will be suppressed. Therefore it is surprising that the shop appears to be at a slight positive pressure even at night when the radon is entering. This suggests that the radon source is not in the subslab and that it may be somewhere in the walls. We have been unable to locate the entry point and it may be necessary to conduct further investigations when the HVAC system is not pressurizing the room.

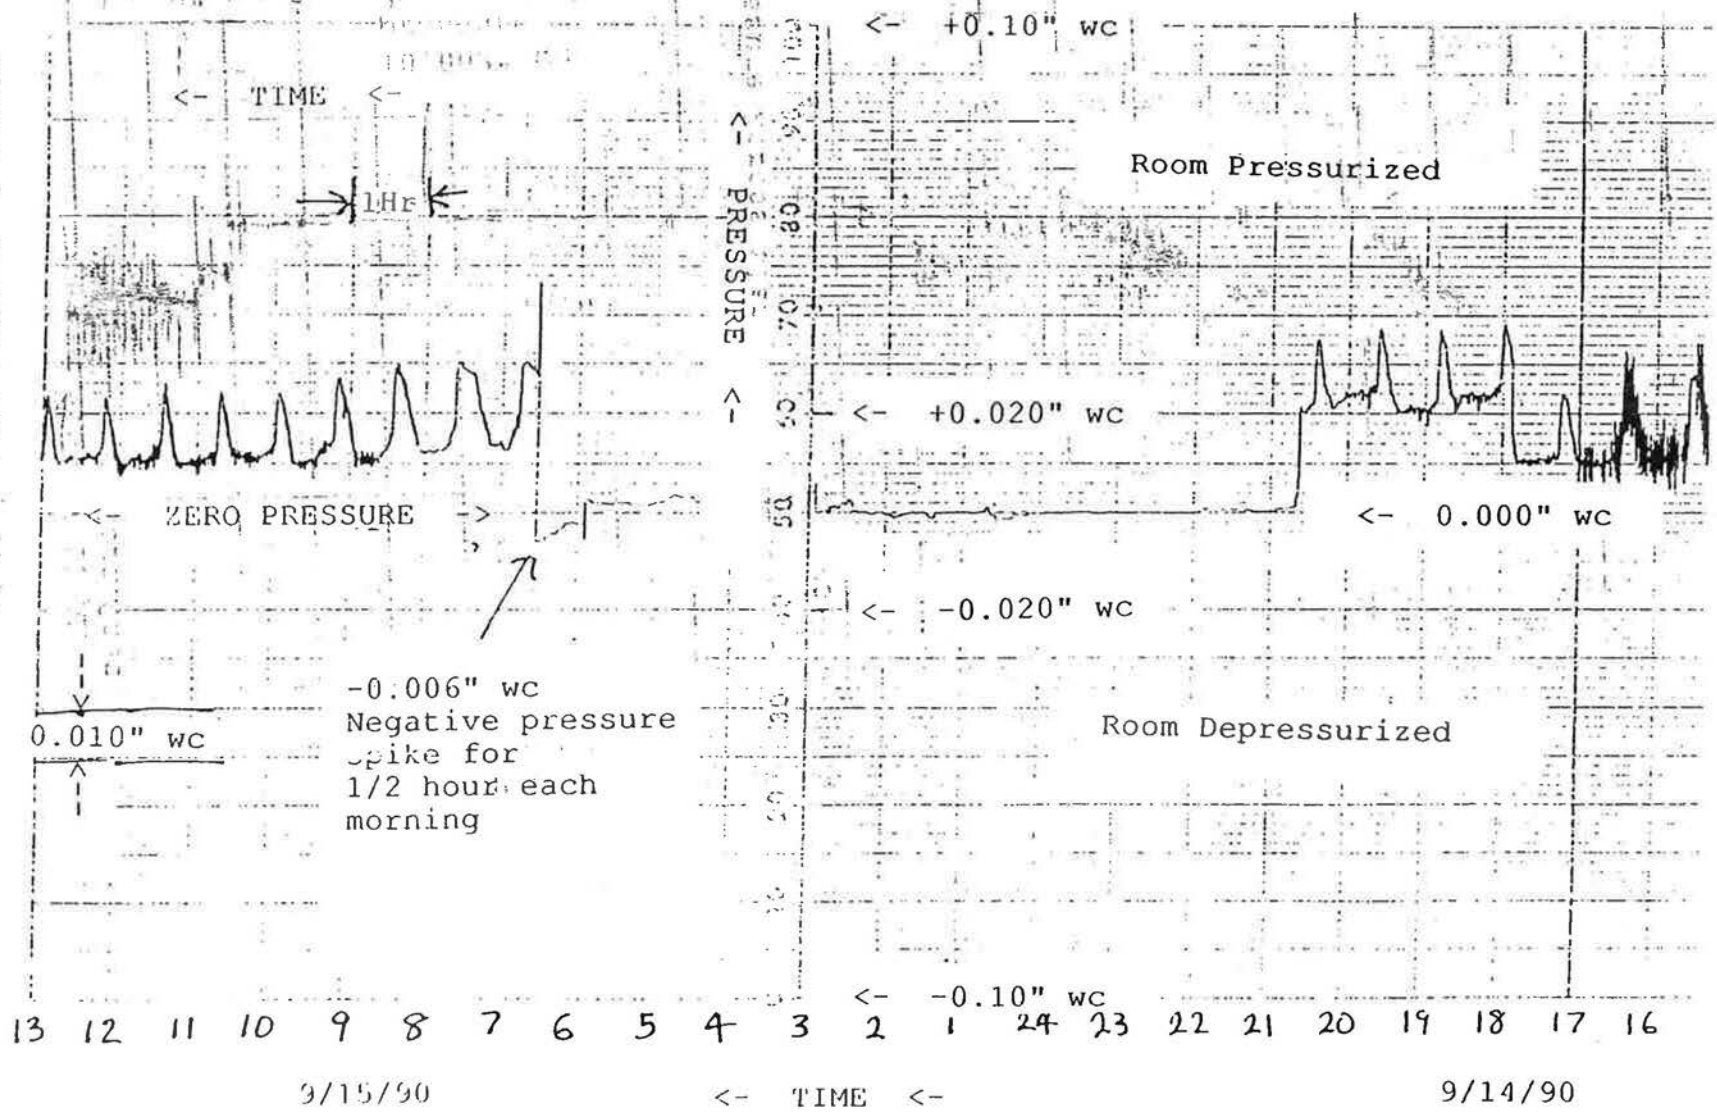
Figure 5: Continuous Pressure in Zone B, Room H0226

Figure 5 shows the pressures measured through a hole drilled through the slab in room H0228A in HVAC zone B. Again we see good HVAC pressurization during the day (0.01 to 0.01 "wc) and nighttime pressure around zero, with the exception of a half hour negative period (about -0.006 "wc) just before the HVAC system comes on in the morning. Note that several days of data were recorded and each daily pressure cycle is almost identical to the one shown. Table 1 pressure measurements made under the doors in zones B and C show that the only rooms that are significantly negative are the HVAC and electrical rooms. When these rooms were investigated for possible radon sources, drains were found that had large gaps around them leading directly to the subslab. When radon measurements were taken in these drains, levels of about 250 pCi/L were found (Table 2) together with significant air flow into the HVAC rooms. It seems reasonable to believe that the negative pressure in the HVAC rooms pulls in radon during the day and distributes it around zones B and C, and that when the HVAC system goes down at night this radon does not decay enough to show any decrease in levels.
