INVESTIGATION OF CRAWL SPACE VENTILATION
AND
MOISTURE CONTROL STRATEGIES
FOR B.C. HOUSES

APPENDICES

Research Division
Canada Mortgage and Housing Corporation

Sheltair Scientific Ltd.
#2 - 3661 W. 4th Ave.
Vancouver, B.C. V6R 1P2

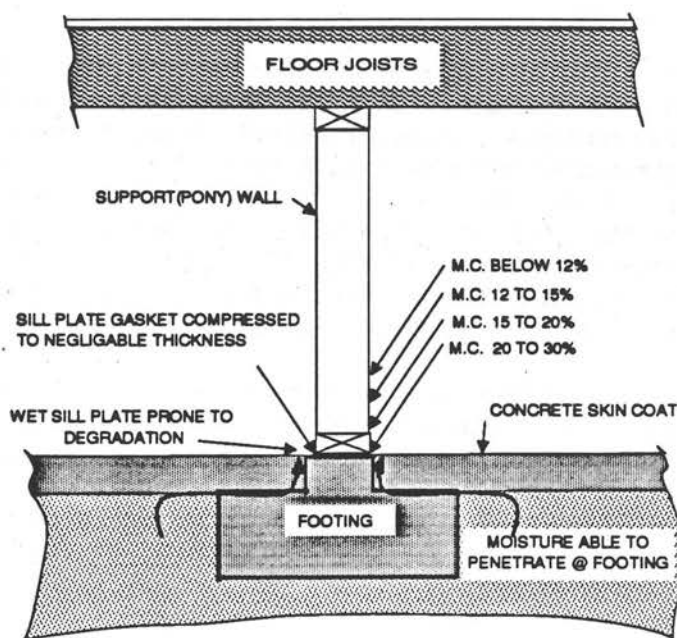
Figure A2-1: Typical support wall moisture gradient.

The absence of concrete curb walls for interior support walls may cause structural damage in many houses built in this manner. Three (3) of the houses visited had support walls built at floor level and in House #2 and House #10, measured wood MC's were greater than 20 % at the sill plates. These pony walls rest on a concrete footing that is flush with the floor slab. Moisture moving horizontally through the floor slab saturates the sill plates. Figure 4 shows the typical moisture gradient of sill plates resting on the slab.

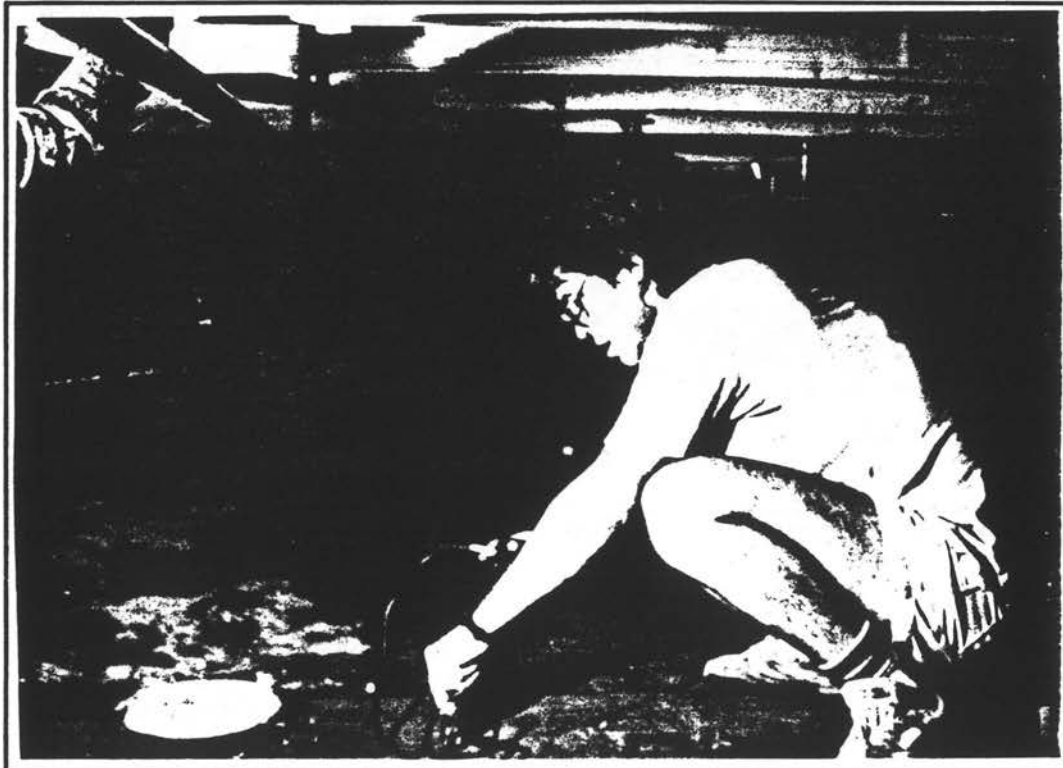
Figure 2: Moisture measurement in wet area

Problem History & Remedial Measures Taken: Large wet areas were found on the C.S. floor. Concrete was found to be cracked in some sections. Occupants experienced high humidity in all areas of the house, condensation on windows in winter and odours in the living room in fall & spring. Two weeks after our visit NHWP proceeded to take measures to reduce moisture. Six (6) passive vents were cut through headers and the entire floor above the C.S. was insulated with RSI 2.9 batt insulation. Heating ducts were also wrapped with batt insulated. A 0.5 m X 3 m test strip of polyethylene was placed on a wet area of the floor by NHWP to test its effectiveness.

Test Results & Observations: High summer temperatures, humidity and winds prevailed on the day of testing. MC content of the crawl space floor was $> 85\%$ in areas though the wood MC was low. In winter conditions, the wood MC is expected to be much higher and a return visit is planned to verify this. Air leakage testing was difficult because of high winds and also because of the location of the crawl space hatch. The ELA of the crawl space was 1340 cm^2 . This figure includes the below floor leakage (Qa) and the interface leakage (Qb). The house ELA was 928 cm^2 (Qc).

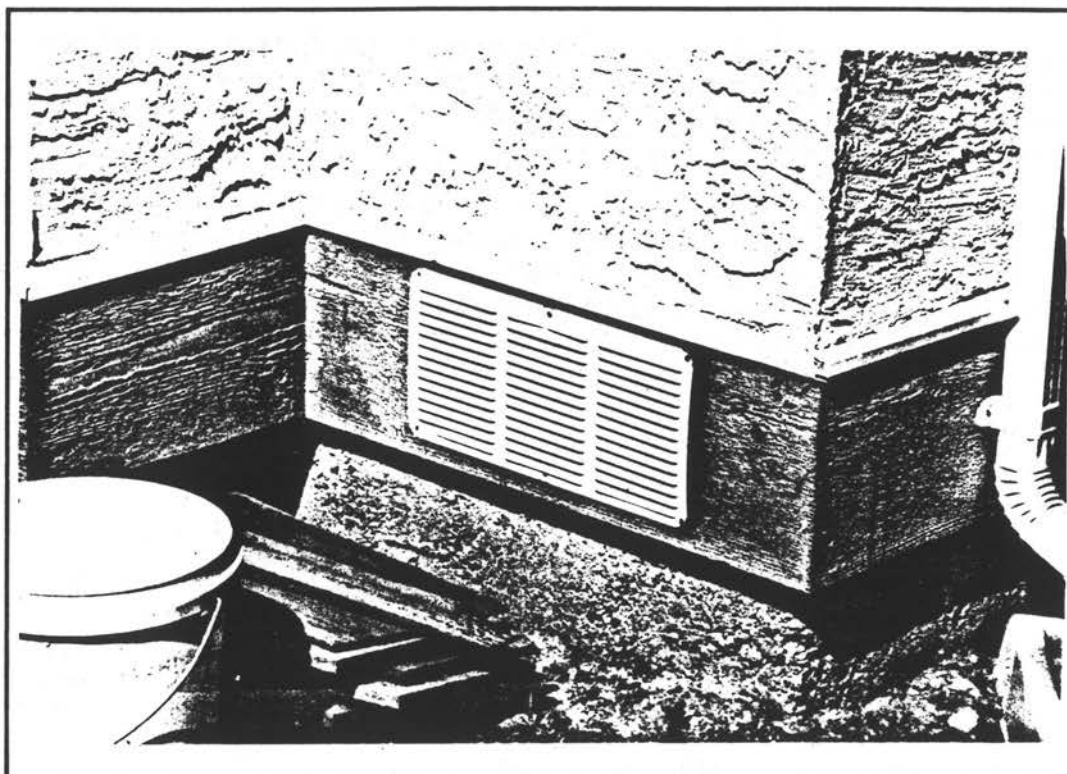
Figure 4: Crawl Space Vent

Crawl Space Description: The crawl space of House #2 was initially a heated and non-vented but groundwater problems led to remedial measures by NHWP. Before our visit, six 300 cm² inoperable louvred crawl space vents were installed by NHWP. Insulation was initially applied to C.S. perimeter walls but again had been removed by NHWP to reduce condensation on the concrete. Joist headers were insulated with RSI 1.75 batt insulation. As in House #1 heating is provided to the crawl space from 2 supply outlets cut directly in the main plenum, fitted with 50 mm X 300 mm grilles. There is also a return grill and a 5" return duct in a far corner of the space fitted with a damper. The duct is presently sealed.

Problem History & Remedial Measures Taken: Groundwater entry into the crawl space was the main persistent problem which was addressed by NHWP who tried several techniques to resolve the situation including 1) installing vents, 2) removing insulation, 3) adding a dehumidistat operated fan, 4) applying at least two types of concrete sealants to the crawl space floor and finally 5) covering the slab with a layer of 6 mil poly. The poly barrier was the most effective at reducing the moisture level but did not stop water entry into support-wall sill plates, resting directly on the slab. The absence of a concrete curb under the walls may result in yet another expensive and labour intensive task - reconstruction of the support walls. Occupants experienced high humidity in all areas of the house and condensation on windows last winter and a musty odour in the living room most of the time.

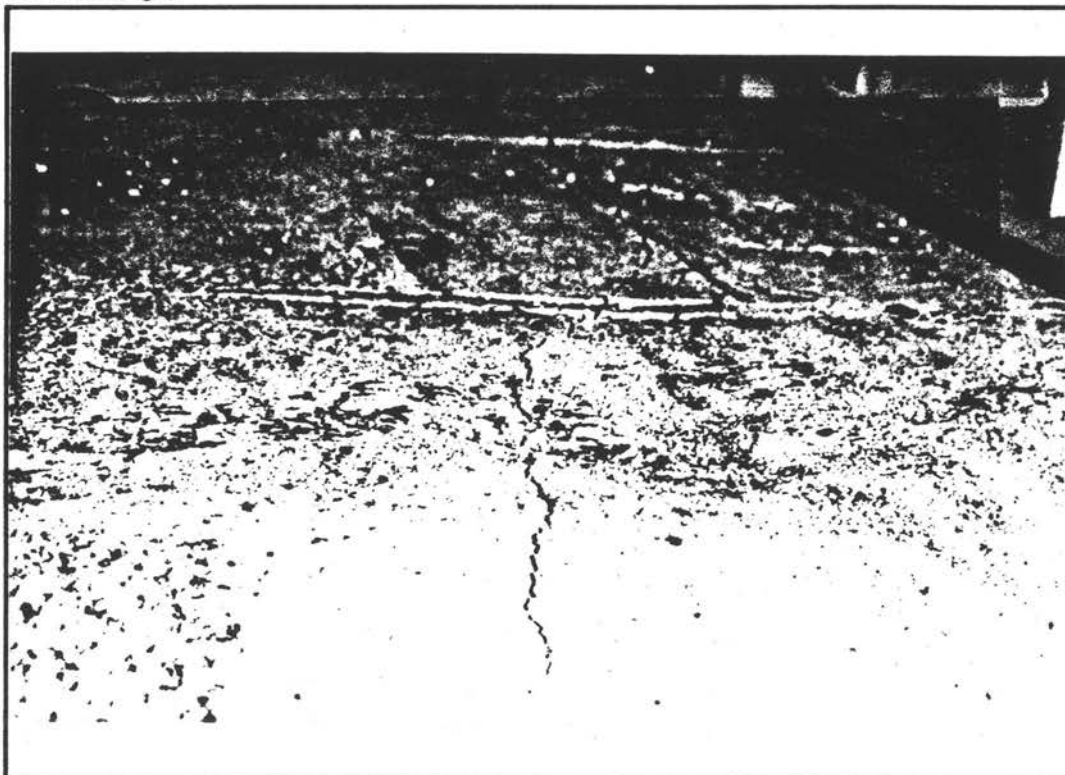
Figure 9: Cracks in concrete skin coat.

Extensive cracking of the skin coat was common to all houses. House #5 and House #8 slabs were the most severe effected. These were also two of the driest crawl spaces. In House #8, examination of a large crack permitted investigations to assess whether concrete cracking might be effecting the vapour seal. It was observed that a 12 mm wide crack in the concrete had no effect on the poly barrier which remained intact.

Test Results & Observations: Tests were performed in mid October in mild dry weather. Air leakage tests were performed and the interface ELA was measured to be 285 cm² and the crawl space 332 cm². MC levels in both wood and concrete were normal except in one small area where concrete at the base of the perimeter wall was wet. Measured MC of the concrete wall at that point was 55% and the floor 85 %. Concrete was notably cracked in several areas as can be seen in the photograph below. This implies fast curing with no expansion joints provided to accommodate for the shrinkage.

Modification of the crawl space construction had been considered for this house. Project limitations made this an unworkable option.

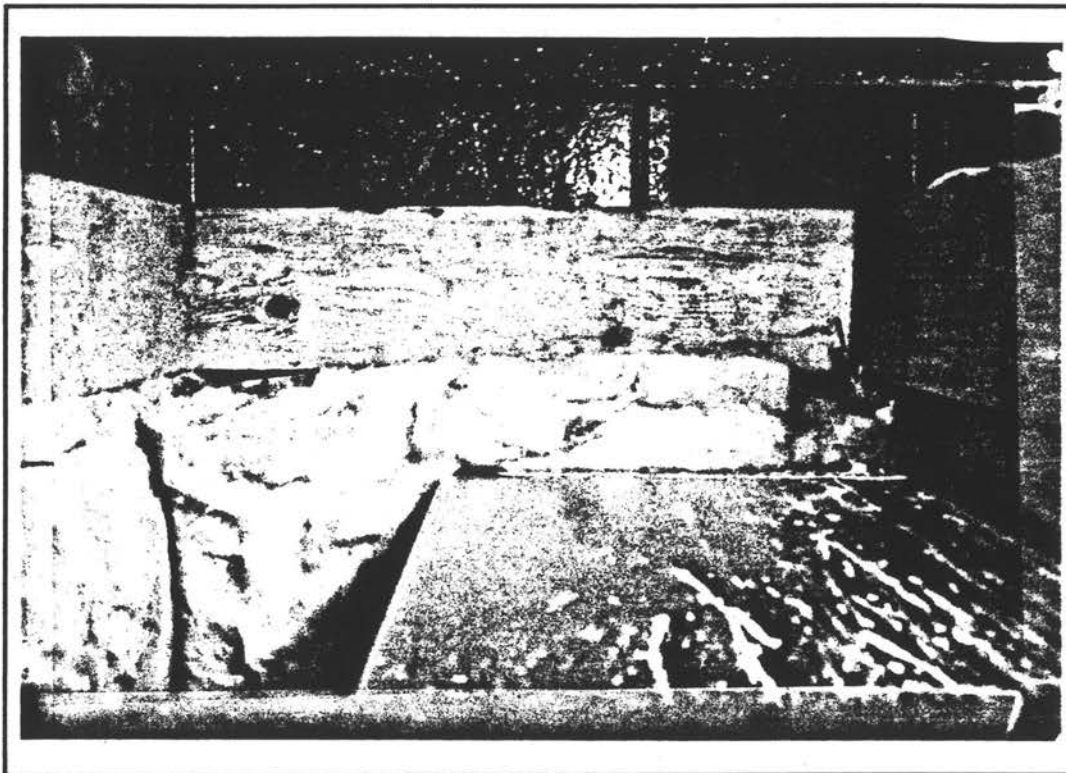
Figure 13: Condensation in Chimney Cavity

- In House #6, an especially confusing problem misled the contractor into unnecessary expense. Incidence of water, pooling under a chimney cavity in the crawl space, led to an assumption that the drain tile was blocked or damaged. The entire front elevation of the house was re-excavated and drain tile replaced. To ensure quick migration of groundwater drain rock was installed to a full 1 metre in depth above the footing. It was later determined by Sheltair that the water pooling had been caused by the migration of moist crawl space and house air into the back of the fireplace opening. Moisture was condensing on the cold masonry and metal surfaces in the chimney cavity then running down the inside foundation wall into the crawl space. This type of confusion reflects a need for builder education or technical support services in the area of moisture, humidity, and foundation construction.

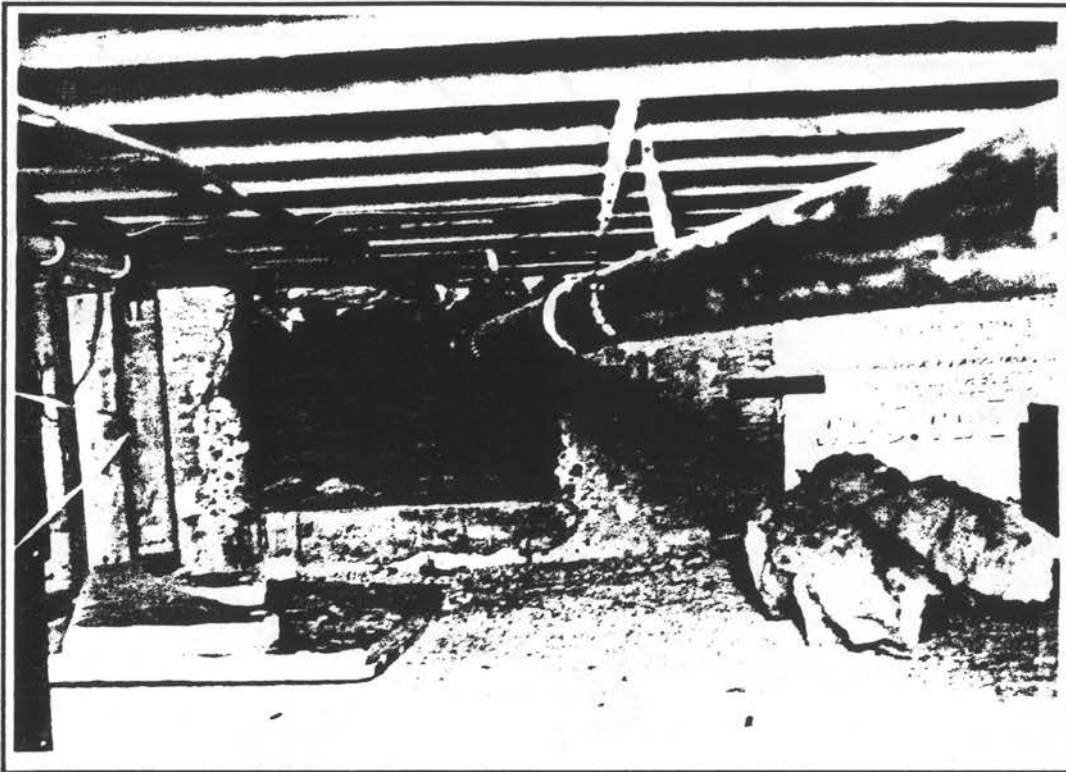
Figure 15: Access between heated and non-heated portion of crawl space.

Crawl Space Description: The crawl space is split into two distinct construction types corresponding to the new and existing sections of the building.

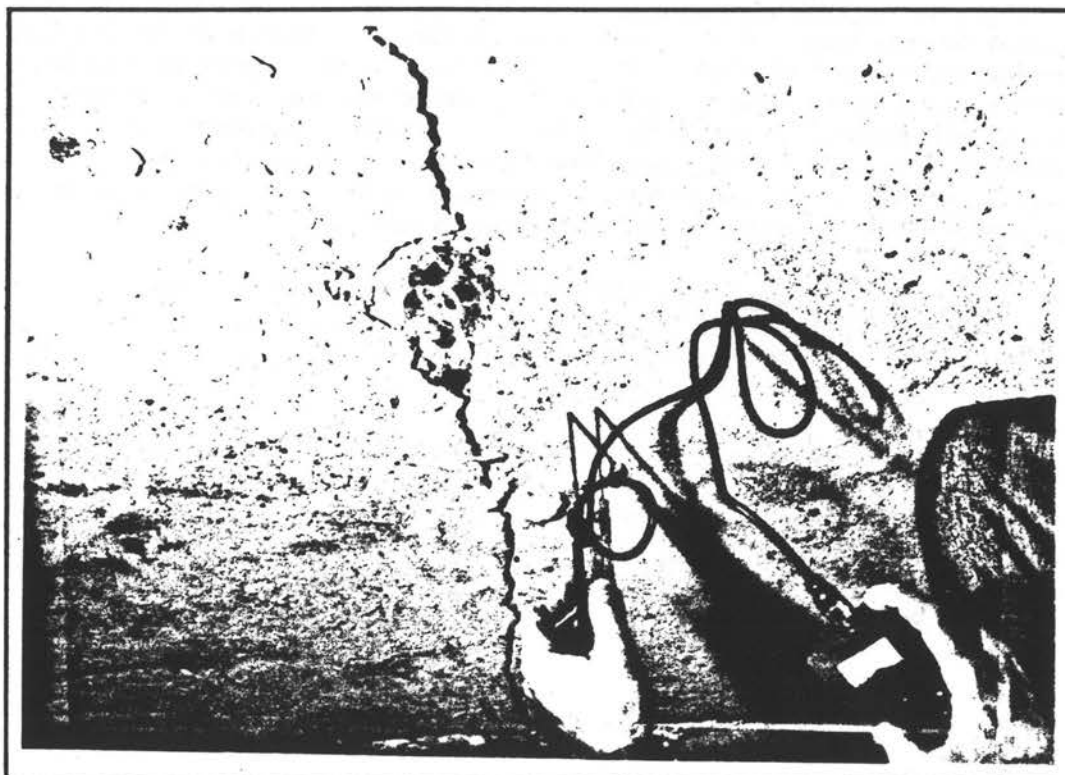
Figure 17: Crack in Thin Concrete Revealing Poly

Crawl Space Description: Crawl Space floors covered with a skin coat of concrete, overtop of a 6 mil. polyethylene barrier. The poly is lapped up and visible around the perimeters in most locations, and also through cracks in the skin code in various locations. The inside of the crawl space foundation wall is insulated with one inch expanded polystyrene board insulation from sill plate to below grade. In accordance with typical construction practice, each board of insulation is attached with two nails to the concrete, causing the boards to bow away from the wall and destroying the effectiveness of the insulation. Pieces of RSI 2.9 batts are stuffed in the joist ends. Supporting pony walls in the crawl space are sitting on a foam gasket and concrete curb.
