Minor Adjustments Solve Air Quality Problems in Italian Building

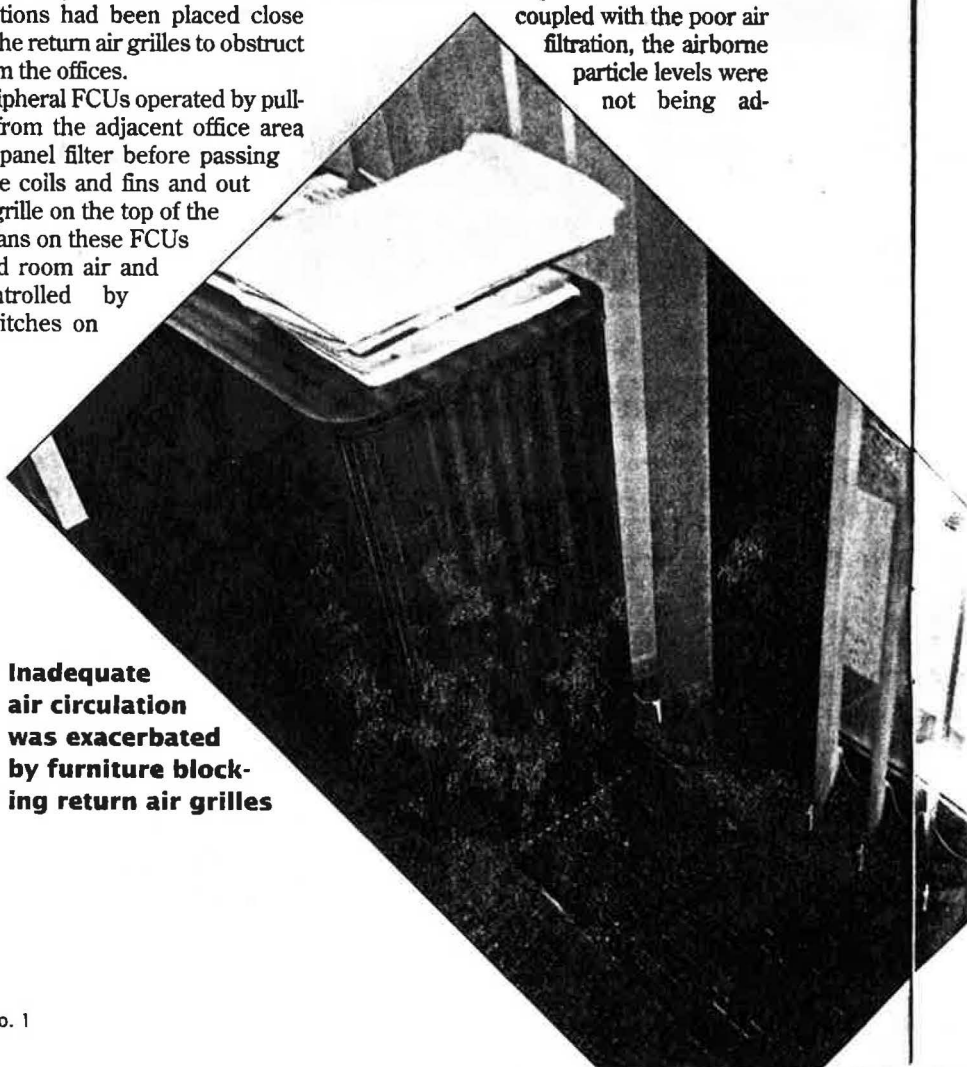
were fitted with a gridwork of ceiling tiles hanging perpendicular from the suspended ceiling to form a honeycomb effect. These were designed for sound attenuation, but the vertical panels greatly interfered with the supply of air and its circulation since the air supply diffusers fitted almost flush with the drop-ceiling. This meant that the air flow from the diffusers instead of being "four-way" became "one-way"—almost vertically downward. With the combination of the return air grilles being almost at floor level, and only on certain columns, the result was the uneven distribution of air in the offices with many "dead air pockets." The situation was exacerbated in many areas where desks or office partitions had been placed close enough to the return air grilles to obstruct air flow from the offices.

Inadequate air circulation was exacerbated by furniture blocking return air grilles

Finally, the installation of the acoustical baffles across the ceiling, in an attempt to reduce noise levels, was inadvertently contributing to poor air distribution. The latter being further exacerbated by the careless positioning of office furniture directly in front of the return air grilles inside the office.

up the vertical "honeycomb" of ceiling tiles. By removing sections of tiles that interfered with the correct air distribution from the ceiling diffusers, air circulation was vastly improved. The furniture blocking the return air grilles was moved to allow better air circulation.

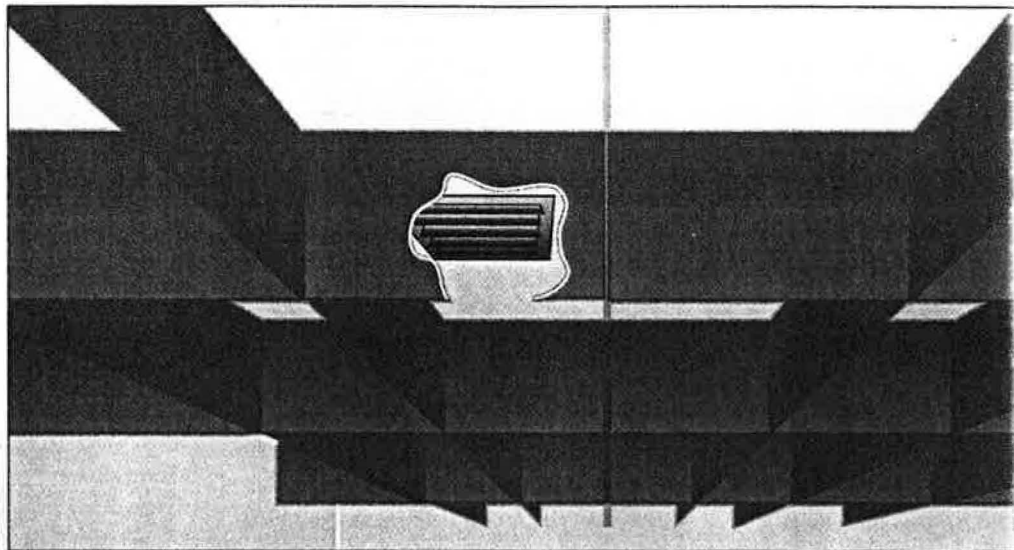
Dead air pockets were created throughout the office when a gridwork of ceiling tiles was installed perpendicular from the suspended ceiling to act as a sound buffer

The lack of adequate air circulation in the office areas was addressed by opening up the vertical "honeycomb" of ceiling tiles.
